# PRESIDIO THEATRE BUILDING 99

Historic Structure Report

August 2015

Presidio  
Trust

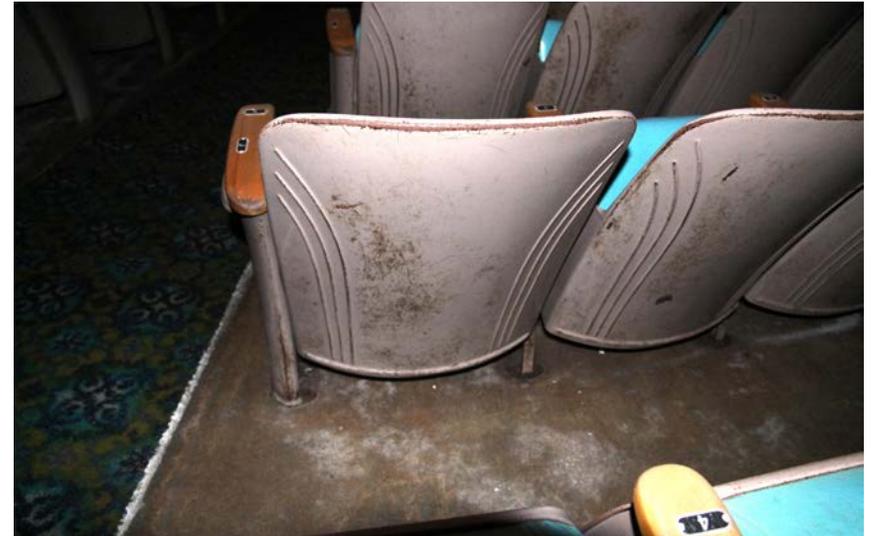
1.11 (upper left, clockwise) A comparison of historic photos and existing conditions concludes that the armrests, backs and legs of the extant chairs are not original to the theatre. (2014, Pons-Sorolla, PT)

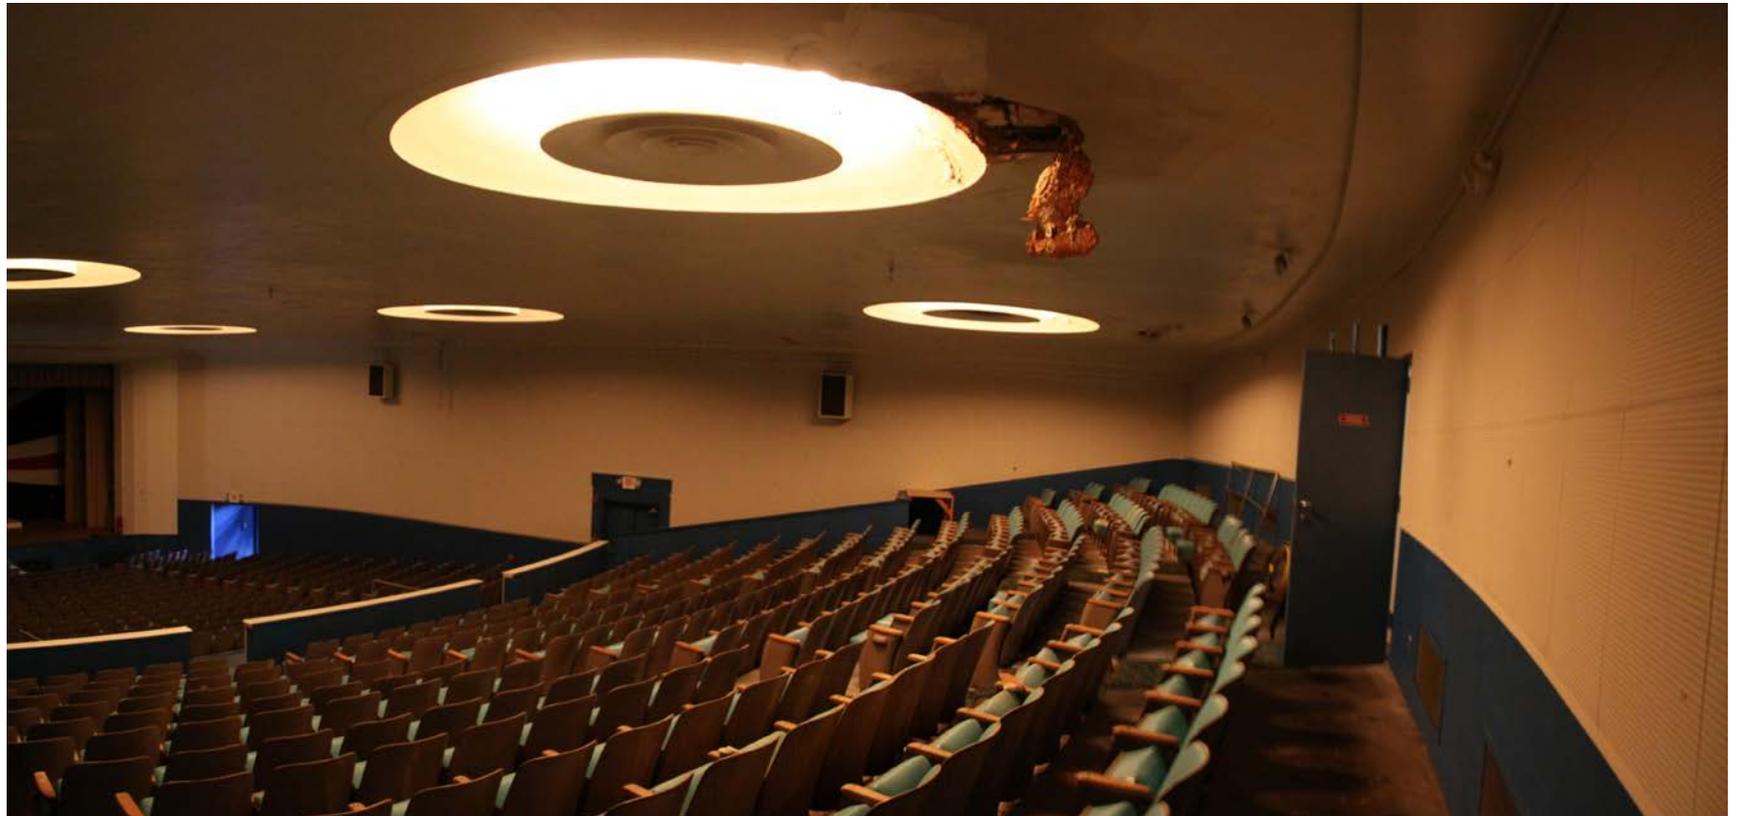
*2.69 Room 12. Upper auditorium seating looking east. Ceiling damage caused by water infiltration. Projector Room door on right. (2014, PT)*

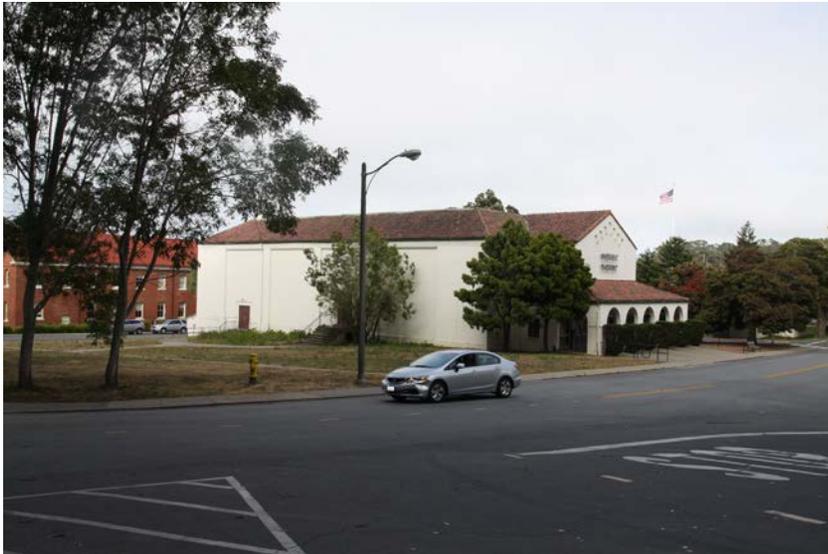
2.102 The current condition of the west elevation shows only remnants of the original foundation plantings. The hedge at the edge of the forecourt has been removed. (2014, PT)

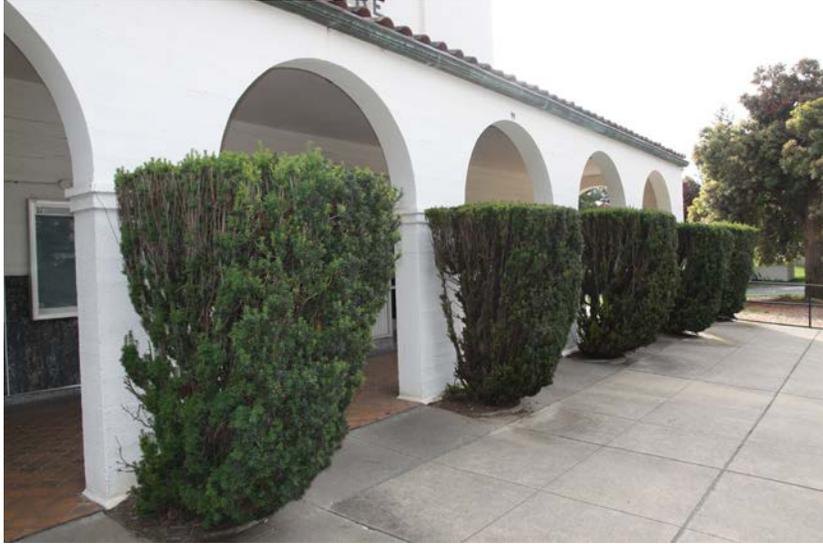
The forecourt is in good condition however the concrete semi-circle yew tree planters have lost their crisp edges. An examination of the planters shows a slight variation in concrete color and a minor grade change. Though the yews are intact, they have been topped but are in fair condition.

2.103 Topped yew trees are set within deteriorating concrete planters at the north end of the Theatre's forecourt. (2014, PT)

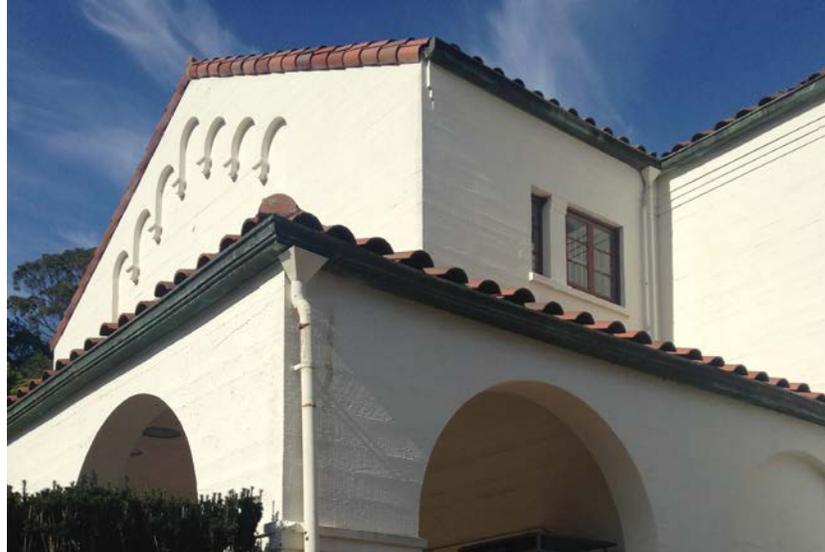
3.2 Exterior crown detailing and the gable ornamentation is crisp and in good condition. (2014, PT)

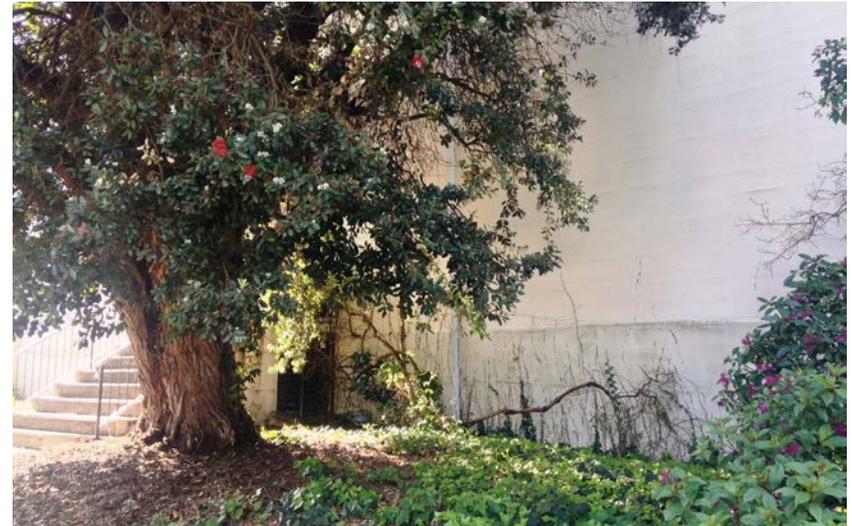
3.4 Current and past evidence of damage caused by foundation plantings can be seen on the east elevation. (2014, PT)

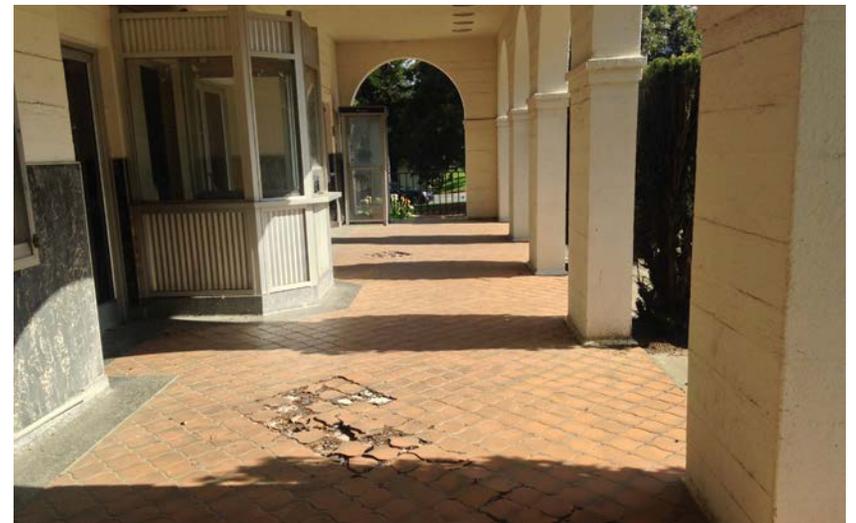
3.10 The loggia looking east. The delaminating and broken tile continues to worsen. (2014, PT)

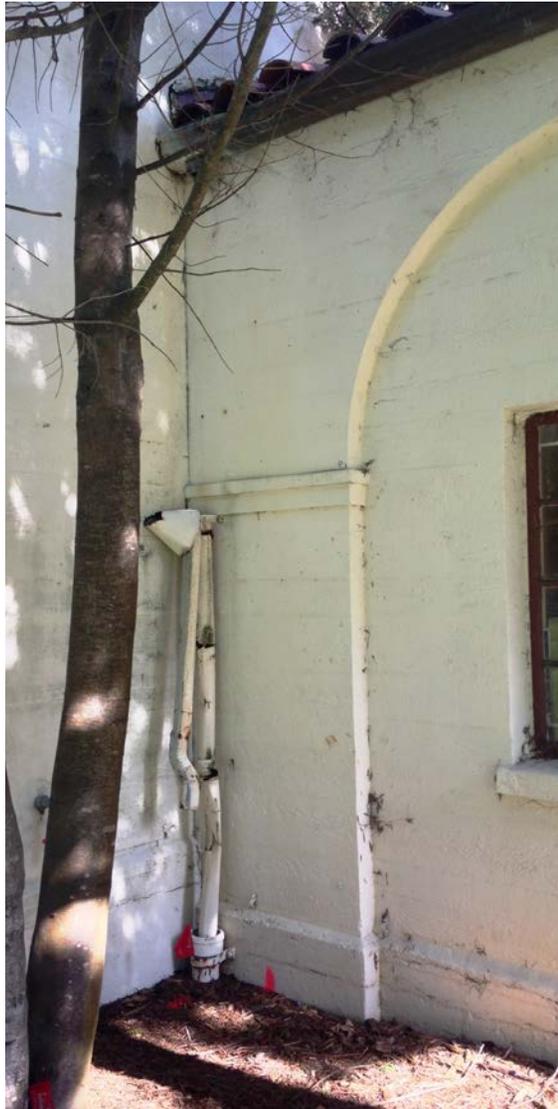
3.13 At this corner near the west office shows a dismantled downspout. (2014, PT)

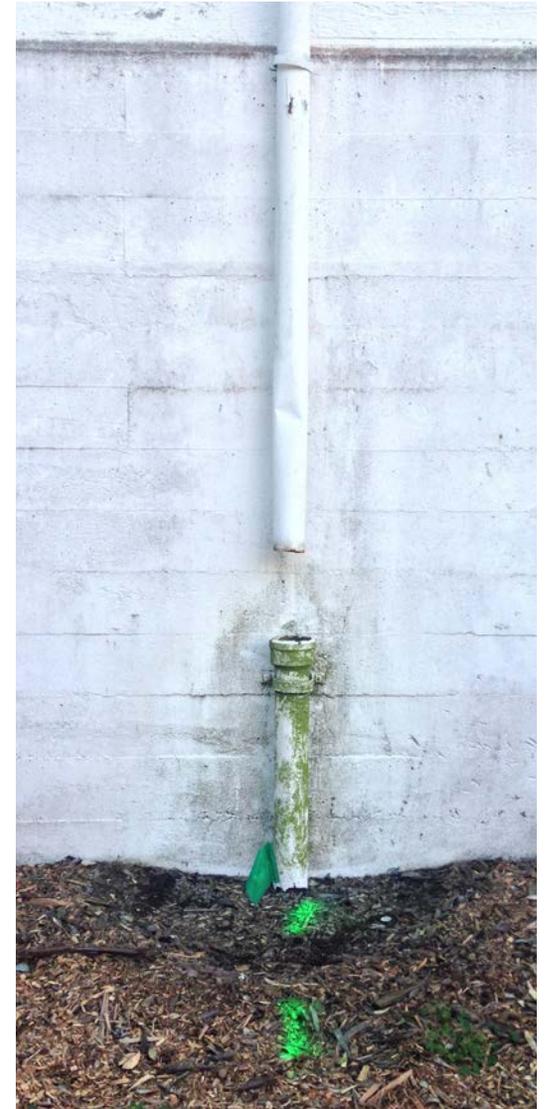
3.14 A portion of this north elevation downspout is missing. (2014, PT)

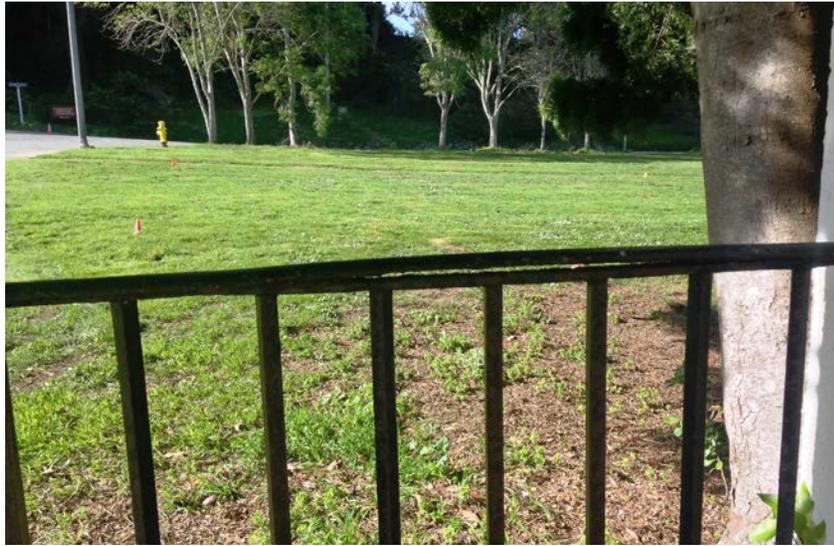
3.15 The top rail at the west loggia opening, is rusting and has split. (2014, PT)

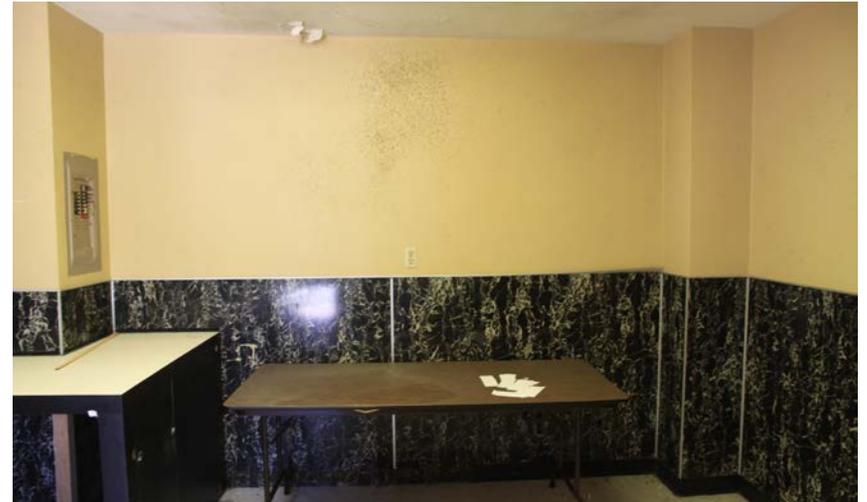
3.37 Mold and peeling paint on the north wall and ceiling in the west office suggests water infiltration. (2014, PT)

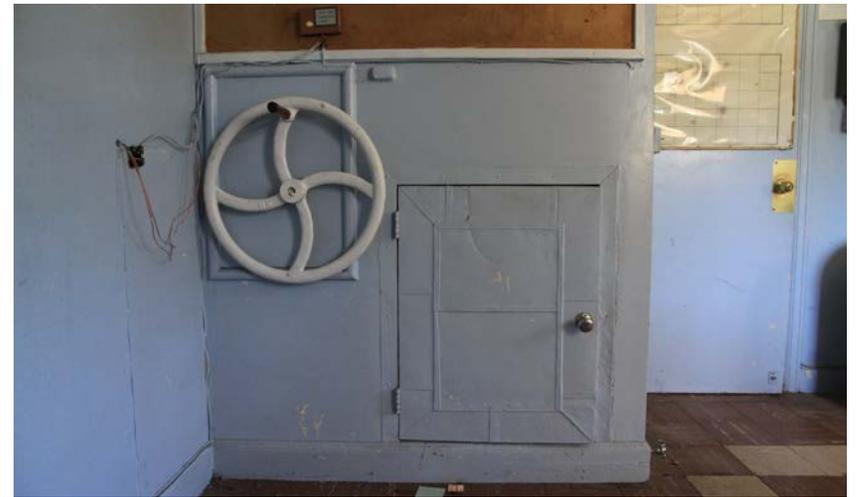
3.53 The wood-frame dumbwaiter with a metal shaft, metal door and elevator wheel is in fair to good condition. There is evidence that updates to the dumbwaiter included electrifying the system; it is uncertain whether the manual or electric systems are functional. (2014, PT)

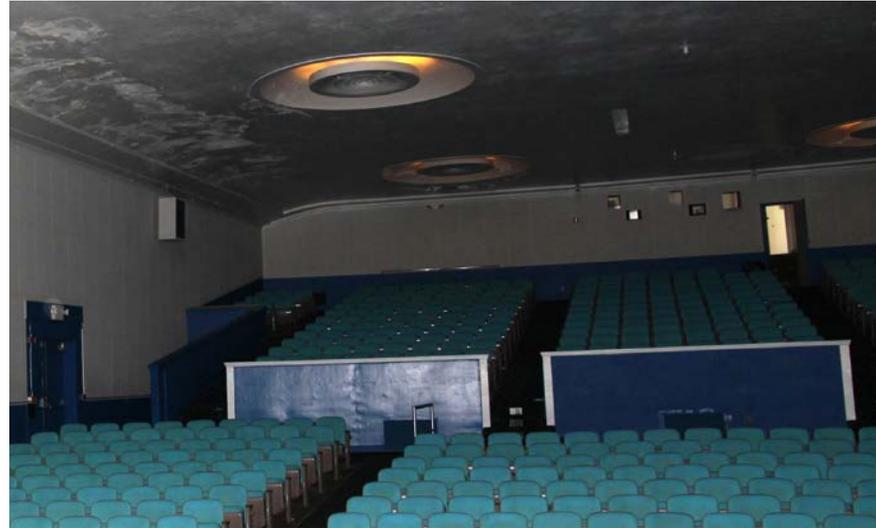
3.60 The partial height plaster-concrete partitions with a wood cap that separate the upper and lower seating sections are in good condition. (2014, PT)

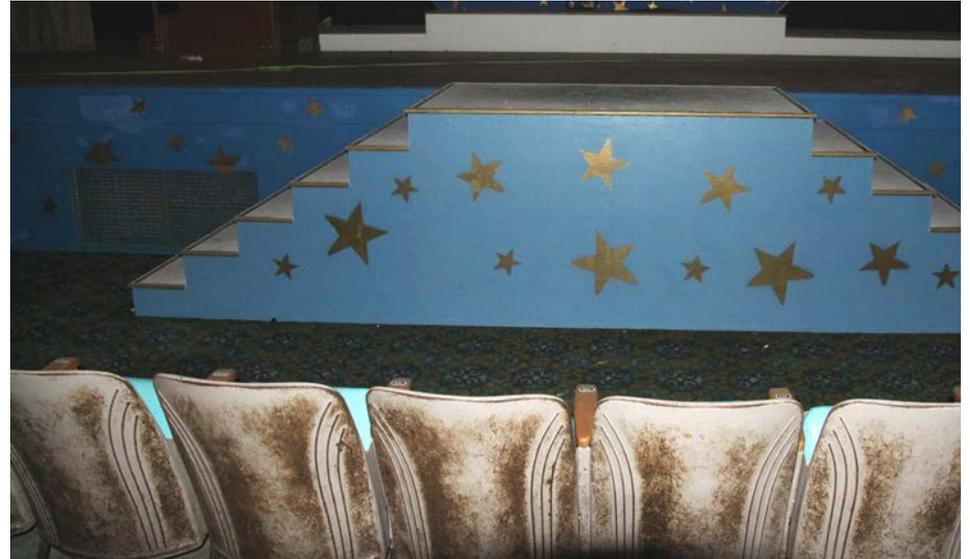
3.62 Rust is evident on the backs of these seats in the front row. (2014, PT)

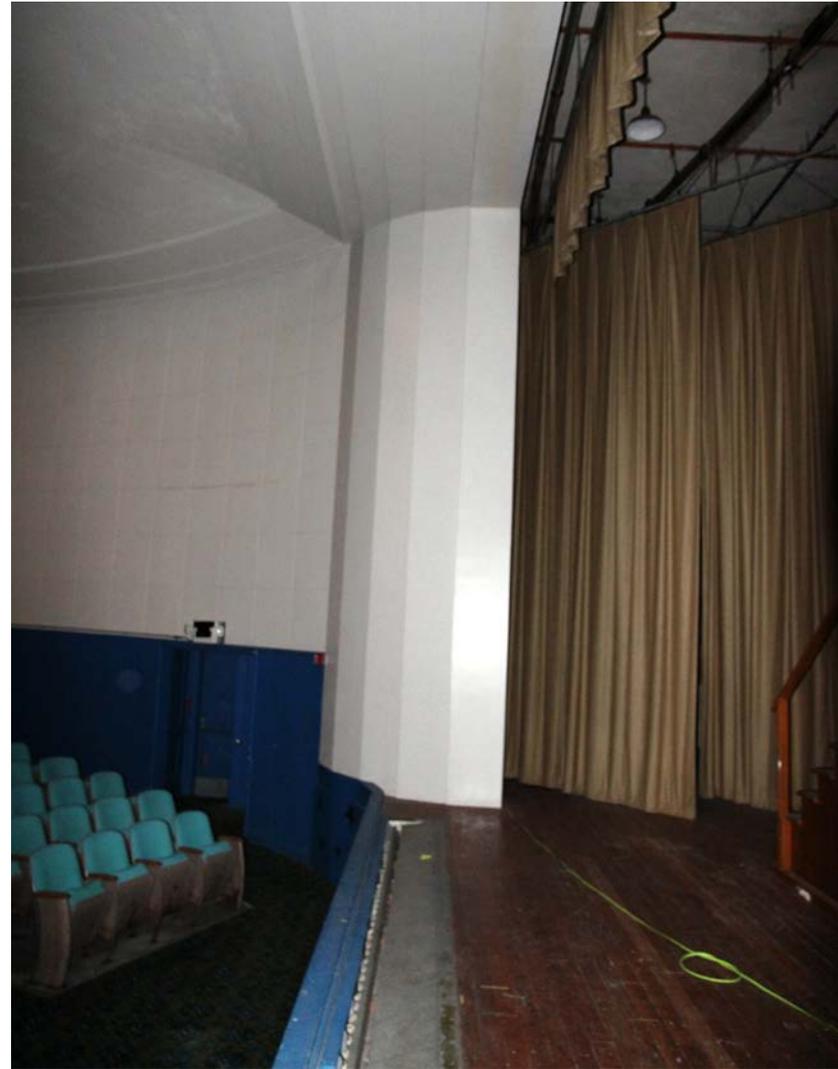
3.67 The proscenium is an original feature that is in good condition. The plaster finish of the proscenium retains its original material finish and detailing. (2014, PT)

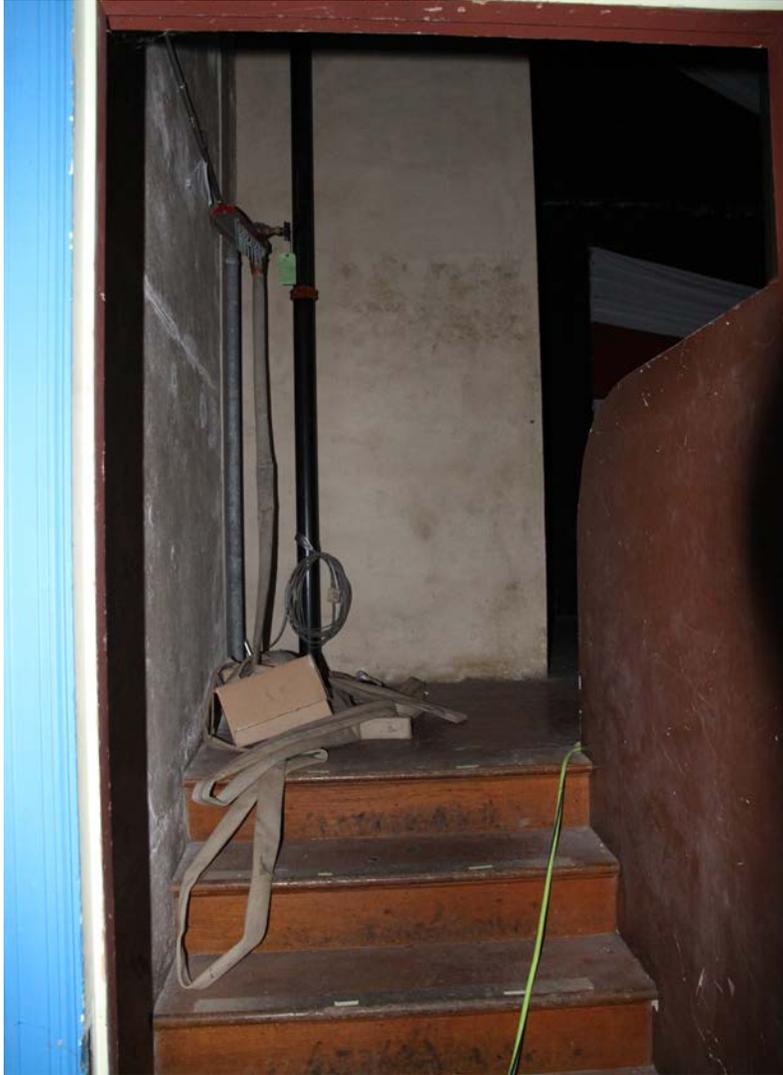
3.73 Wood stairs at the west end of the stage do not exhibit signs of dry rot and are in fair condition. (2014, PT)

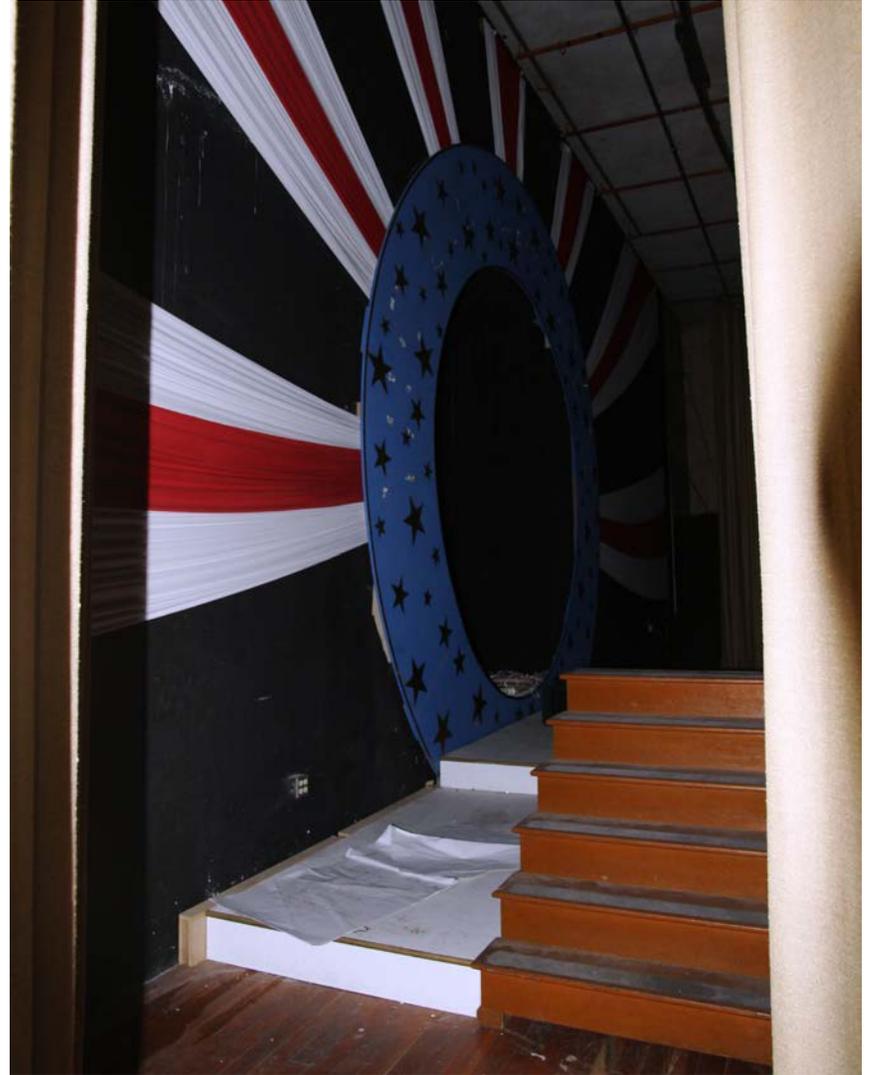
3.74 A decorative backdrop and wood platform are located at the back of stage. The colors and materials of the feature are generally intact and in good condition. (2014, PT)

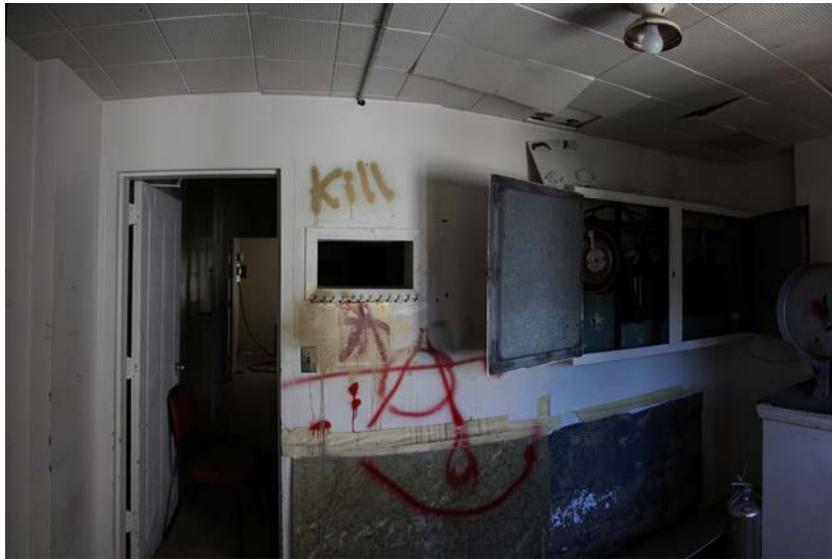
3.75 The eastern projection room contains a mix of finishes and some graffiti. The west wall of this room features original plaster walls with hardboard wainscoting haphazardly attached (or detached) from the wall. (2014, PT)

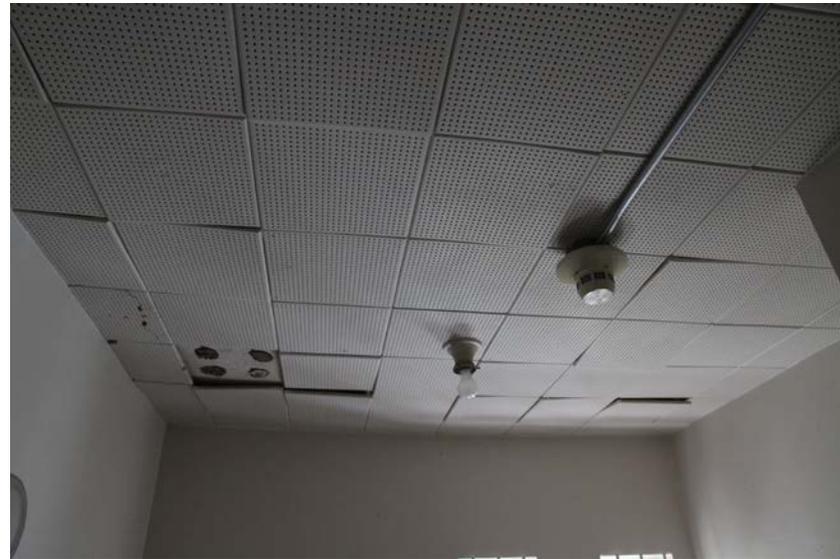
3.76 The missing or falling ceiling tiles in the western (generator) room is a typical condition found in each of the projection rooms. (2014, PT)

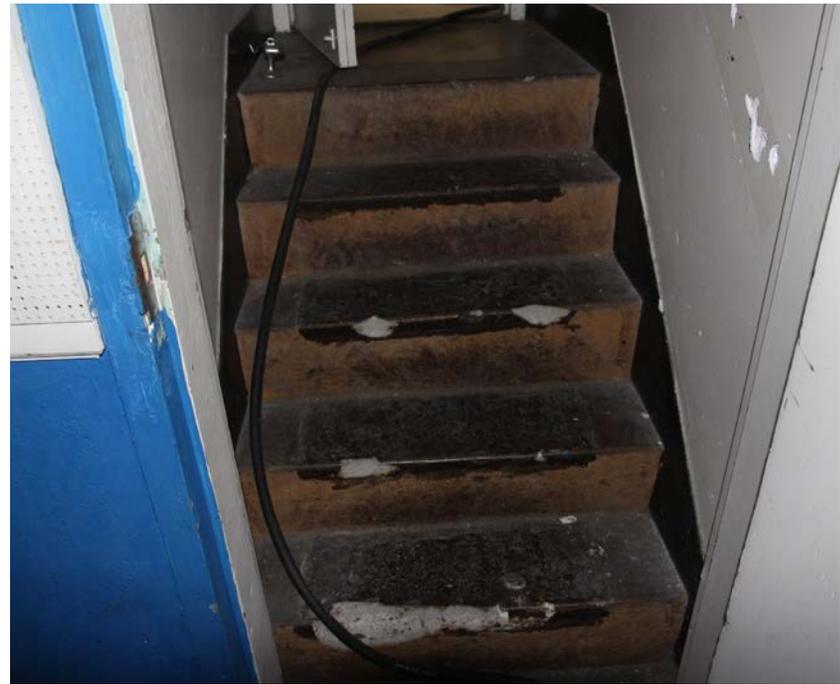
3.80 The concrete projection room stairs show loss of material and continued deterioration. (2014, PT)

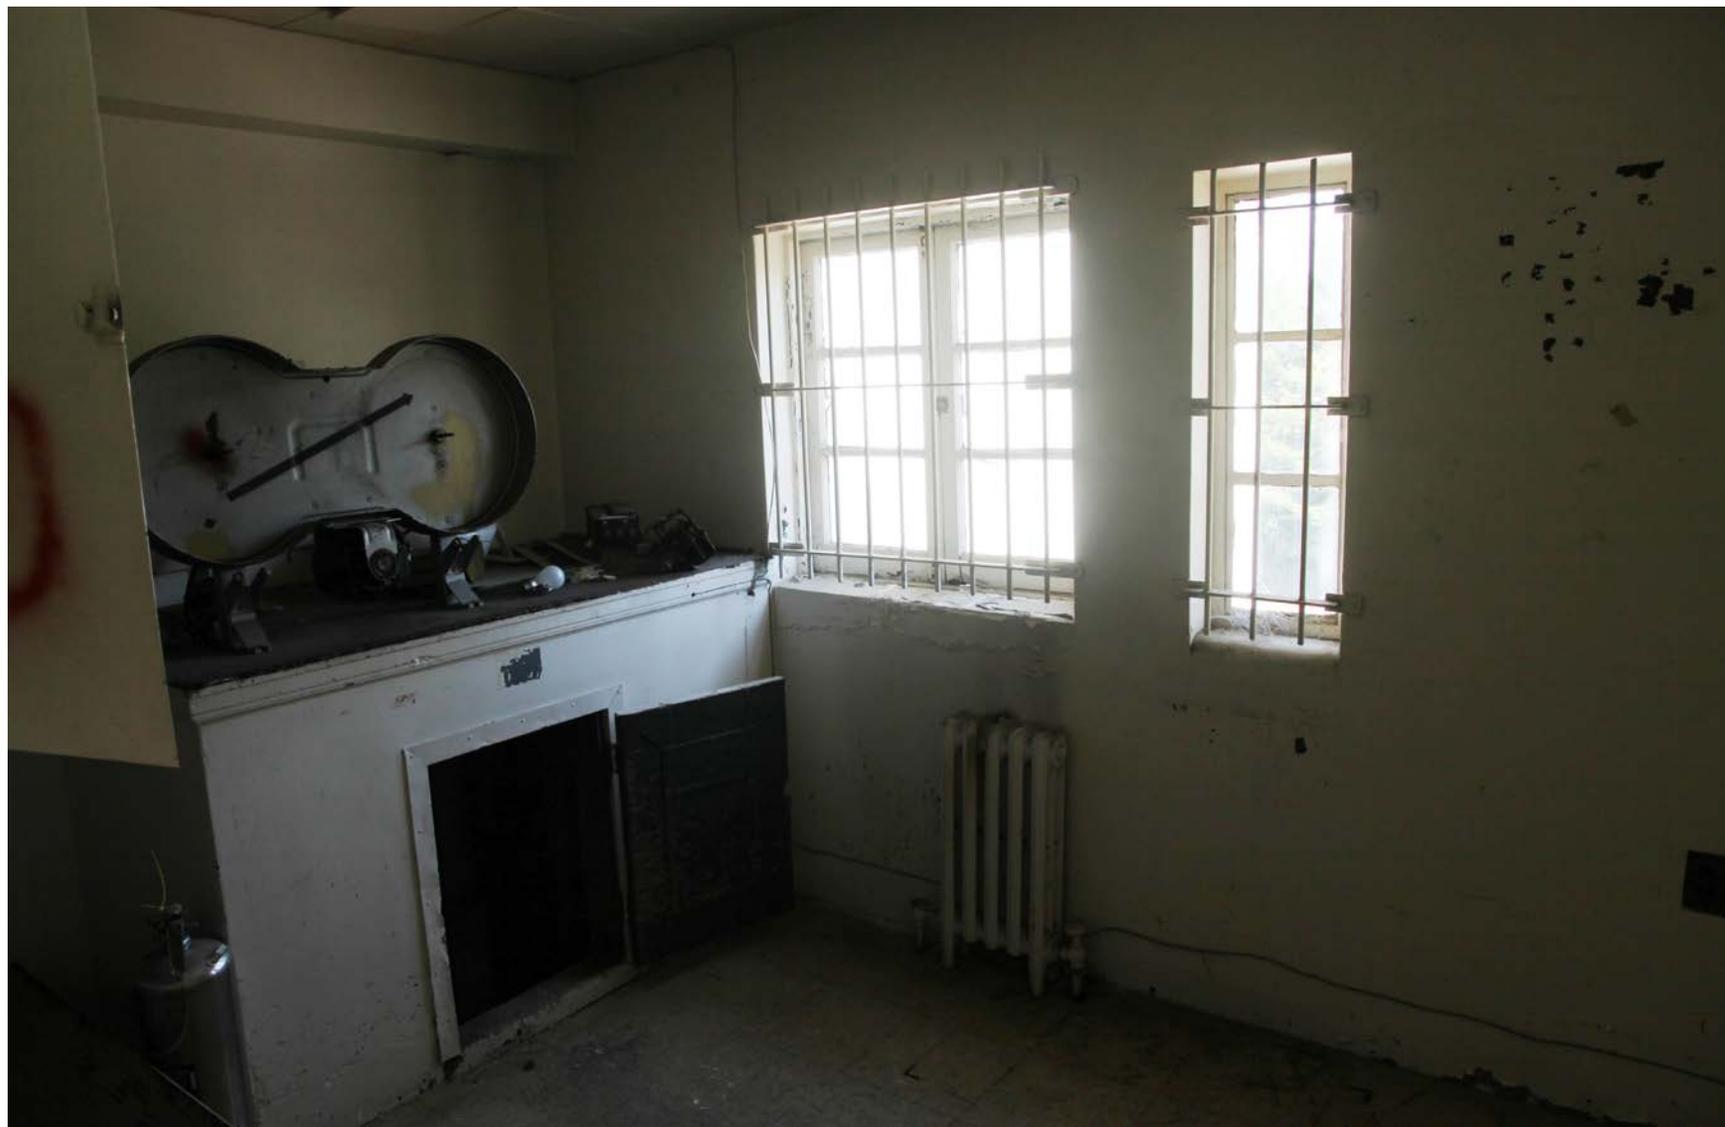
3.85 A rewinding machine and dumb waiter (connected to the east office) are intact and in fair condition in the east room. (2014, PT)

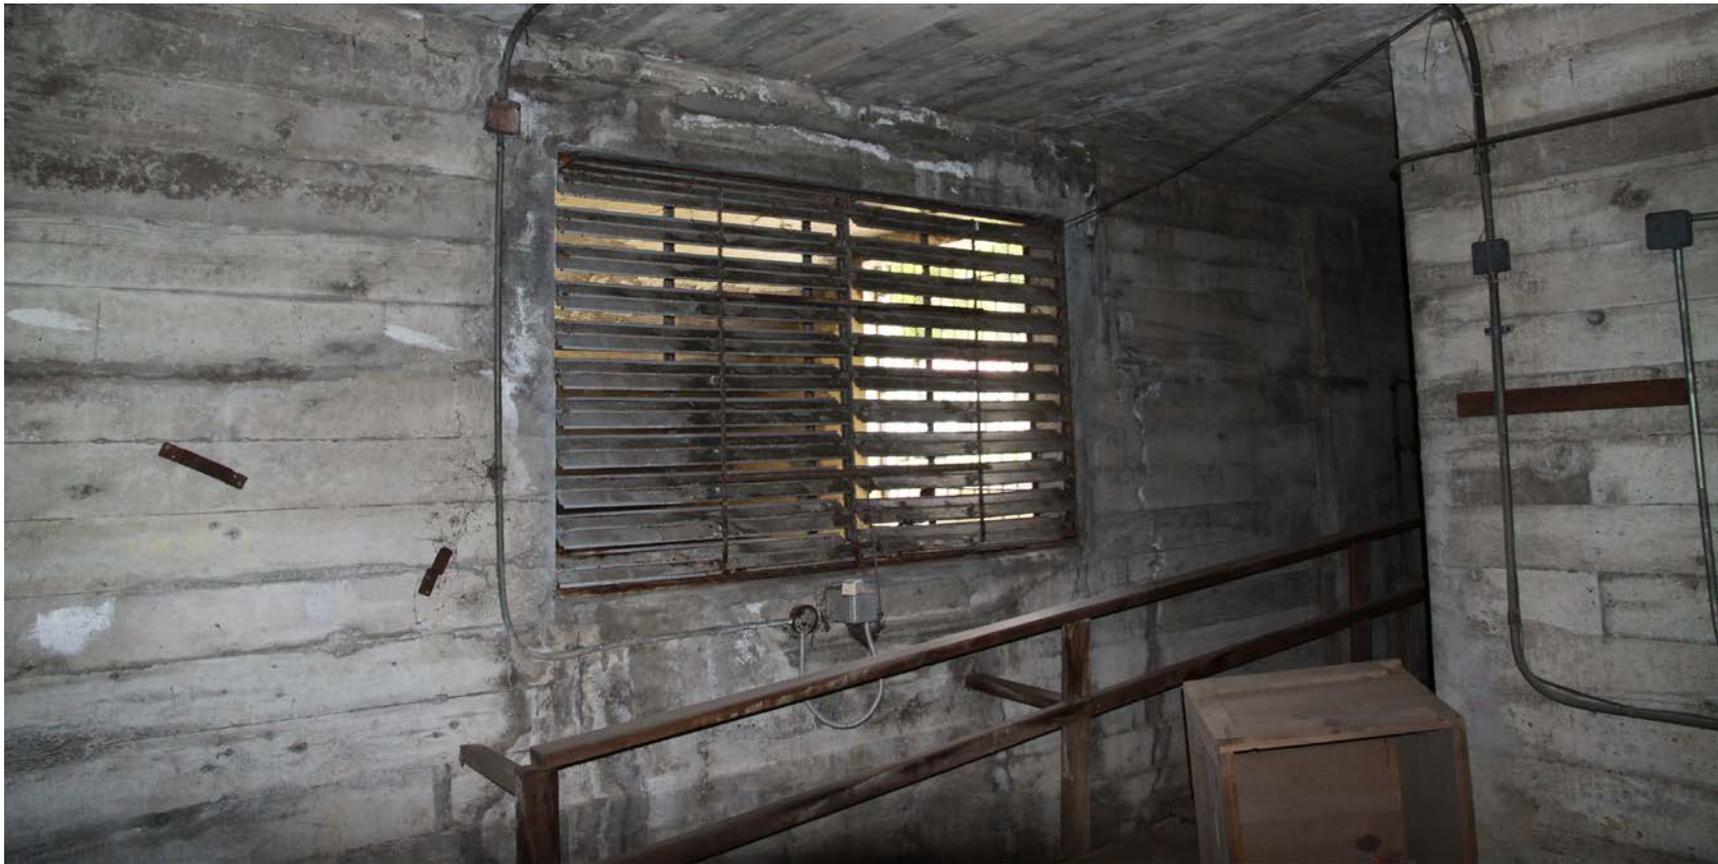
3.86 A vent showing signs of rust and deterioration is located at the east wall of the basement. (2014, PT)

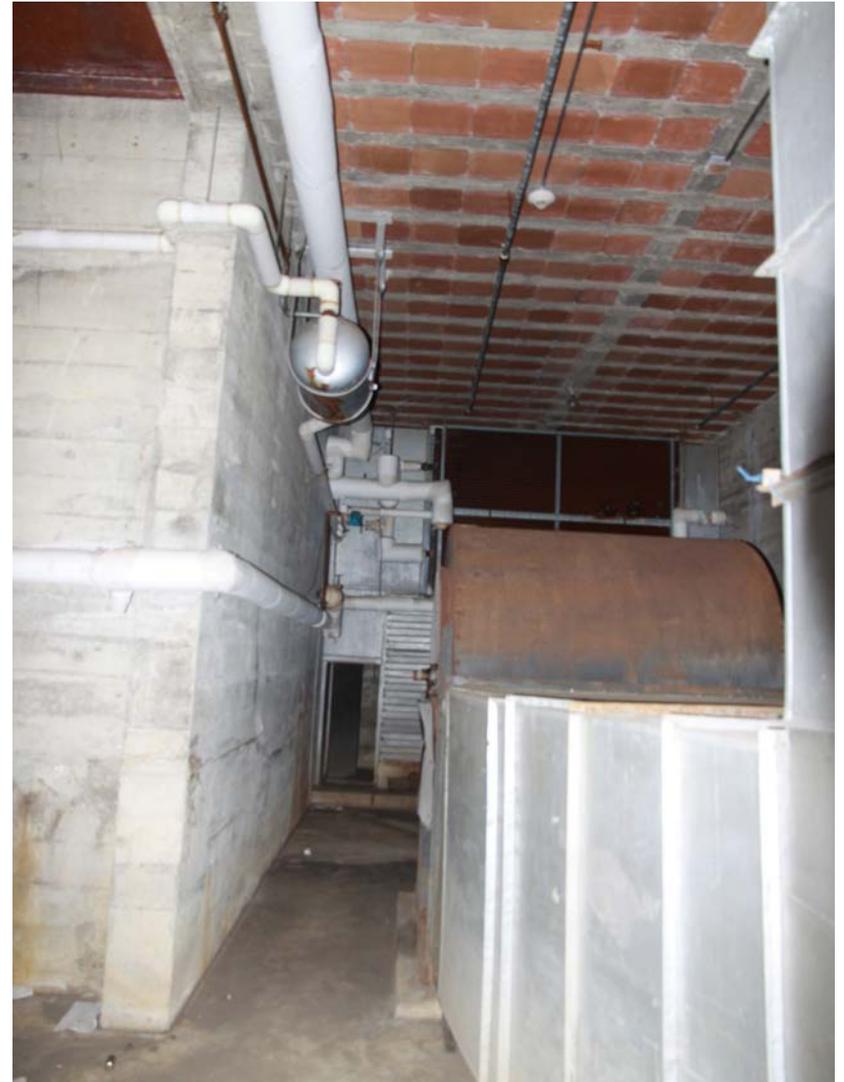
3.87 The exposed clay tile ceiling, unpainted concrete walls and unfinished concrete floors in the basement appear to be in fair condition. (2014, PT)
