Building 1208 - ENLISTED MEN'S BARRACKS

BUILDING 1208, ENLISTED MEN'S BARRACKS

REHABILITATION GUIDELINES BUILDING 1208
 PRESIDIO OF SAN FRANCISCO
 NPS CX-2000-0-0030 W.O. 14

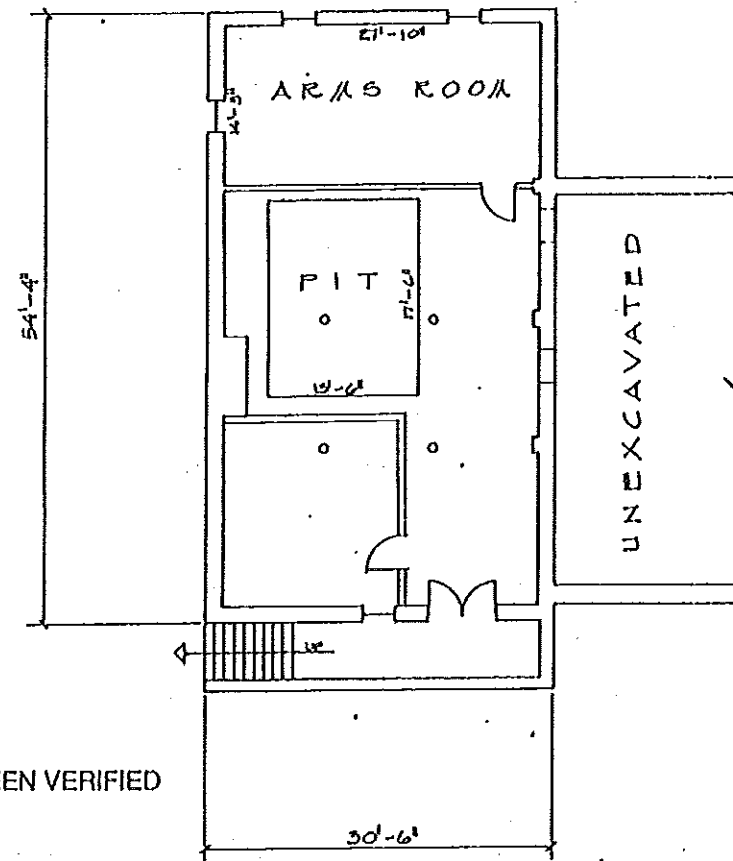
BASEMENT PLAN

<i>Exterior</i>	<i>Interior</i>	<i>Life Safety/Egress</i>	<i>Disabled Access</i>	<i>Mechanical/Electrical</i>
4140 Broken mullions, wood deteriorated on exterior window. Replace sash with new to match existing.	4210 Efflorescence, broken and cracked plaster wall in basement. Patch damaged plaster and paint.	None Noted.	None Noted.	None Noted.

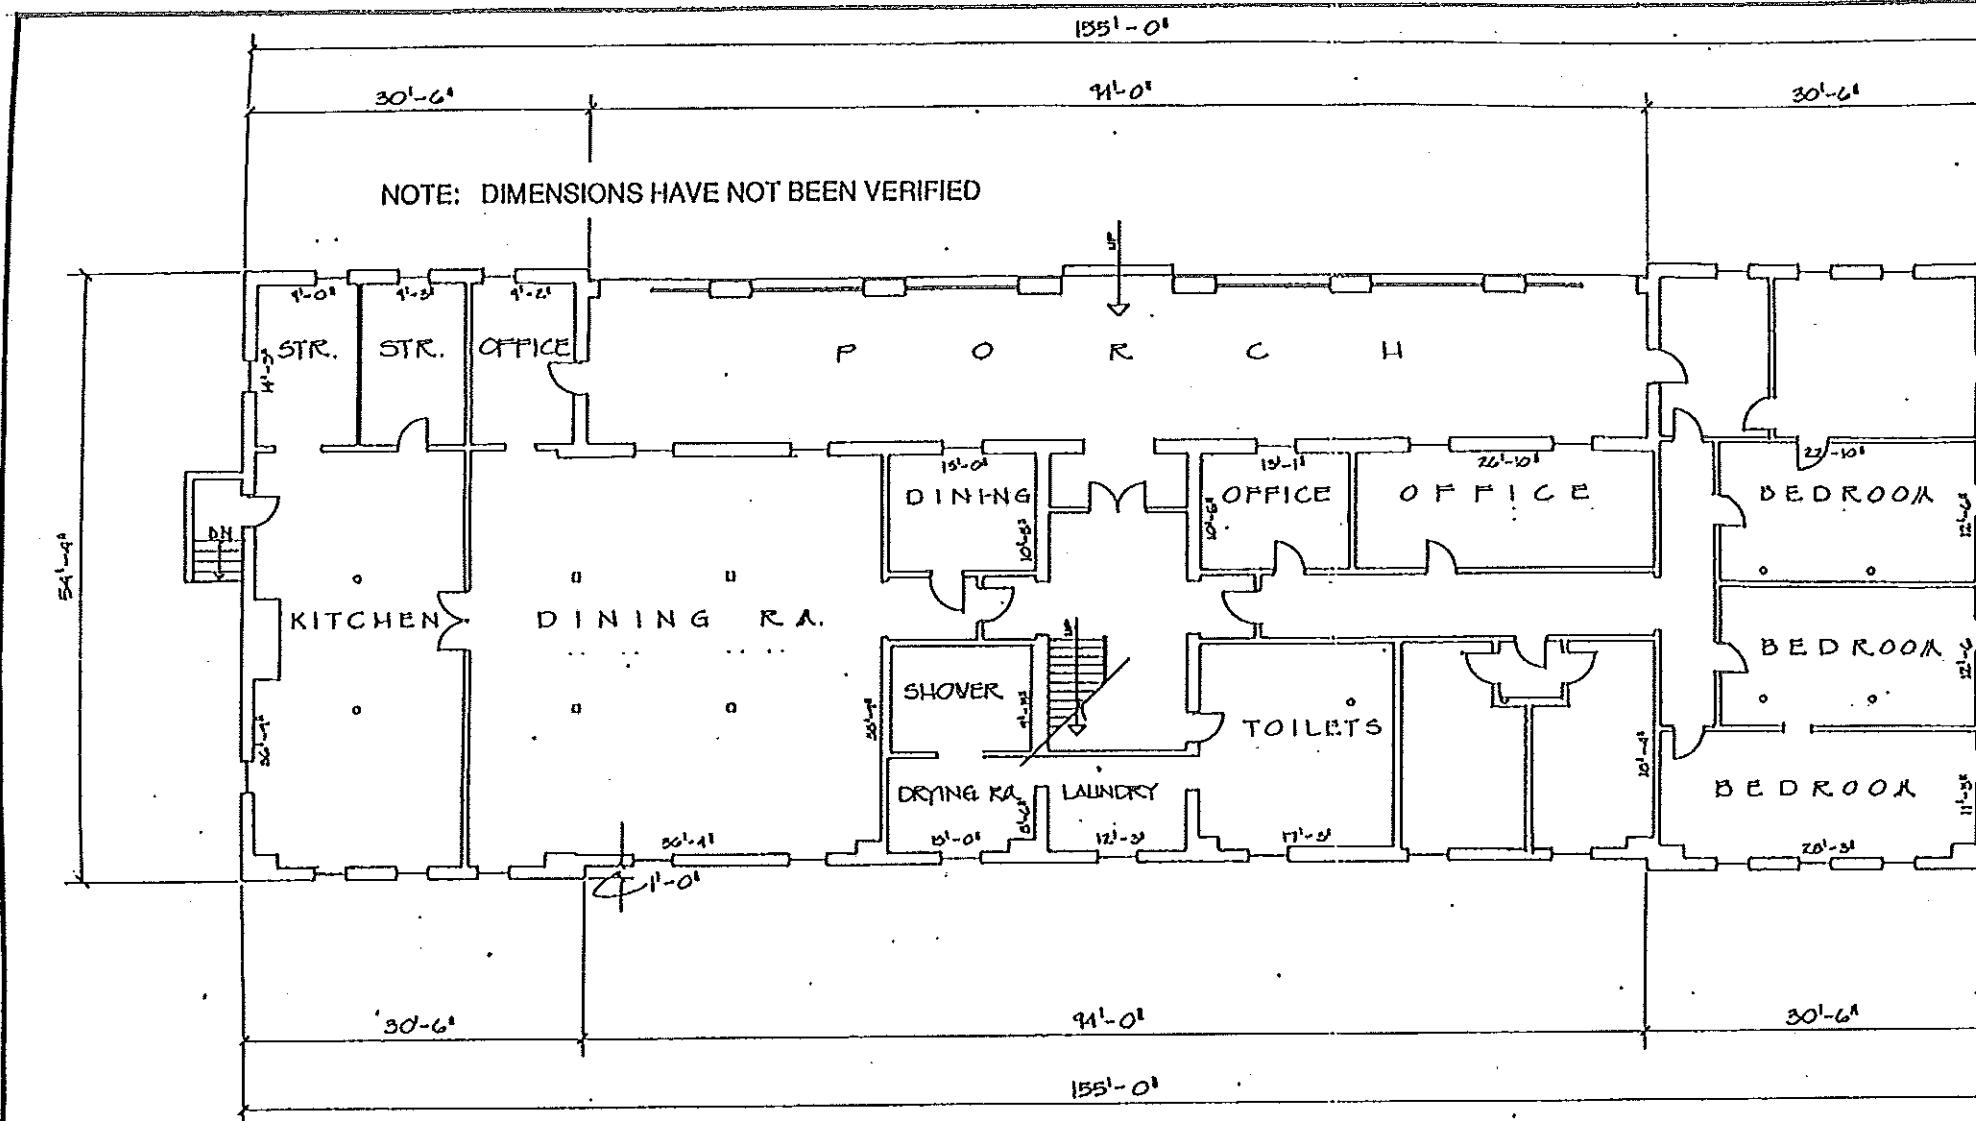
FIRST FLOOR PLAN

- 4110 Broken clay tiles on exterior wall. Replace with new clay tiles to match existing.
- 4131 Spalling and cracks in concrete porch floor. Patch spalling and cracks.

- 4244 Transom glass is painted over. Remove paint from glass.
- 4253 Trim is missing. Install new trim in historic style.

- 4133 Exterior guardrails too low; openings between rails too large. Install new guardrail behind existing; new guardrail to be 1 pipe rail and wire mesh.
- 4254 Interior doors have non-safety glass in hazardous location. Reglaze with safety glass.
- 4273 Stair handrail is too low and not grippable; guardrails are too low. Add new handrail at wall with returns; add rails at guardrail to achieve 42" height.
- 4711 No level landing at exterior side door. Install 44"x 60" landing at each door.

- 4712 No handrails on exterior stair. Install new metal handrails.
- 4712 There is a step at the door, handrail and guardrail are non-conforming, stairs too steep, open risers, guardrail missing. Replace entire stair.
- 4255 Knob hardware on interior doors is not code compliant. Replace with lever lockset hardware.
- 4713 Doors do not meet disabled access requirements. Install 36" wide door, patch wall to match adjacent finishes.

- 4771 No designated handicap parking. Provide striping, signage, curb cut for disabled parking space.
- 4772 No handicap access to door; no access to porch from grade. Install handicap accessible ramps and railings.
- 4772 No disabled access between floors. Install 3-stop elevator.
- 4773 Floor is 1" lower than corridor; 1/2" max. allowed for handicap accessibility. Flare flooring at 1:15 slope to corridor floor.

- 4774 No handicap accessible fixtures or accessories in restrooms. Rework to provide 1 disabled accessible wc, lavatory and accessories.
- 4775 Drinking fountain not handicap compliant. Replace with handicap compliant electric water coolers.

- 5026 No back flow prevention at hose bibbs. Install back flow prevention devices.
- 5074 No bird screen at kitchen exhaust. Install bird screen.

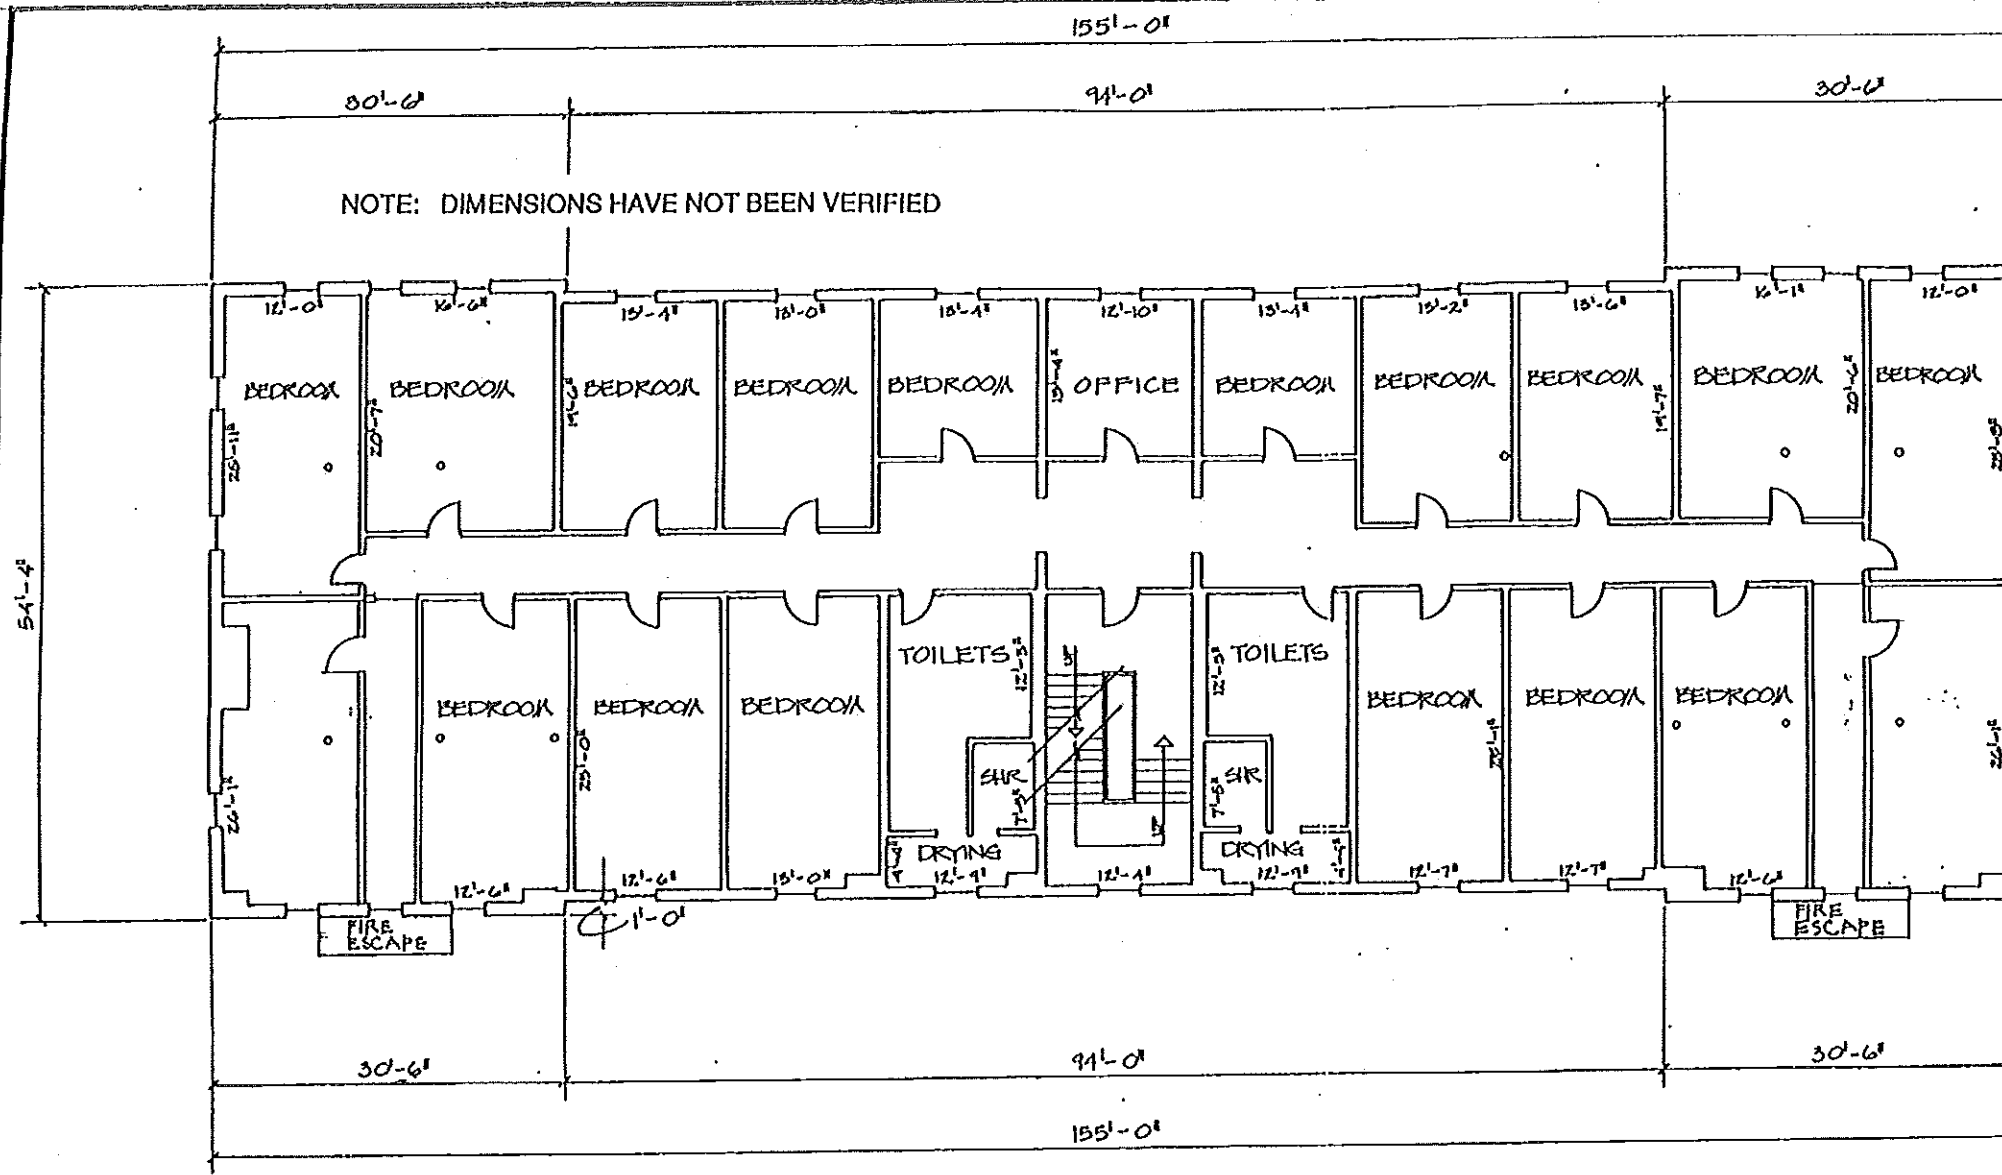
SECOND FLOOR PLAN

4213 Vinyl base is missing. Install new vinyl base.

4254 Interior doors have non-safety glass in hazardous location. Reglaze with safety glass.

4273 Stair handrail is too low and not grippable; guardrails are too low. Add new handrail at wall with returns; add rails at guardrail to achieve 42" height.

4711 No code compliant second means of egress from second floor or attic. Provide enclosed exit stairs at each end of building.

4255 Knob hardware on interior doors is not code compliant. Replace with lever lockset hardware.

4713 Doors do not meet disabled access requirements. Install 36" wide door, patch wall to match adjacent finishes.

4772 No disabled access between floors. Install 3-stop elevator.

4774 No handicap accessible fixtures or accessories in restrooms. Rework to provide 1 disabled accessible wc, lavatory and accessories.

4775 Drinking fountain not handicap compliant. Replace with handicap compliant electric water coolers.

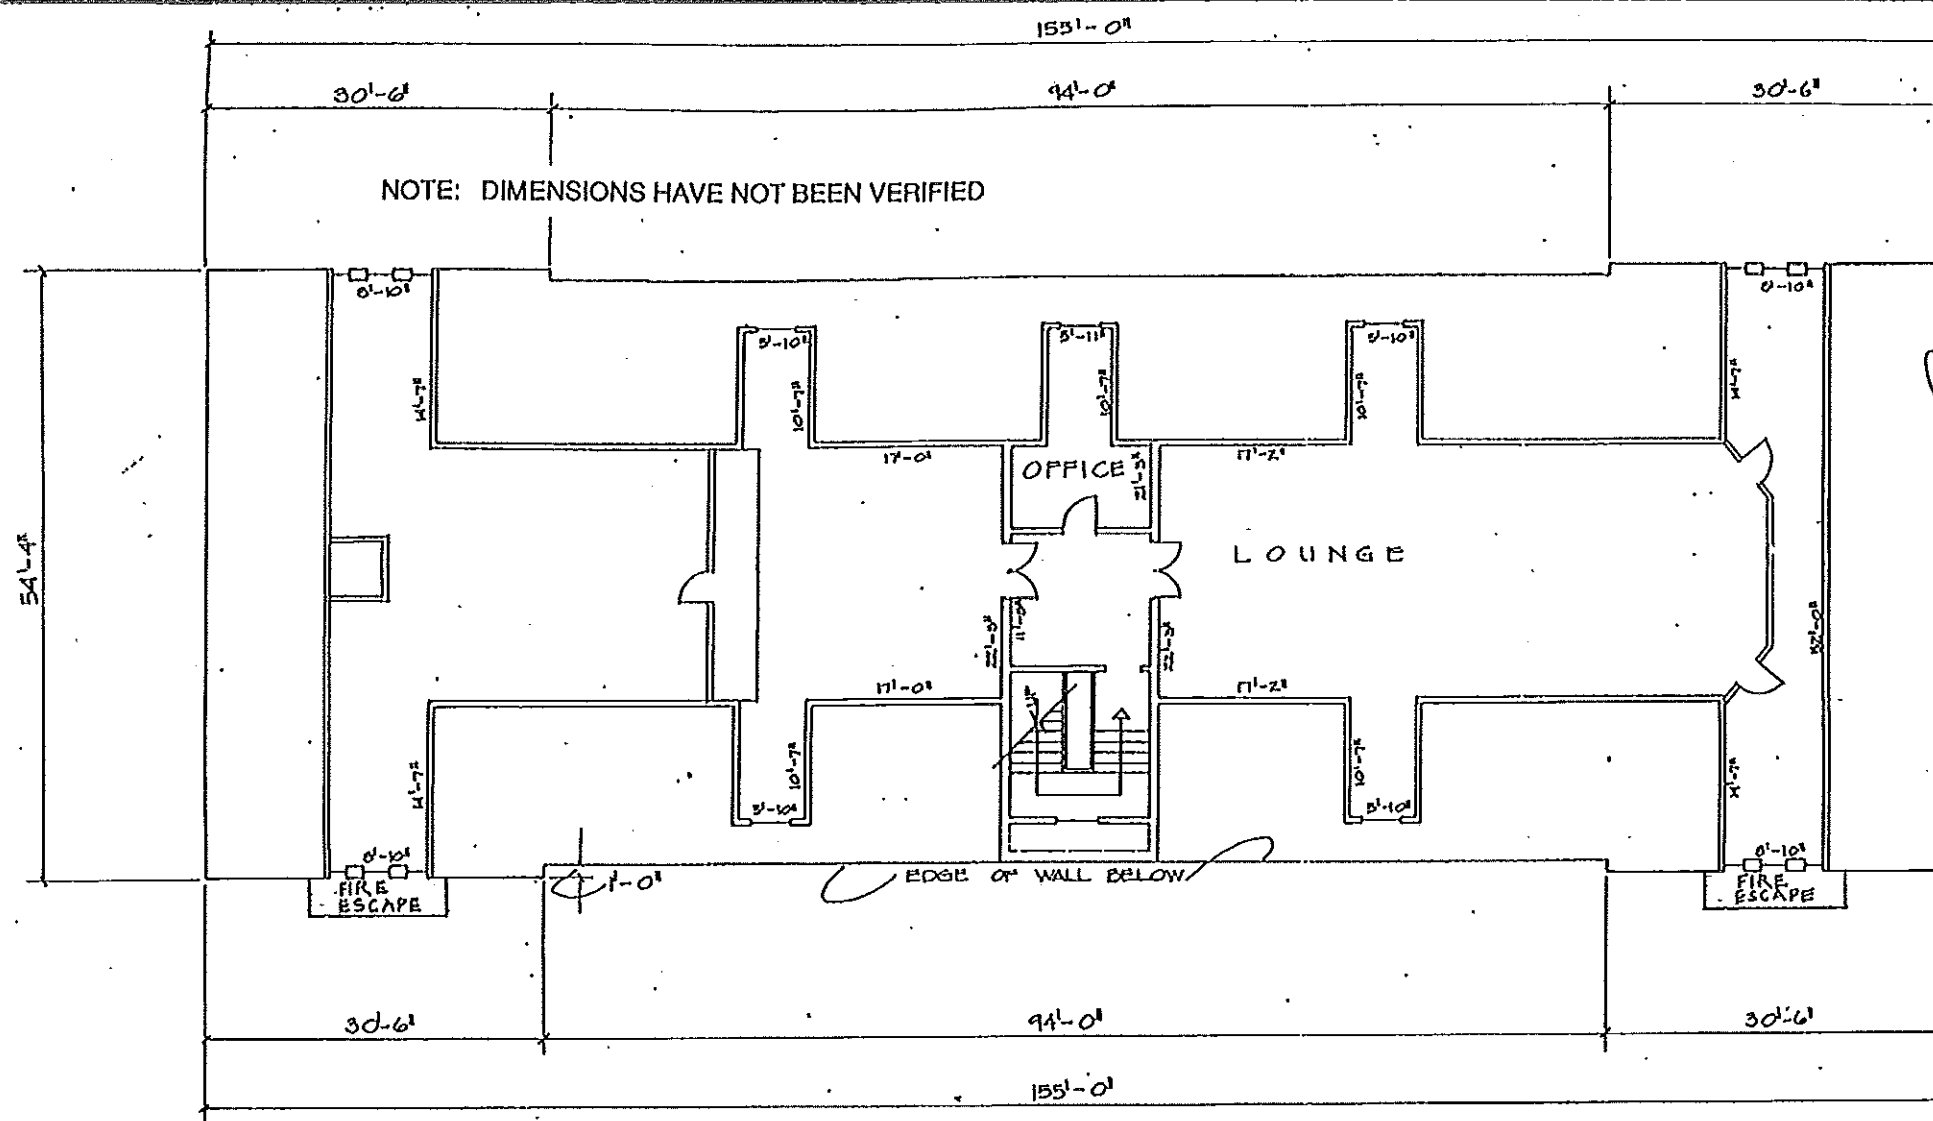
ATTIC PLAN

- 4142 Window sash is missing. Install new sash to match existing.
- 4144 Glass is painted over. Remove paint from glass.
- 4146 Wood window sill is deteriorated. Replace with new to match.

- 4254 Interior doors have non-safety glass in hazardous location. Replace with safety glass.

- 4273 Stair handrail is too low and not graspable; guardrails are too low. Add new handrail at wall with returns; add rails at guardrail to achieve 42" height.

- 4711 No code compliant second means of egress from second floor or attic. Provide enclosed exit stairs at each end of building.

- 4255 Knob hardware on interior doors is not code compliant. Replace with lever lockset hardware.

- 4713 Doors do not meet disabled access requirements. Install 36" wide door, patch wall to match adjacent finishes.
- 4772 No disabled access between floors. Install 3-stop elevator.

- 4773 8" platform/stage with no handicap access. Install wood ramp.
