# PRESIDIO CHAPEL BUILDING 130

Historic Structure Report

March 2012

PAGE & TURNBULL

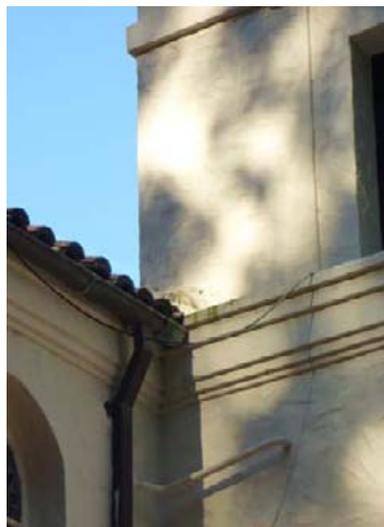
Example of stucco surface and staining at intersection between the main chapel and bell tower.

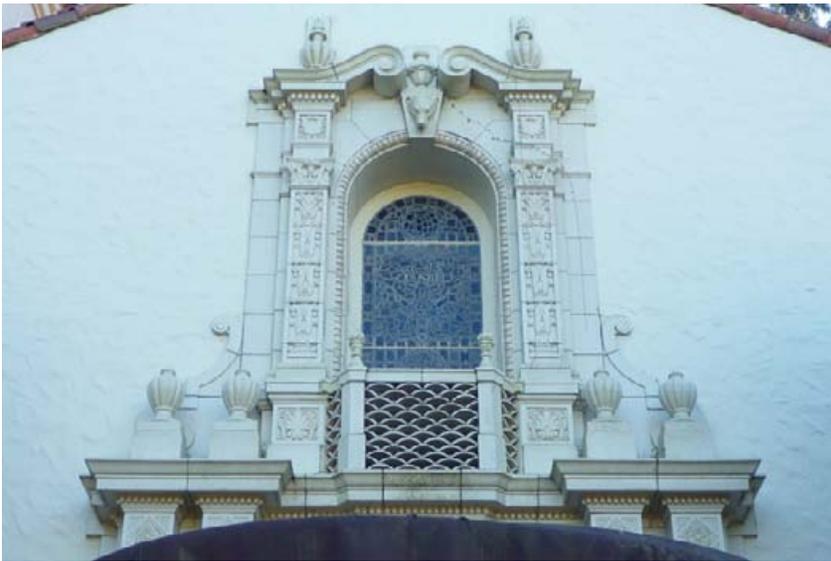
Terra cotta door surround; note stains, vines, and vegetative growth.

The complicated geometries of the terra cotta surround provide many niches for water and moisture to collect in. The soffit above the main entry door is heavily stained at the mortar joints, suggesting water may be telegraphing down through the joints and hence onto the main entry door below. The heavy oak door, particularly the transom, is heavily streaked and stained with white residue from the terra cotta above. Furthermore, the upper-west corner of the transom's stile and rail are separating and delaminating. The simplest mitigation method is to repoint the terra cotta joints above and install a low-profile drip edge at the base of the entablature above the transom.

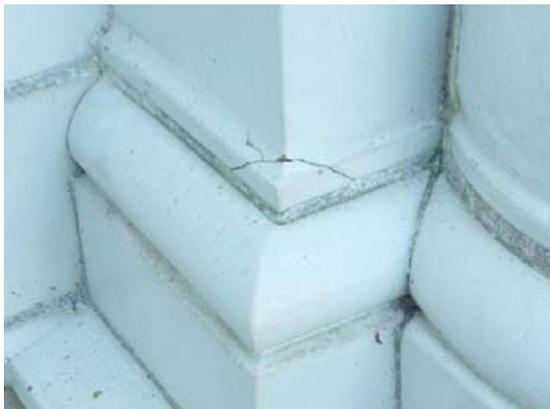
Cracking at base of terra cotta column.

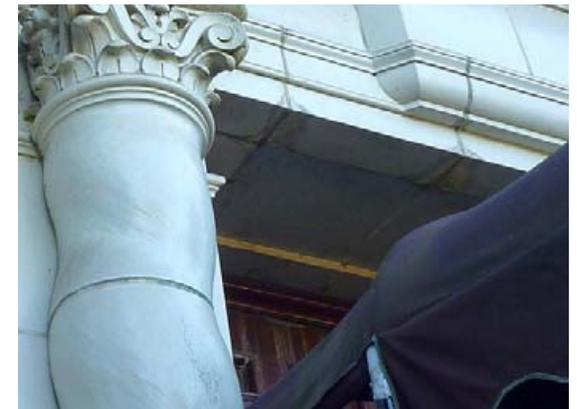
Detail of main entry door; note white stains due to water telegraphing down through terra cotta joints above.

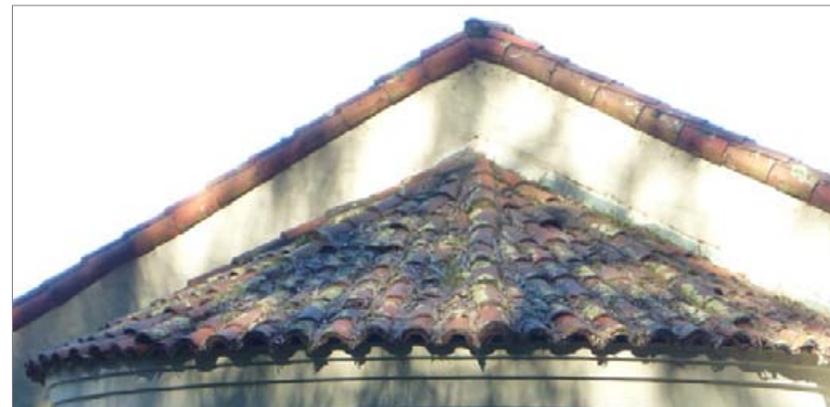
Condition of chancel roof; note absence of gutters and downspouts.

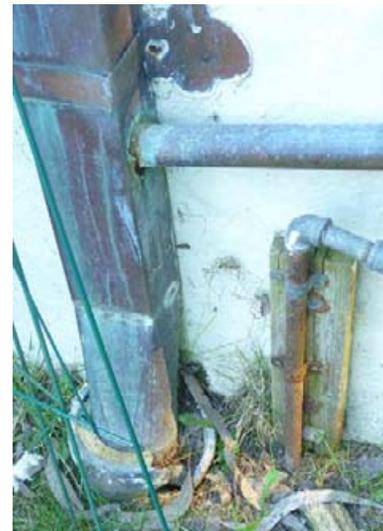
Downspout boot entering cracked drop inlet; note corrosion at downspout and plumbing union.

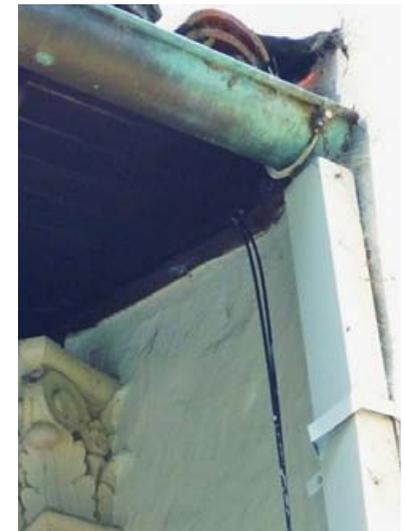
Example of inadequate intersection of gutter and downspout.

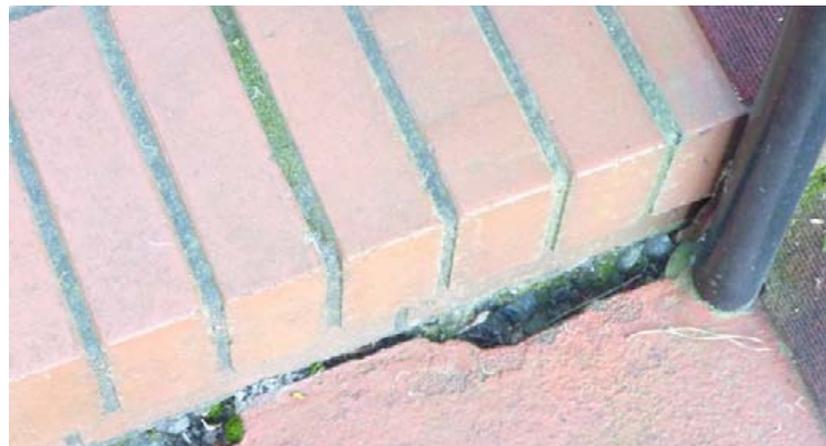
Mortar gaps at base of the main entry stairs.

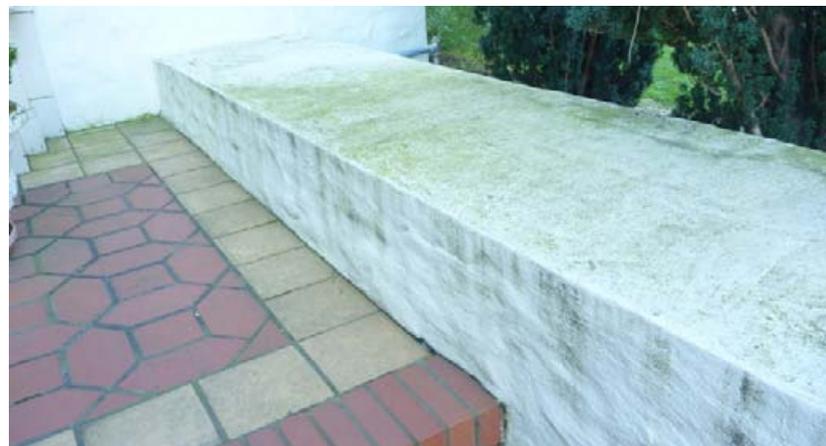
Example of biological growth and staining on stucco retaining walls flanking the main entry.

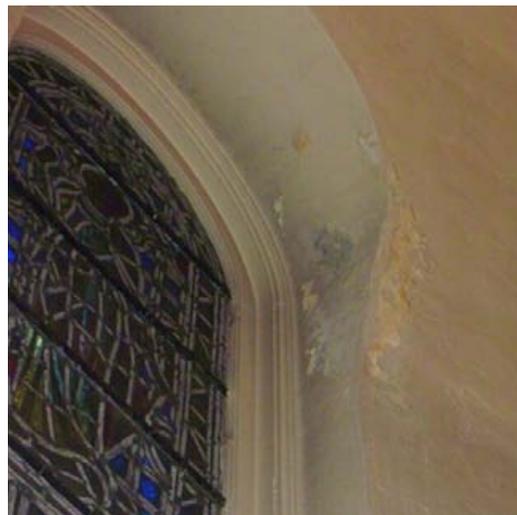
Paint delamination at chancel window.

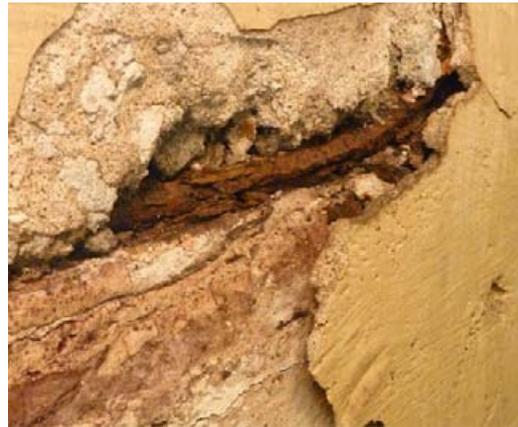
Example of corrosion and spalling in organ pipe chamber.

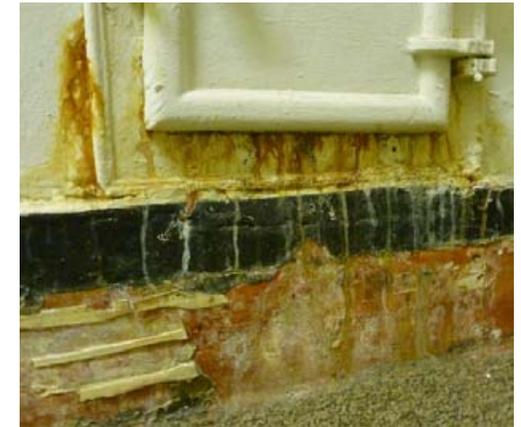
Efflorescence and staining at ashpit door.

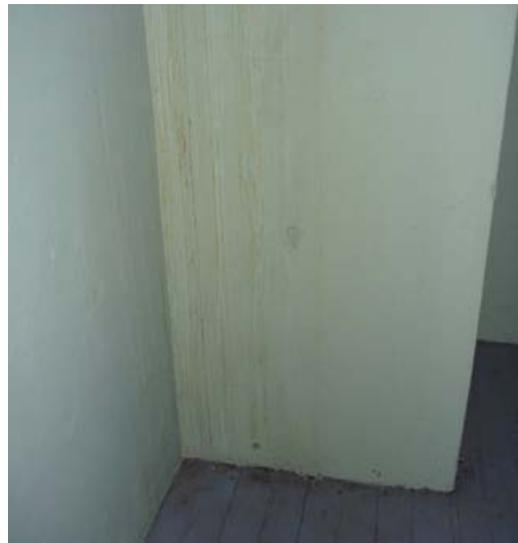
Water staining along chimney mass in bell tower.

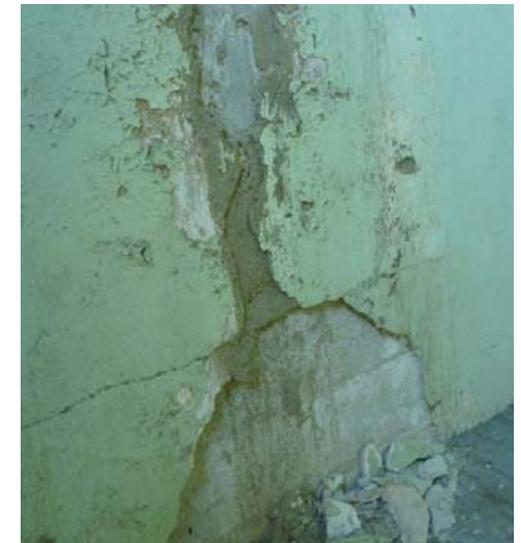
Efflorescence and spalling in bell tower.

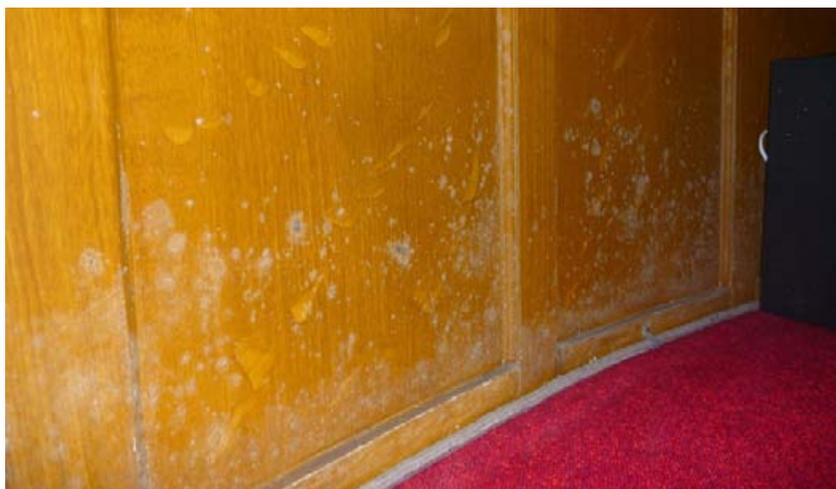
Mold and delamination on wood wainscoting in the chancel.

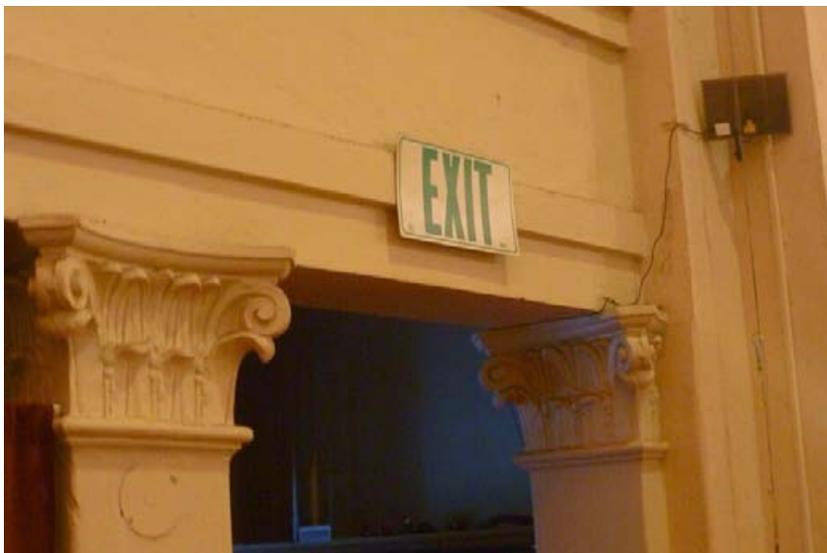
Example of unilluminated exit sign and cast stone capitals.

- Exit signs are required to be illuminated. The exit signs in the chancel do not meet this code requirement and must be replaced with approved illuminated exit signs, particularly if one or both are going to be designated as the alternate means of egress.

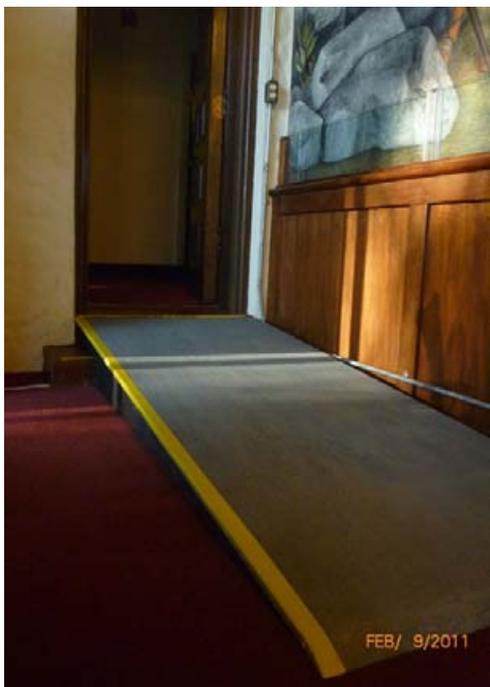
Temporary wood ramp in the mural room.

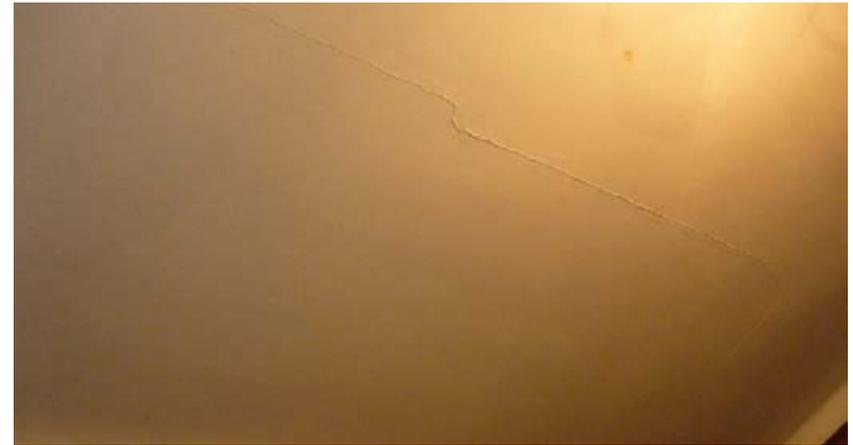
Ceiling crack in bride's room, caused because plaster has detached from the lath.

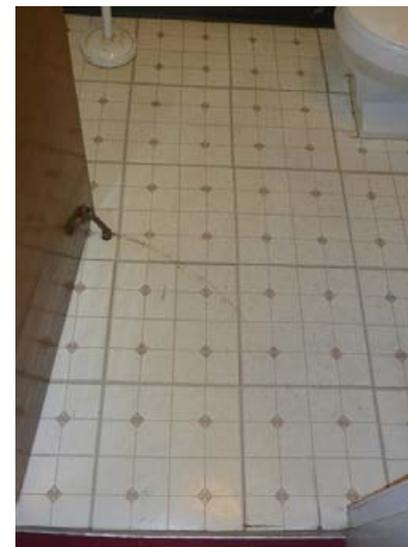
Note condition of worn vinyl flooring in upper level restroom.

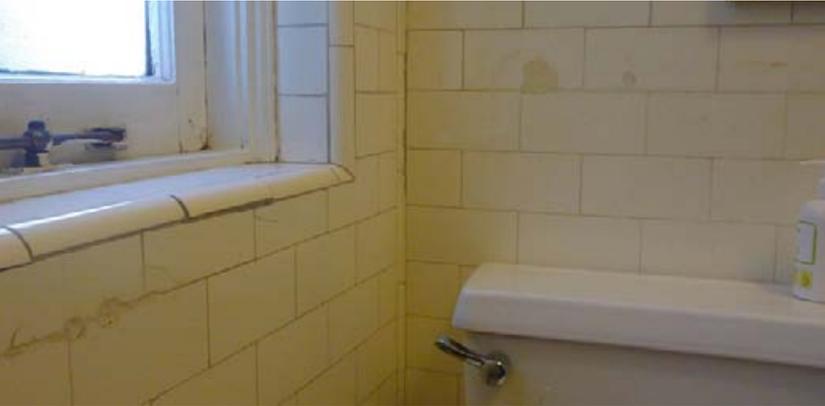
Patched and broken porcelain tile wainscoting in upper level restroom.

- Some of the historic porcelain tiles have been patched as bathroom fixtures were moved/removed. It is recommended that all patched and cracked tiles be replaced to match historic tiles.
- Though not a requirement for rehabilitation, it is recommended that the existing non-historic toilet be replaced with one that is more water-conserving and historically compatible.
- Wear and tear on the non-historic sheet vinyl flooring has had a significant impact on the appearance of this

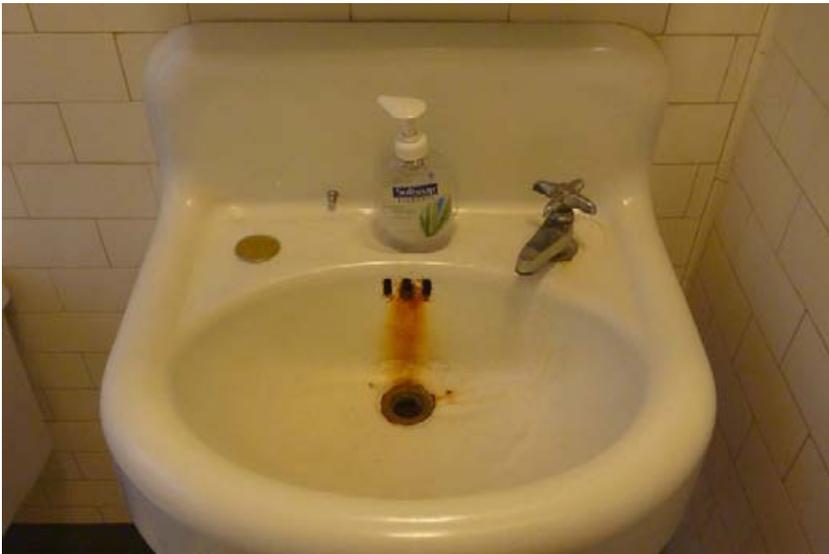
Ferrous stains in historic porcelain sink.

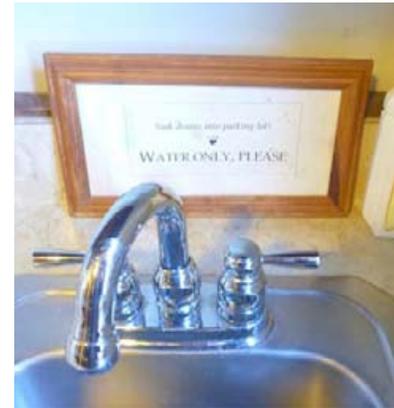
- The vestry sink is not presently tied to the building's sewer system, but instead drains into a nearby downspout and thence to the parking lot. This arrangement is in clear violation of building code and plumbing code. If a sink is to remain in this location, then it must be tied to the domestic sewer system.
- As noted under "Concrete Floors" above, the cement floor tiles exhibit cracking, loss of setting grout, deterioration of the finish surface, and general spalling and loss of material. See concrete floor treatment recommendations below for detailed information.
- The existing location of the organ console provides good sight lines for accompanying weddings and is in a good vantage point for listening to the proper balance of the two organ chambers. Moving the console back to its original location in the west hall recess would be a negative from the organist's point of view.

Vestry sink; note sign that says "Sink drains into parking lot! Water only, please"

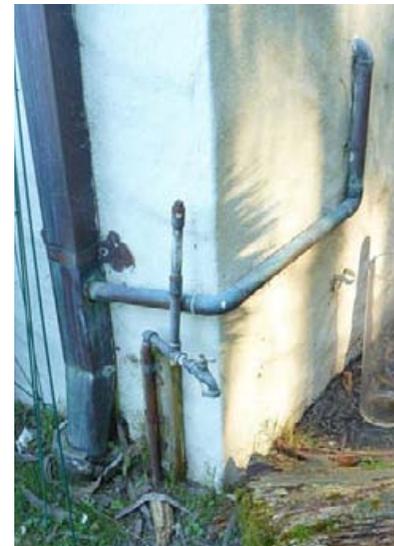
Vestry sink draining into copper downspout.

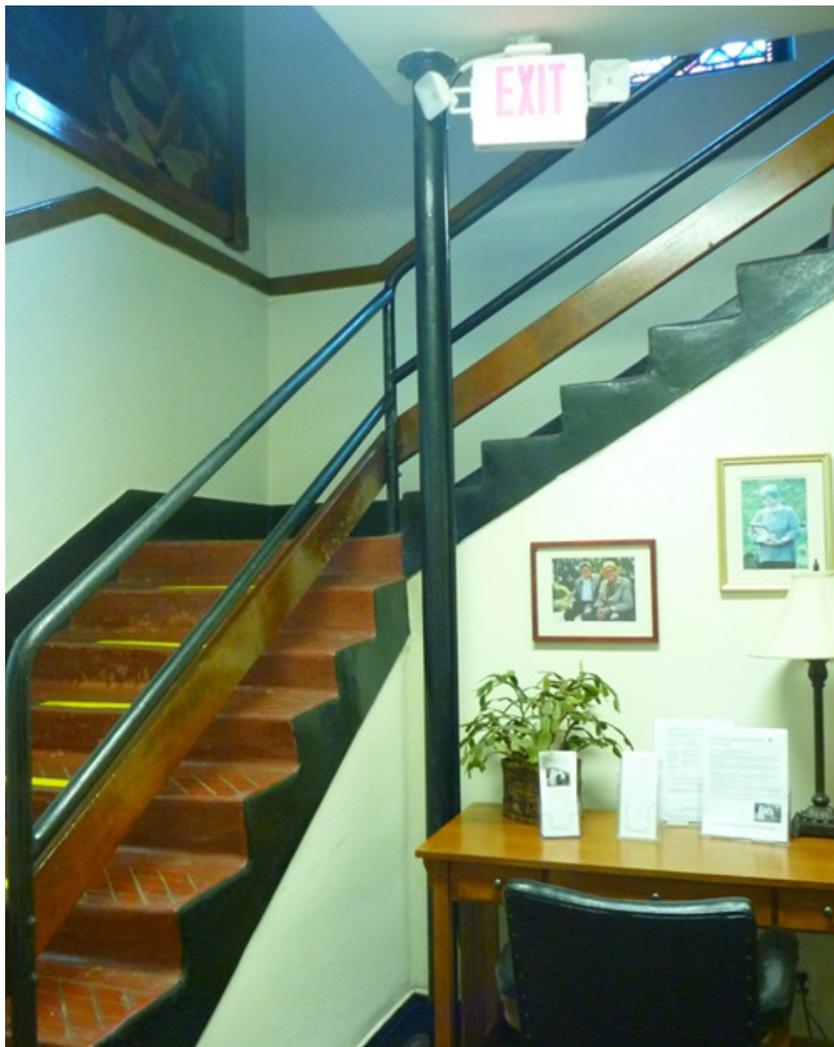
Lower bell tower stairwell; note height of handrail, 3" support post, and exit sign.

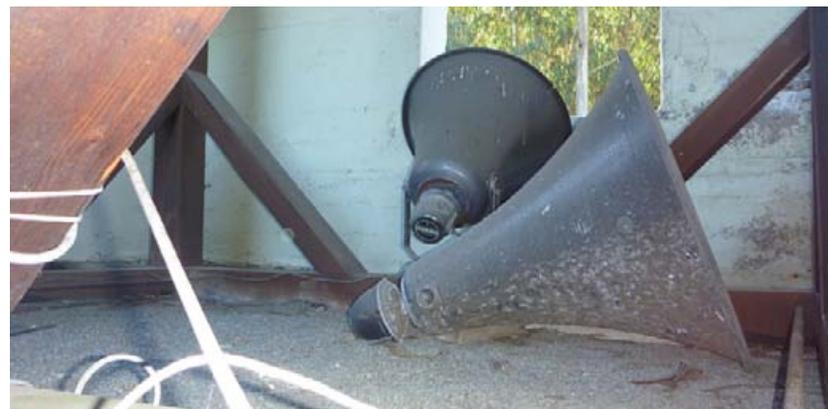
Horn-style loudspeakers in bell room; note condition of roofing and deteriorated wall surface.

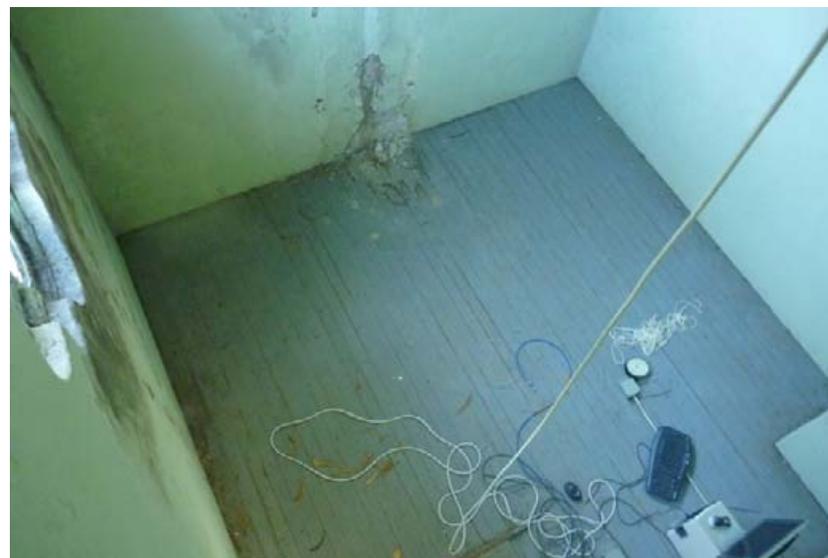
View looking down into upper bell tower room; note deteriorated conditions throughout.

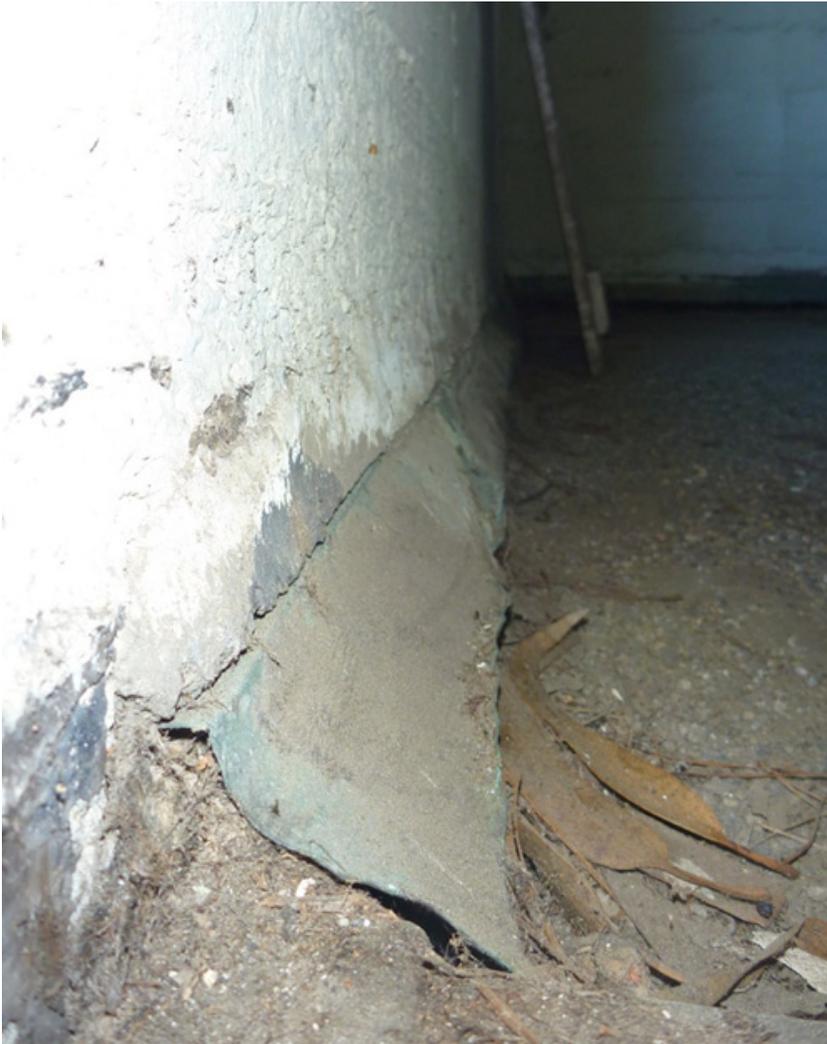
Roof flashing in the bell tower and chimney has failed, allowing significant amounts of moisture to enter the building. The flashing needs to be repaired/ replaced as soon as possible to prevent water infiltration, stucco delamination, and efflorescence within the bell tower rooms.

Deteriorated condition of roof flashing in bell room at the top of the bell tower.

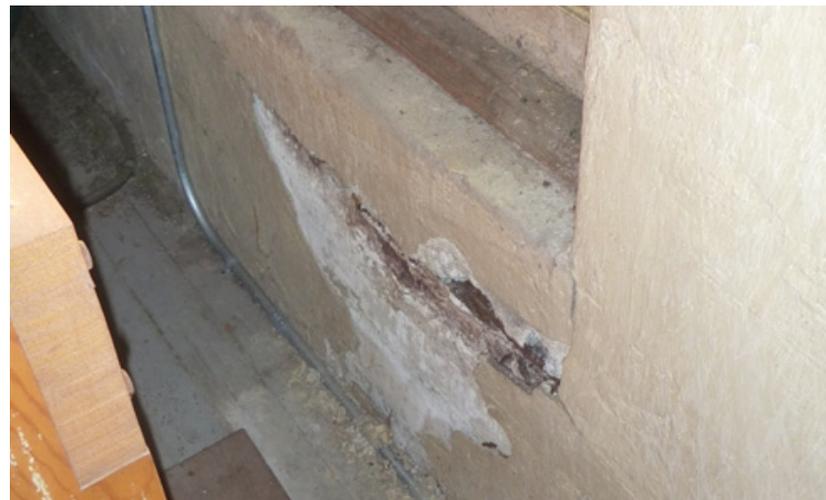
Organ pipe chamber window with spalled plaster and corrosion below.

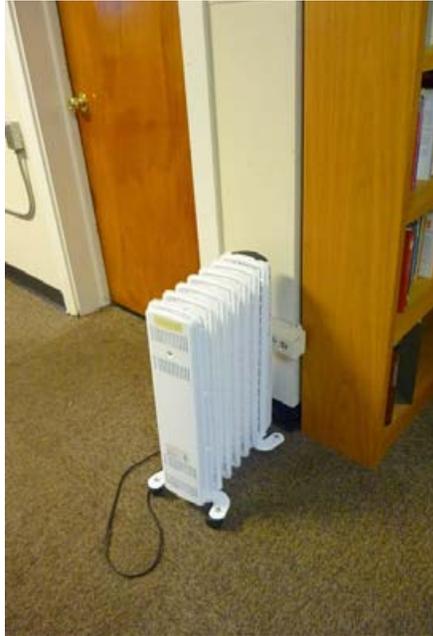
Example of space heater in use in the basement level common room.

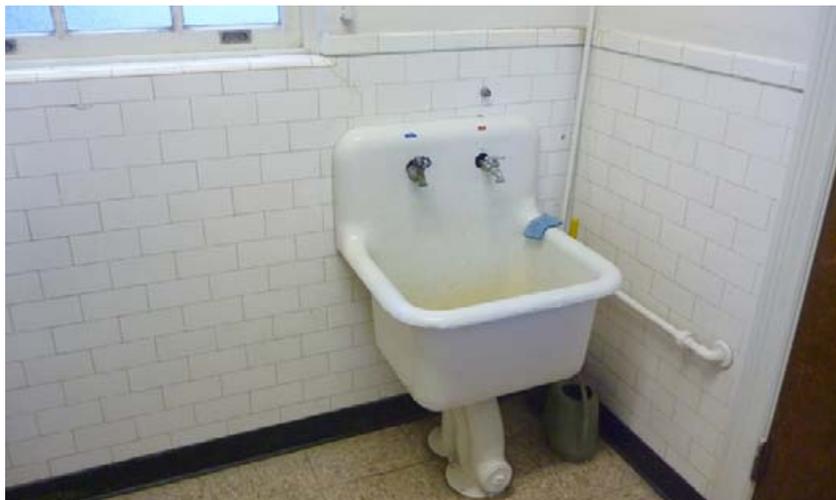
View of lower level restroom; note historic sink, cracked historic porcelain tile wainscoting, and double-hung window.

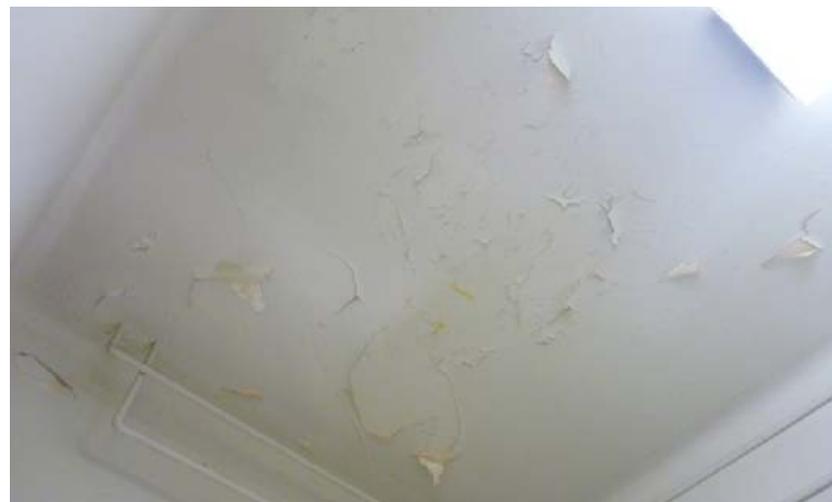
Delaminated paint on kitchen ceiling.

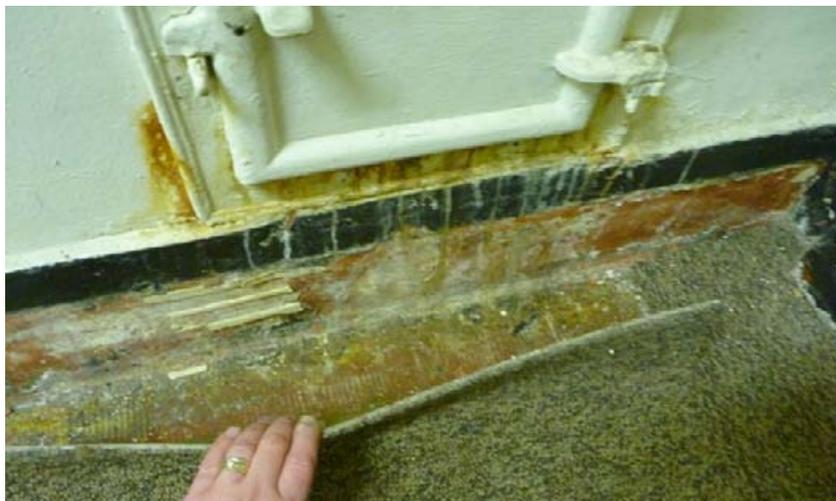
Efflorescence and staining from ashpit door.

well as along the chimney walls. Water infiltration, efflorescence, and plaster delamination is concentrated at the bottom of the chimney surrounding the ashpit door in the boiler room hall, but the source of the water clearly originates at the top of the chimney. Efflorescence on the interior plaster surface suggests that water is being transported through the material, causing delamination of the finish coat, and may be corroding the embedded steel. To alleviate delamination caused by efflorescence, the transportation of water through the concrete must be mitigated. A qualified structural engineer should assess the viability of the concrete. Once the chimney cap and flashing is repaired, then the plaster can be repaired using Big Wally's Plaster Magic or similar product (see treatment of common materials below for repairs to interior plaster).

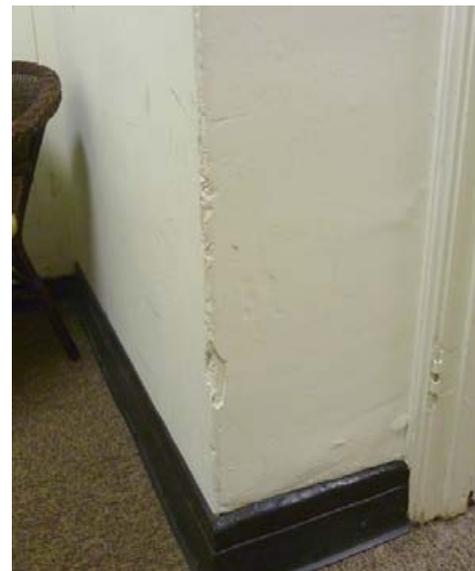
Impact damage to interior corners of boiler room hall.
