Lendrum Court Next Steps

North Fort Scott

Neighborhood Information Session

January 29, 2014

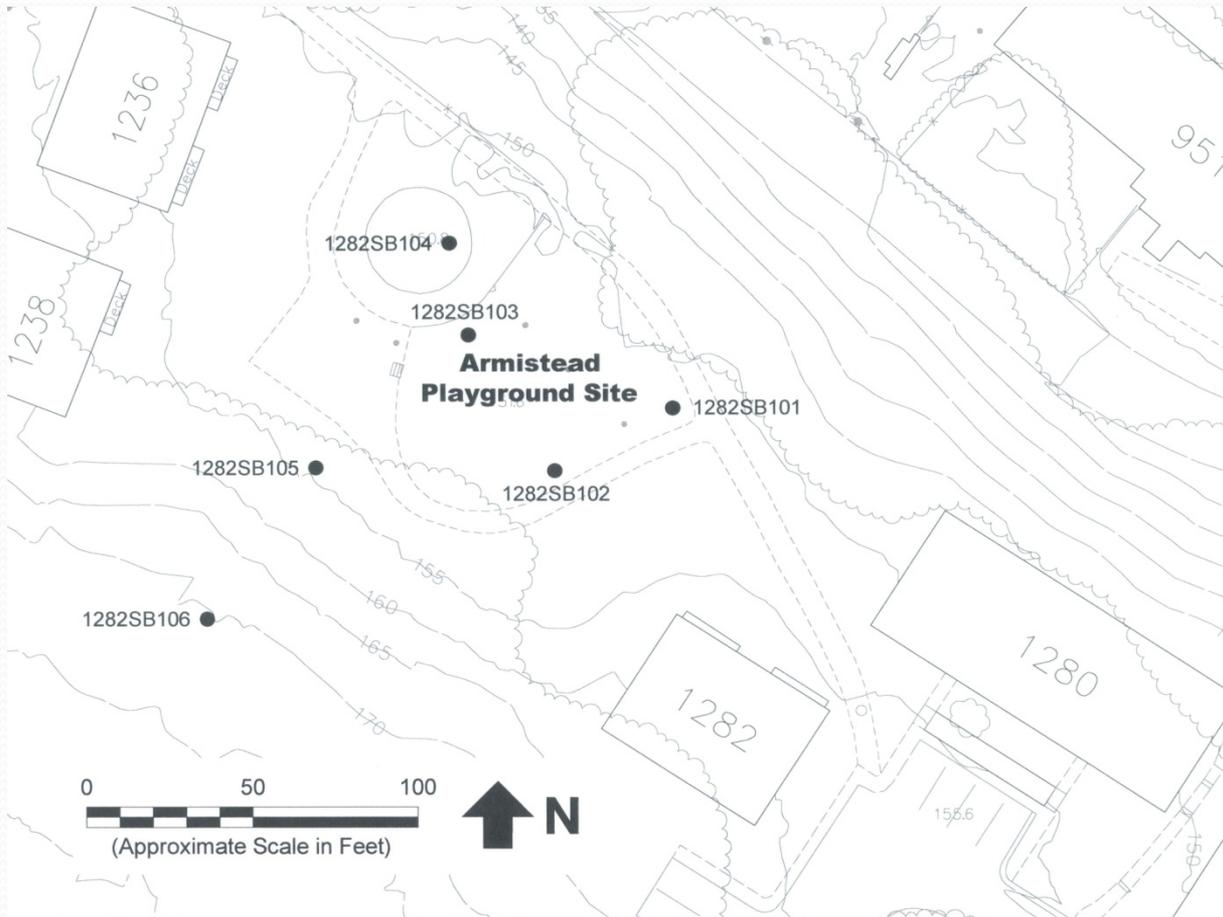
Playground Soil Sample Locations

- The Trust collected seven soil samples from six locations and analyzed for metals and PAHs.
- All sample results are below residential human health and ecological soil screening levels.

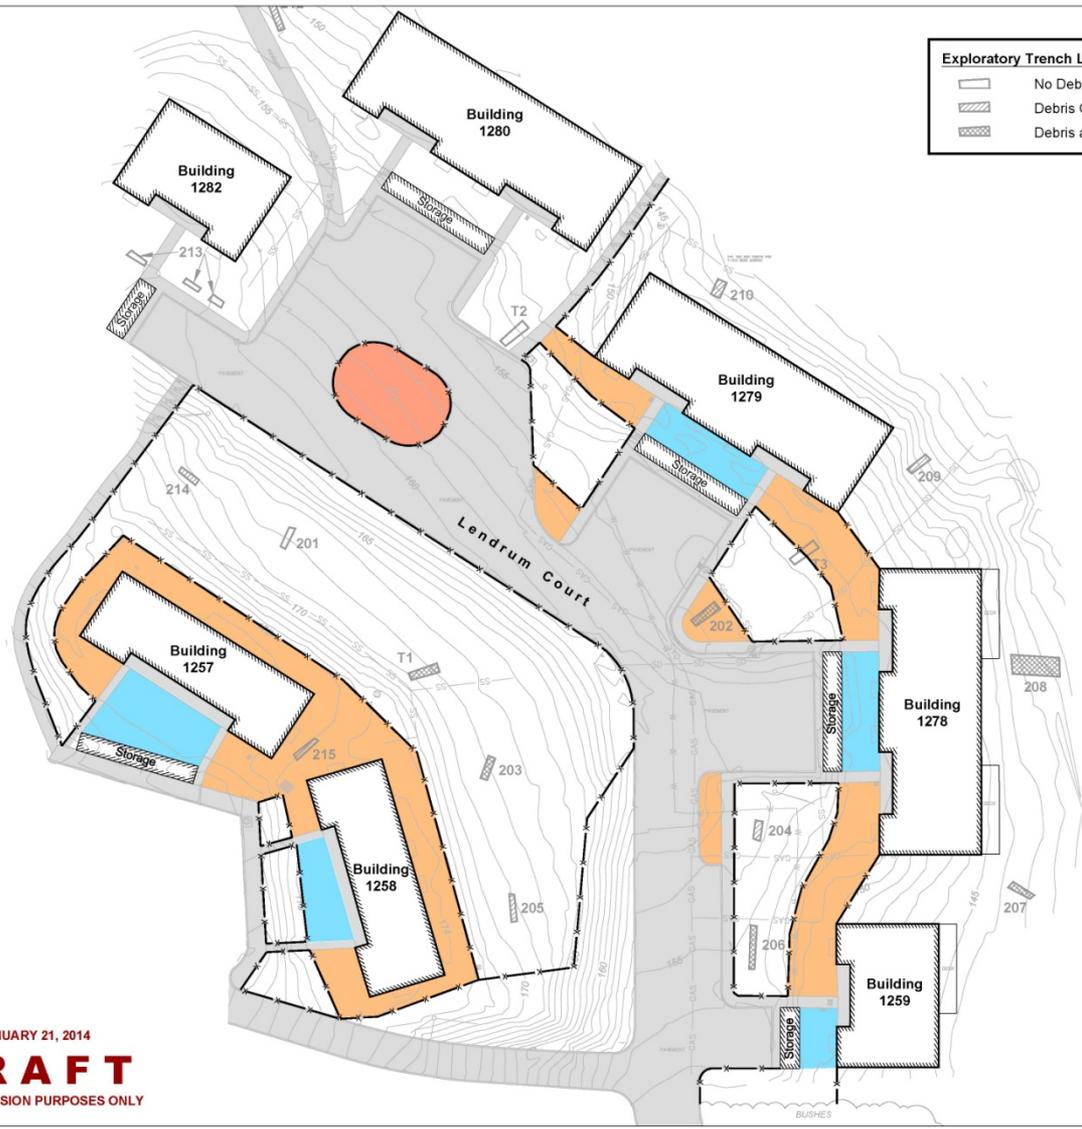
The Presidio Trust
San Francisco, CA
January 2014
EKI B00025.07
Figure 1

Exploratory Trench Location (Note 3)

No Debris or Ash Observed
	Debris Observed
	Debris and Ash Observed

- Notes:**
1. All locations are approximate.
 2. Survey source: PLS Surveys, Inc., dated 9 July 2013. California State Plane Coordinates NAD1927.
 3. Trenches 201 through 214 were excavated in June 2013. Trenches T1, T2, and T3 were excavated in October 2010 and were not surveyed.

Interim Fencing and Covering
at Lendrum Court

- Alternatives evaluated include:
 - Post and cable fencing in large sloped areas, coupled with continued minimal maintenance activities
 - Decomposed granite cover in high traffic/use areas
 - Playground soft tiles over decomposed granite cover in select yard areas
 - Wood chips over jute erosion control blanket in landscaped areas
