# PRESIDIO THEATRE BUILDING 99

Historic Structure Report

August 2015

Presidio  
Trust

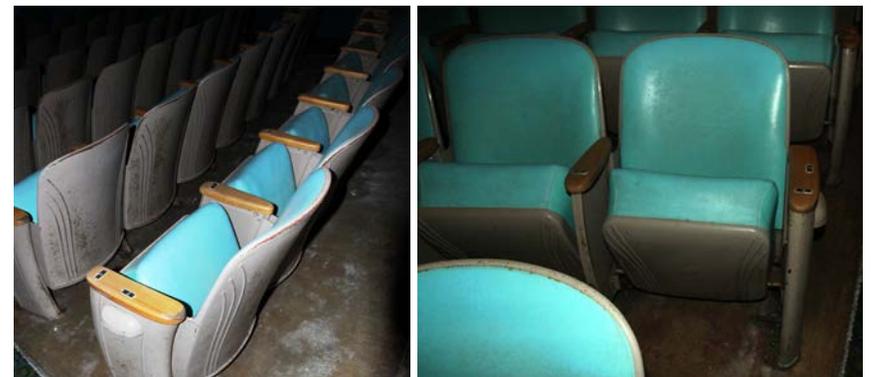
1.11 (upper left, clockwise) A comparison of historic photos and existing conditions concludes that the armrests, backs and legs of the extant chairs are not original to the theatre. (2014, Pons-Sorolla, PT)

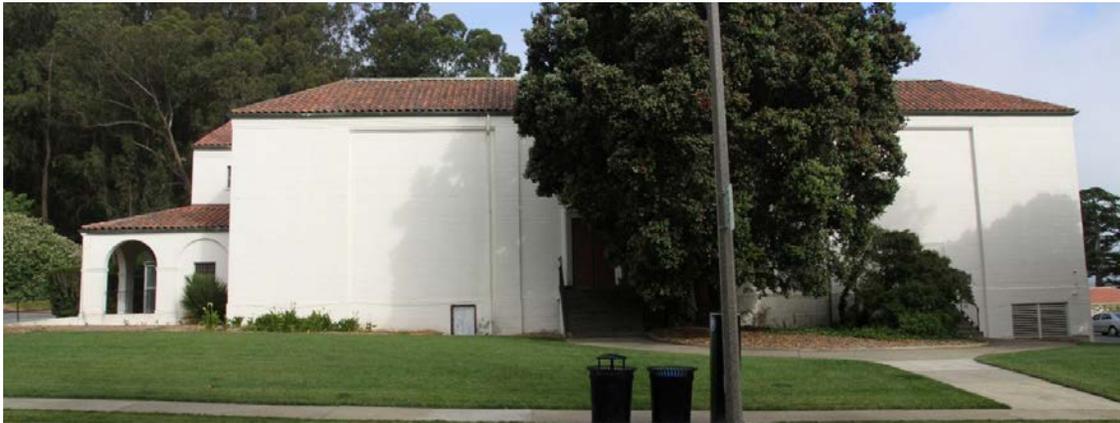
2.5 Building 99 east elevation. Both auditorium exit doors are largely hidden by heavy vegetation. The loggia and pavilion can be seen on the left. (2014, PT)

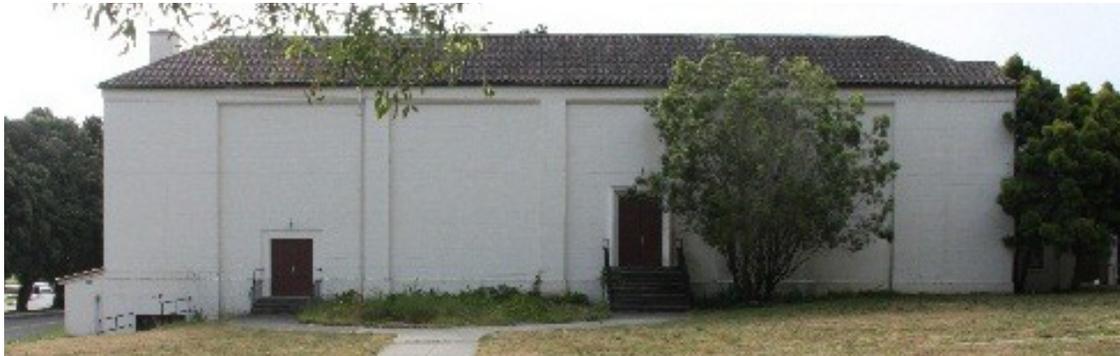
2.6 Building 99 west elevation. Both auditorium exits are visible at this elevation. The pavillion is obscured by heavy vegetation on the right. (2014, PT)

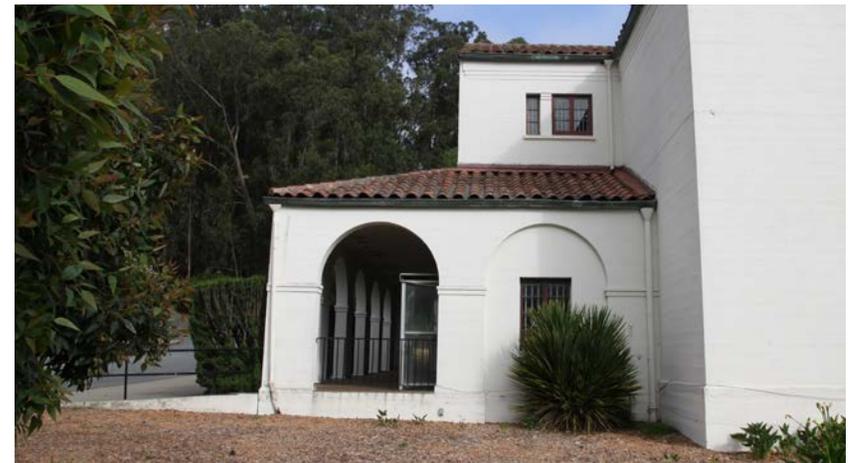
2.8 East elevation of the pavilion. Note the upper story windows where one mullion was removed and two windows were combined. (2014, PT)

- Crawl space access on east elevation added
- Removal of mullion and change in fenestration at the second story of the east elevation of the pavilion

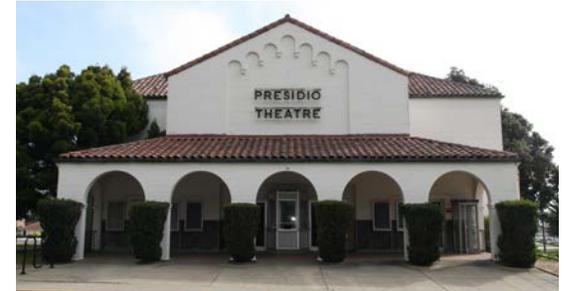
2.13 Room 01. Front view of south elevation showing that the 1962 wainscot is largely intact. (2014, PT)

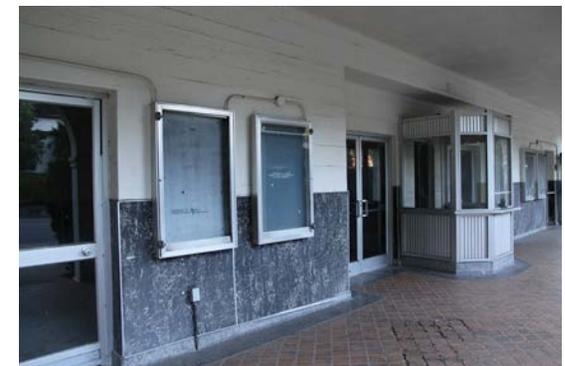
2.16 Room 01. Loggia interior looking east showing the intact storefront doors. (2014, PT)

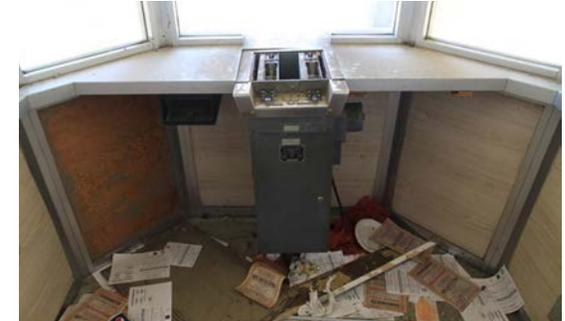
2.23 Room 02. (above) Ticket booth interior, ticket counter and the partially intact ticket booth machine. The original ticket machine was retained when the new ticket booth was constructed. (2014, PT)

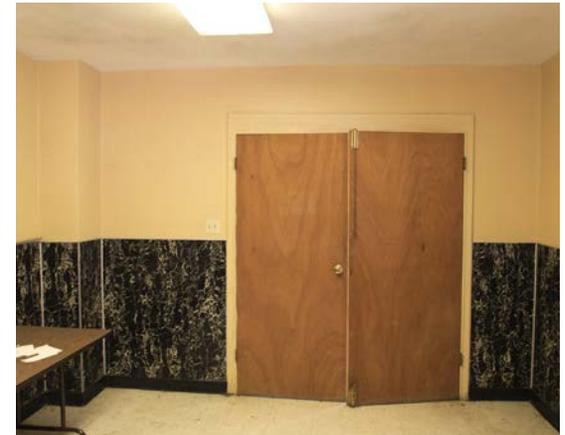
2.37 Room 04. Office interior looking east. The room retains the 1962 wainscot and rubber base. The single door was later widened to a double door after 1962. (2014, PT)

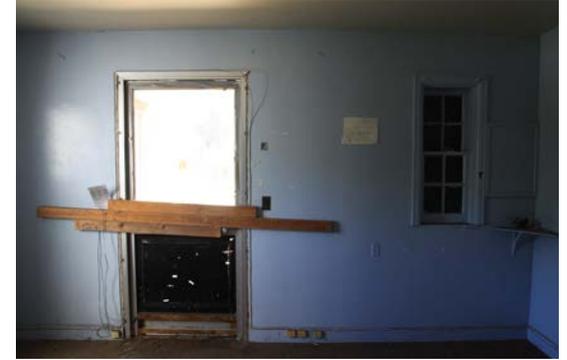
2.43 Room 09. (right) Office, south wall, showing 1962 storefront door with barricade. An original wood-frame window is intact but blocked by a poster case on the exterior wall. (2014, PT)

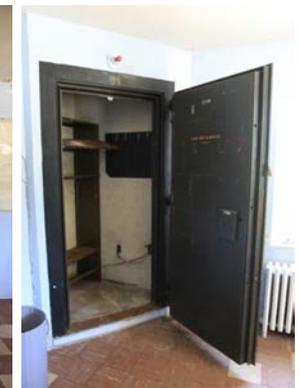
2.45 Room 05. Fireproof film vault intact and unchanged. (2014, PT)

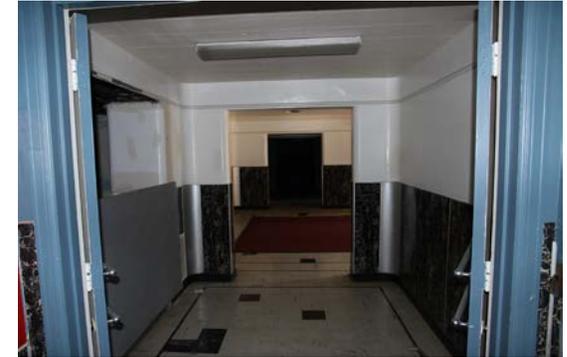
2.51 Room 06. West Foyer looking east from Entrance Hall showing blocked entrance to the private lounge on the left. Note the hardboard wainscot with aluminum curve detail. (2014, PT)

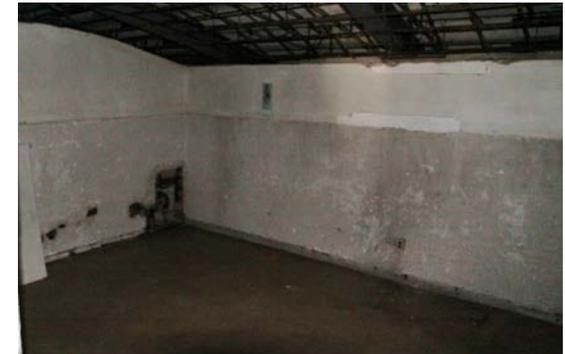
- During the Presidio Trust period of management all bathroom wall and ceiling finishes were removed, exposing curved metal lath at the ceiling

2.59 Room 09. Northwest corner of the east lounge showing that all wall and ceiling finishes were removed. (2014, PT)

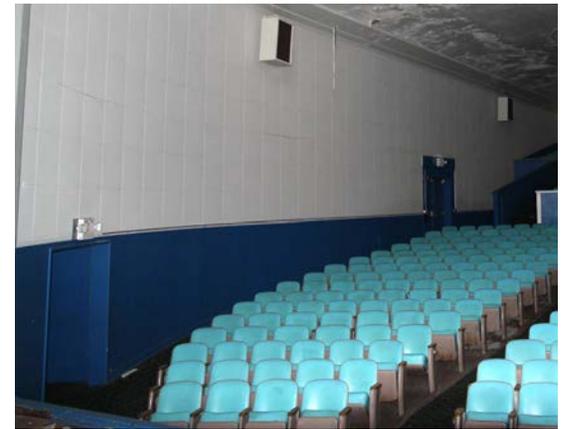
2.67 Room 12. East wall of the Auditorium showing the current acoustic tile finish above the original plaster finish. (2014, PT)

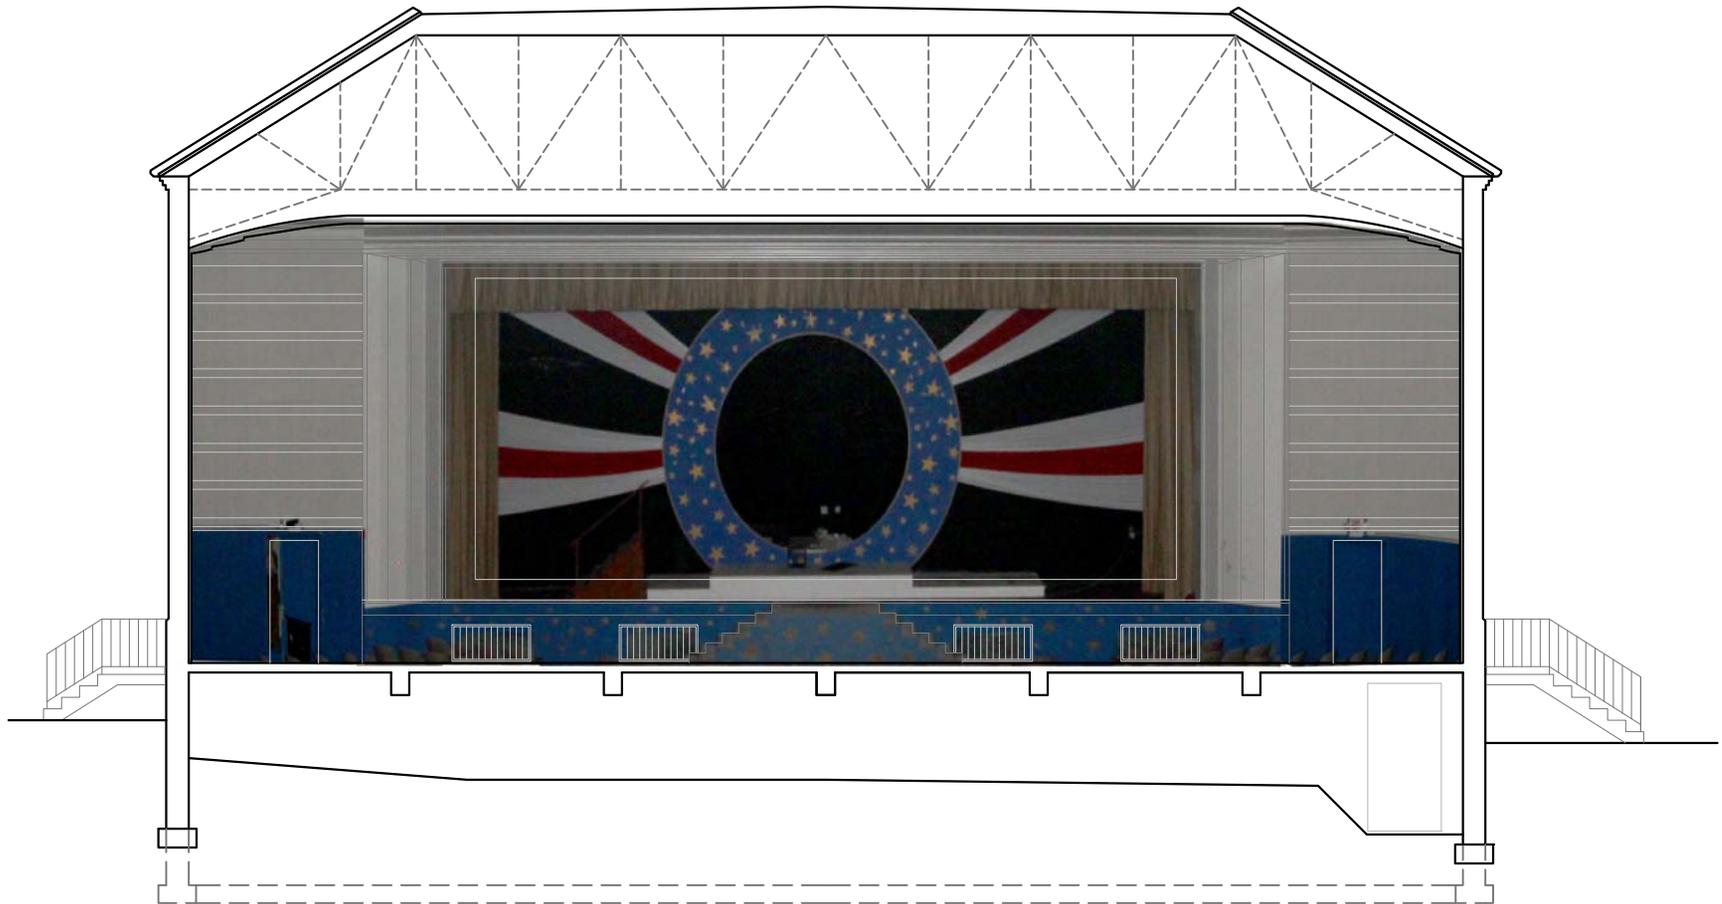
2.80 Room 12. This image illustrates the current stage elevation overlaid upon the original elevation plan. The stage, stage height, and proscenium remain unchanged. (2014, PT)

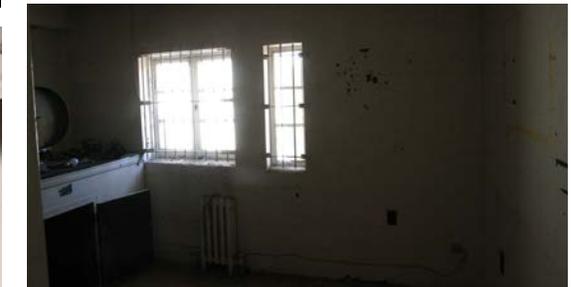
2.87 Room 15. Rewinding room window (east elevation). Note that only one mullion remains. There is no record of this change. (2014, PT)

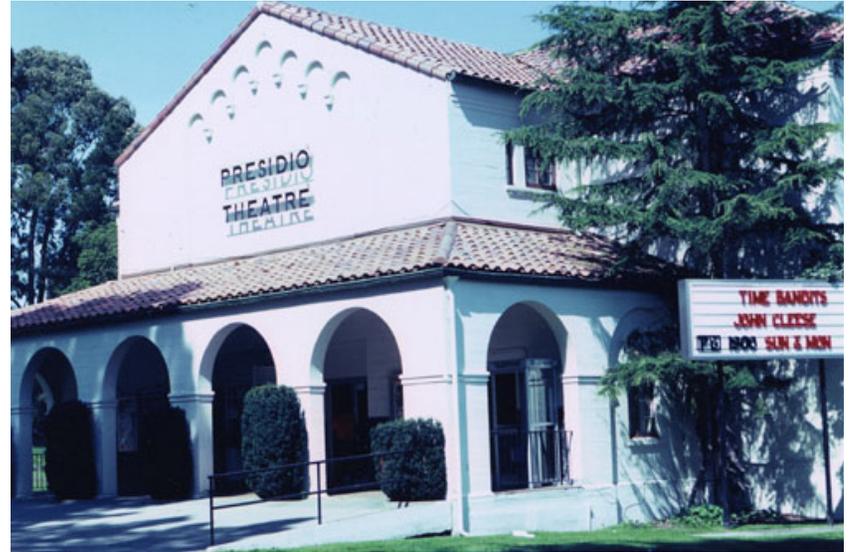
2.104 This 1982 image of the Presidio Theatre shows an evergreen tree at the east elevation that is no longer extant. (1982, Jack E. Tillmany, San Francisco History Center, San Francisco Public Library)

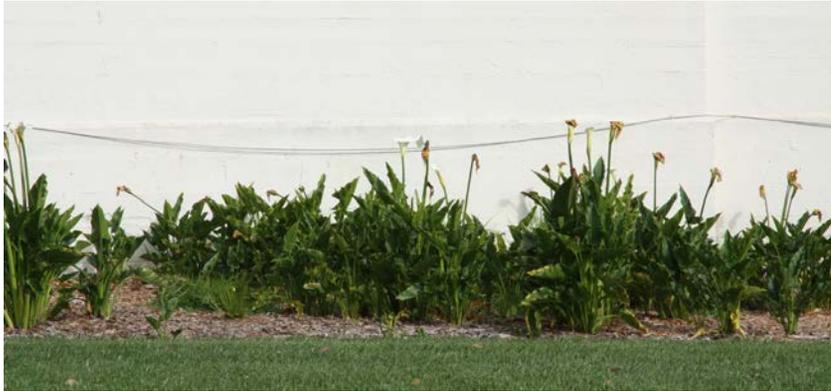
2.108 Calla Lilies at the base of the building at the east elevation. (2014, PT)

At the east elevation, the spatial organization and circulation patterns are intact and in good condition. However, plantings at or near the foundation are generally populated by volunteers, and/or overgrown which has caused deterioration to adjacent building features and materials (see Chapter III).

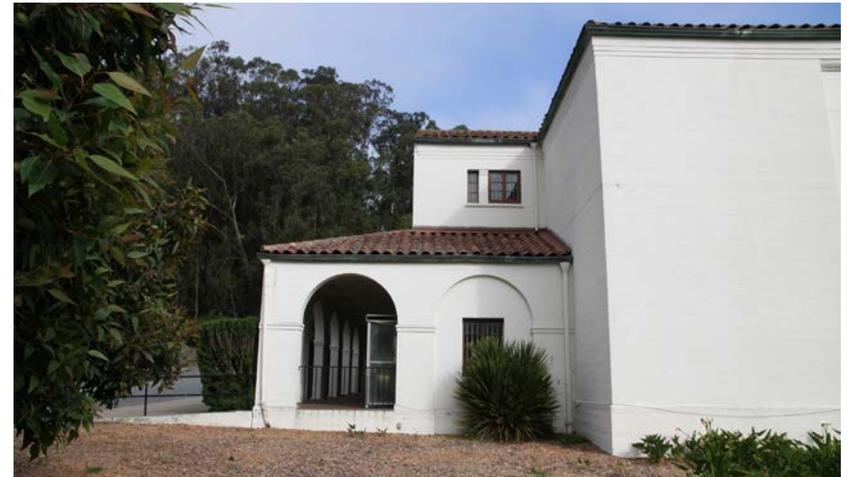
2.109 Foundation plantings are sparse at the southeast corner of the building. (2014, PT)

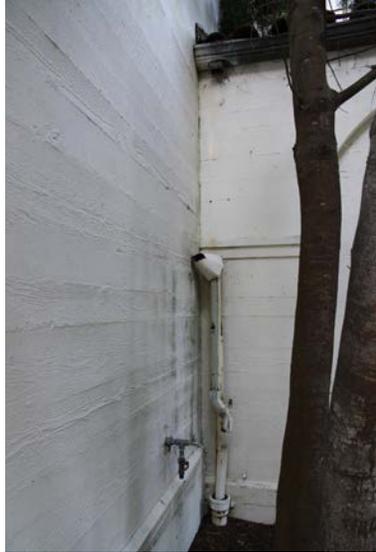
The exterior walls of building 99 are reinforced concrete featuring a board-form finish (see Figure 3.1). The building appears to receive regular maintenance, including exterior painting and most wall finishes are in good condition (Figure 3.2). There is little evidence of abrasive cleaning methods that may have led to the loss of the decorative board form finish. The chimney, at the north elevation, is the only area where paint is failing (Figure 3.3).

3.1 Board form finish exterior walls. (2014, PT)

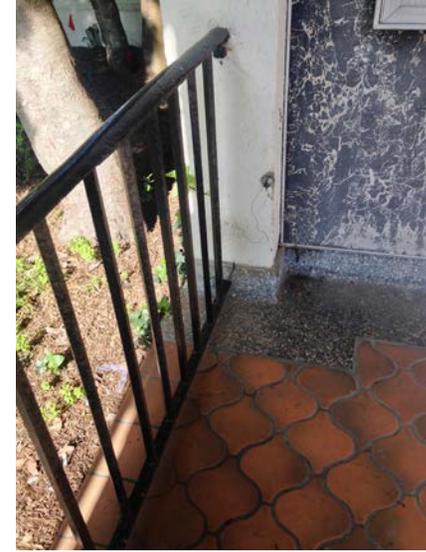
3.3 The northwest corner of loggia wall exhibits cracking and spalling at the connection point with the iron railing. (2014, PT)

a persistent problem and there is evidence of removed vegetative growth that has resulted in spalling and delamination of some concrete (Figure 3.3). An accumulation of dirt and biological growth at and below the water table is particularly apparent at the north elevation (Figures 3.4, 3.5).

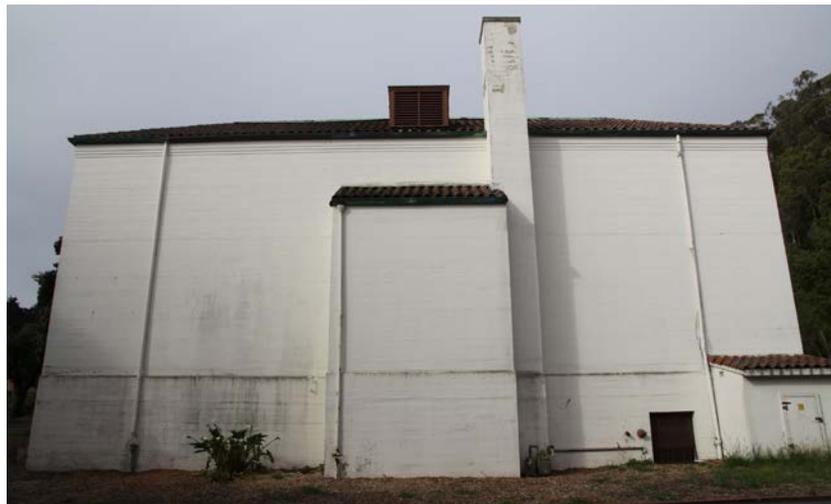
3.5 The dark coloring on the north elevation shown here is evidence of both dirt and biological growth on the exterior wall. (2014, PT)

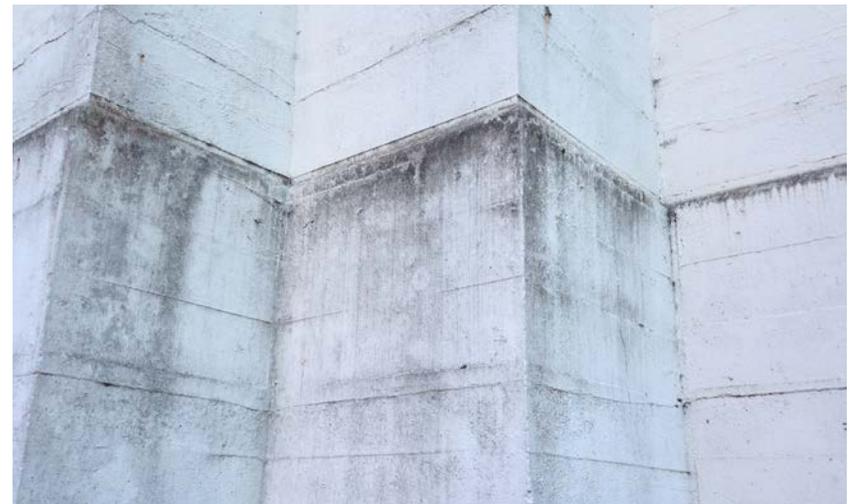
3.6 A detail of biological growth and soiling on north elevation. (2014, PT)

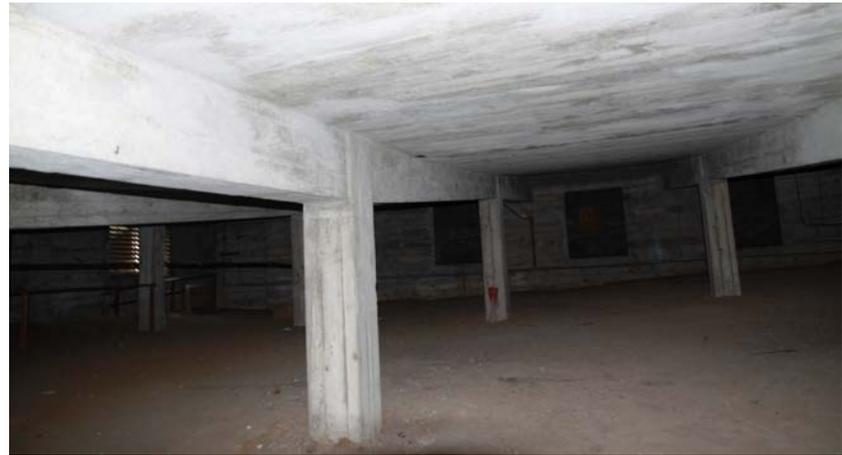
The exterior condition of the foundation appears sound other than some biological growth and staining, (See Exterior Wall section above).

3.8 Interior of the crawl space showing a dirt floor, concrete piers, beams and concrete foundation walls (background). (2014, PT)

A full structural analysis of the building and foundation by a structural engineer is recommended.

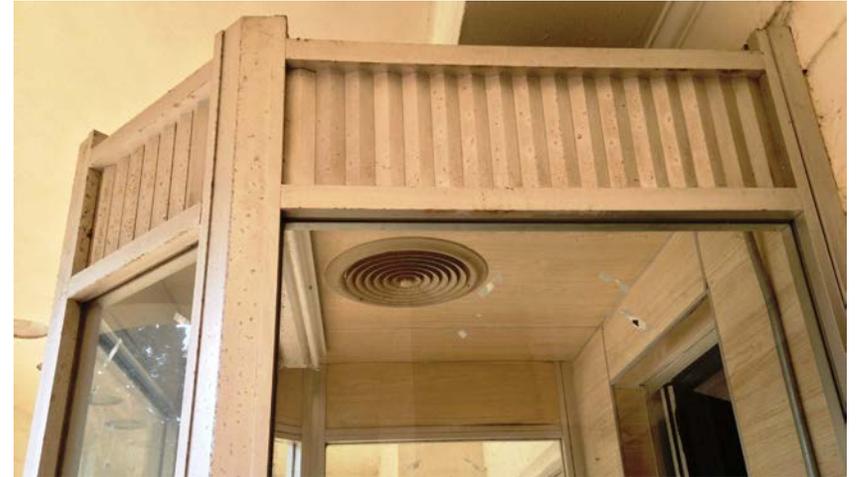
The aluminum ticket booth, added in 1962, features metal framing and fluted aluminum panels that exhibit some pitting and cosmetic flaws, likely caused by deferred maintenance and exposure to the elements (Figure 3.10).

3.9 Ticket Booth Exterior is aluminum in fair condition. Although largely protected from the elements, the aluminum exhibits some pitting. (2014, PT)

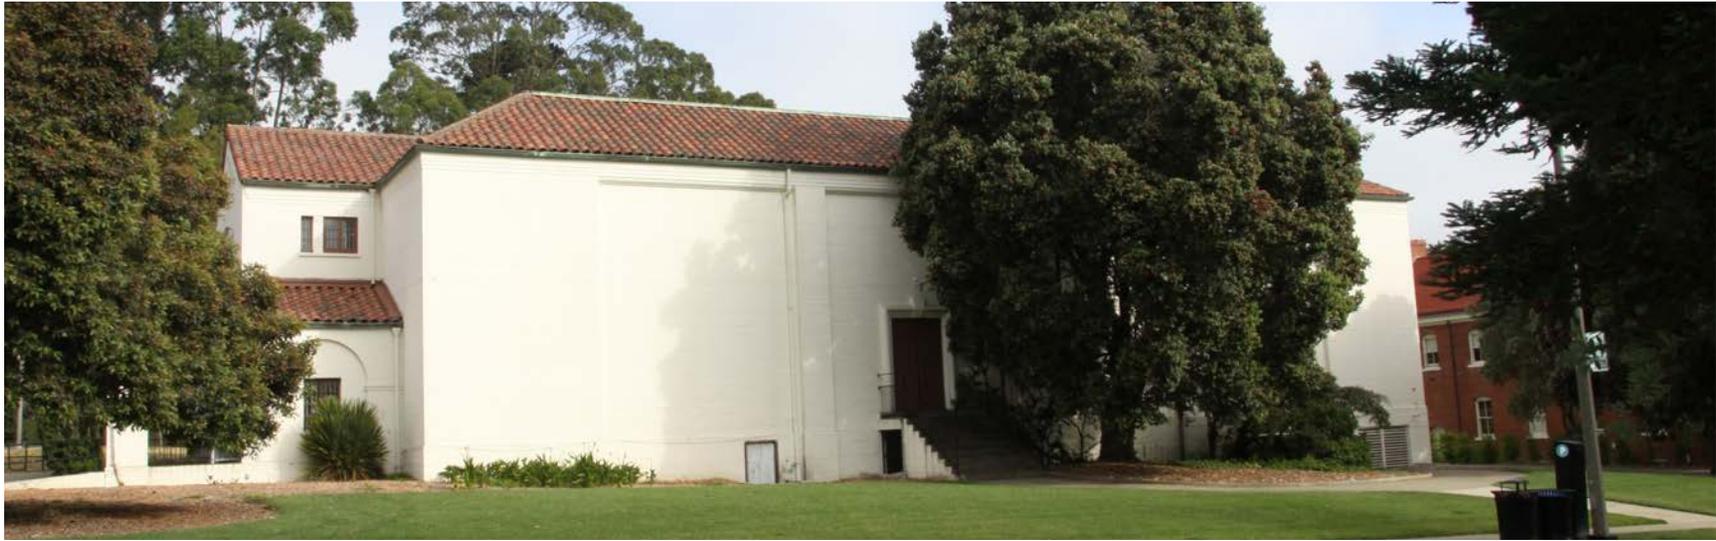
3.11 East elevation roof showing both the gable roof of the south elevation and the hip roof atop of the auditorium. (2014, PT)

The building's Spanish style tile roof appears to be in good condition. It shows no visible cracking or loss of material, though lichen and moss are visible on some tiles. There is no indication of water infiltration at the front portion of the building.

The auditorium features a short tile hip roof at the perimeter but a flat roof is the primary roof of this volume. Though the roof was not accessed for this assessment, persistent leaking in the auditorium and stage indicates that the roof is in need of repair if not full replacement. There is no record of a roof replacement ever being performed.

The condition of the roof was determined through a visual assessment only; a full roof assessment is recommended.

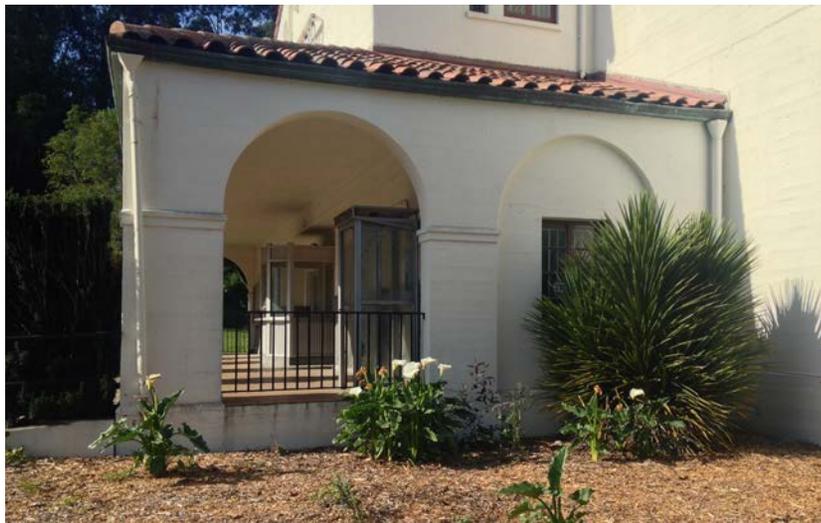
3.12 East elevation of the loggia shows an intact copper gutter and two functioning downspouts. (2014, PT)

The drainage system is comprised of copper gutters and downspouts. The gutters appear to be in good condition although cleaning is required in locations close to trees, primarily on the east and west elevations. The downspouts are in poor to fair condition, many with missing or failed connections. (See figures 3.12-3.14)

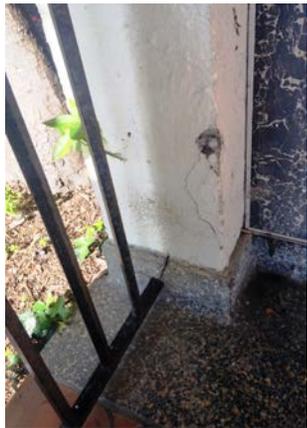
Original iron railings are located in the loggia and at the auditorium stairs along the west and east elevations. The railings are in fair to poor condition showing signs of jacking, buckling and rusting (Figures 3.15, 3.16).

3.16 The railing and concrete connection shows signs of rusting and failure at the west end of the loggia. (2014, PT)

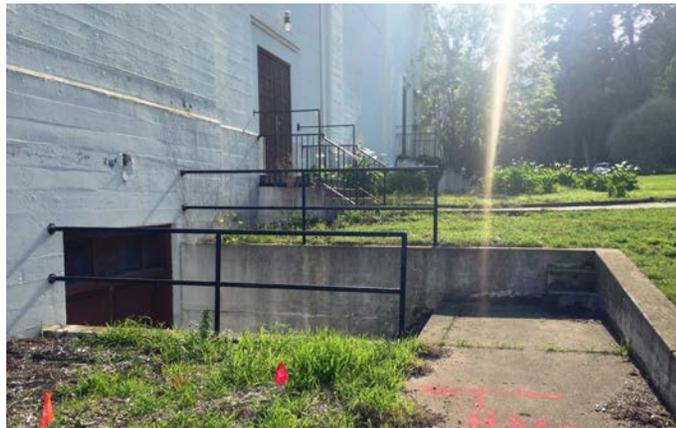
Additionally, some railings at the auditorium exits were later modified with a top railing added to the original fixture (Figure 3.18). Simple tube railings were used at the basement stairs and are in good condition (Figure 3.17).

3.17 Basement iron tube railing is in good condition. The auditorium stairs on the west elevation can be seen in the background. (2014, PT)

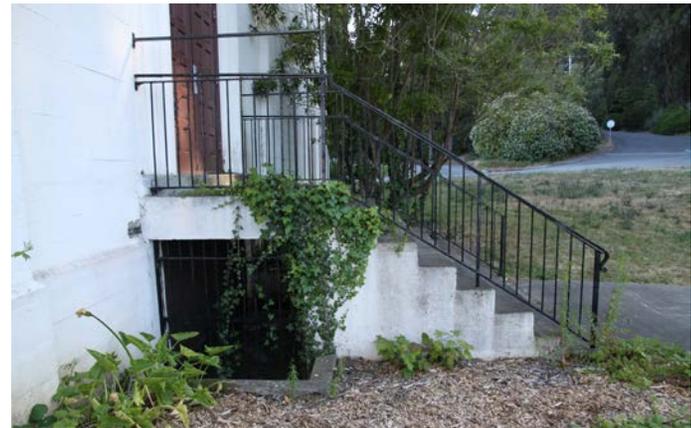
Iron bars placed to secure access to the space beneath the stair are original to the theatre and in fair condition, although increasingly obscured by vegetation. Due to the dark and heavily vegetative environment, these security bars are susceptible to rust and failure (Figure 3.18).

3.18 At the west elevation auditorium stairs, an iron railing was added to the top tube of the original railing, perhaps to stabilize the original railing. Security bars, partially obscured by vegetation, block the open space under the stairs. (2014, PT)

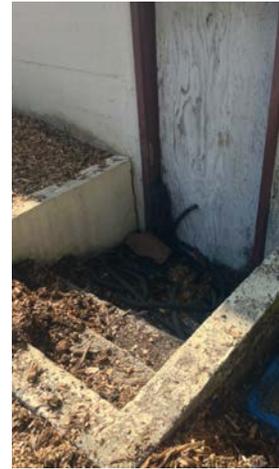
Where the crawlspace stair descends into the building, trash and vegetation debris has accumulated (Figure 3.23). The debris obscures the condition of the stair and evidence of a storm drain.

3.19 Debris in the east elevation, crawl space stairs. Plywood is covering the crawlspace opening. (2014, PT)

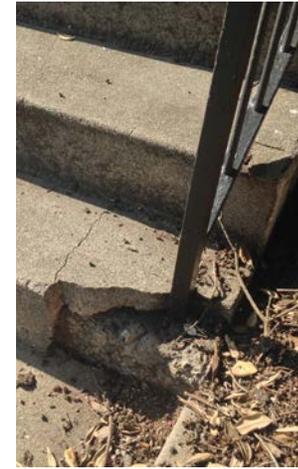
The auditorium stairs are in fair to poor condition due in large part to the heavily planted and shaded landscape adjacent to the stairs along with deferred maintenance. The damp conditions along the west and east elevations has resulted in susceptibility to spalling and cracking of the concrete (Figures 3.19-3.21)

3.20 Failing and missing concrete at the bottom of the south stairs on the east elevation. (2014, PT)

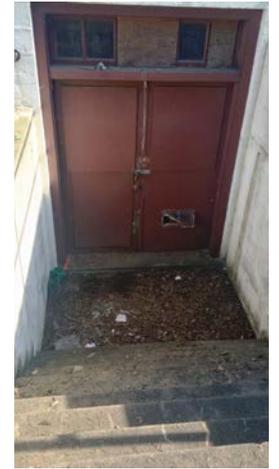
The basement stair descends into the basement and appear to be in good condition although a lack of a storm drain may lead to flooding in the basement (Figure 3.24).

3.21 Debris has accumulated at the bottom of the basement stairs. (2014, PT)

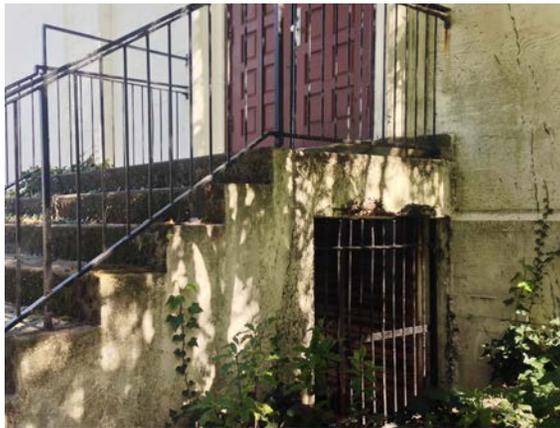
3.22 South auditorium stair on the west elevation is in very poor condition. The shaded and damp conditions have caused concrete failure. (2014, PT)

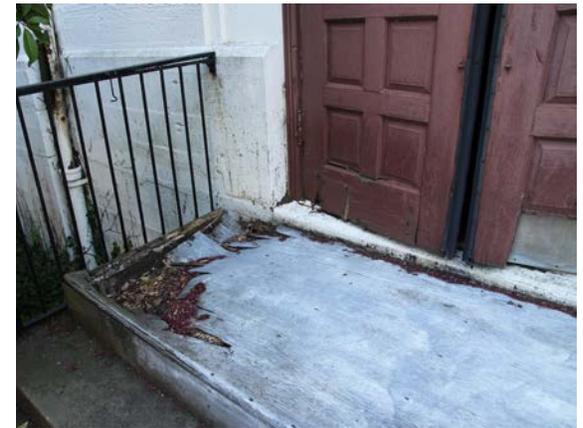
3.24 A failing plywood step added at the landing of the north auditorium stair on the east elevation. (2014, PT)

At most of the auditorium exits a plywood landing atop of the original landing was added to create an at-grade exit landing (3.22). These landings are structurally failing and should be removed.

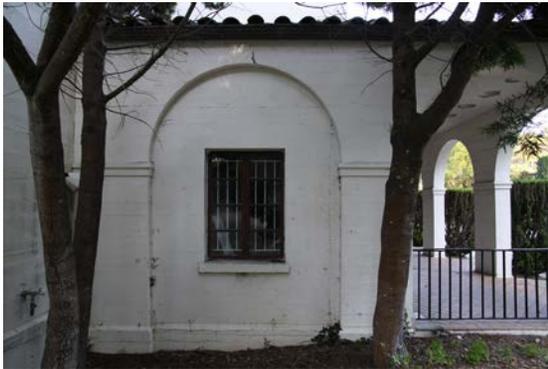
The two offices on the ground floor have identical metal frame windows at the end walls and are in fair condition (Figure 3.25). An additional wood frame sash window is located on the north wall of the loggia and originally functioned as a second ticket window. This window was later covered by a poster case but is still visible inside the east office (Figure 3.26).

3.25 The west office has a metal frame double casement window with security bars installed on the interior sill. The same condition occurs on the east end wall of the east office. (2014, PT)

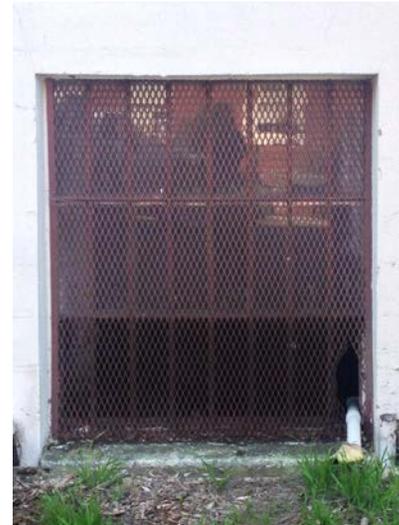
A single opening is located on the north elevation at the boiler room. This window is in poor condition; it is a metal frame hopper window with a rusting metal security grate attached to the outside sill. An opening in the grate and window for mechanical piping has created a path for pests and birds (Figure 3.28)

3.28 North elevation, basement window with metal grate. A hole made for utility piping attracts wildlife into the basement. (2014, PT)

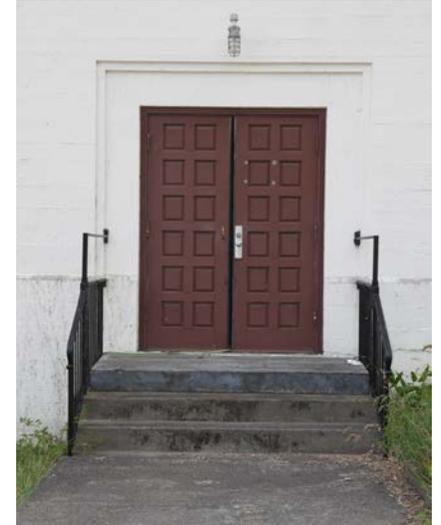
The original wood panel doors, located at each auditorium exit, are in poor to fair condition, exhibiting some dry rot and swelling from deferred maintenance (3.29). Many doors feature incompatible replacement hardware that should be replaced.

3.29 West elevation wood panel doors. (2014, PT)

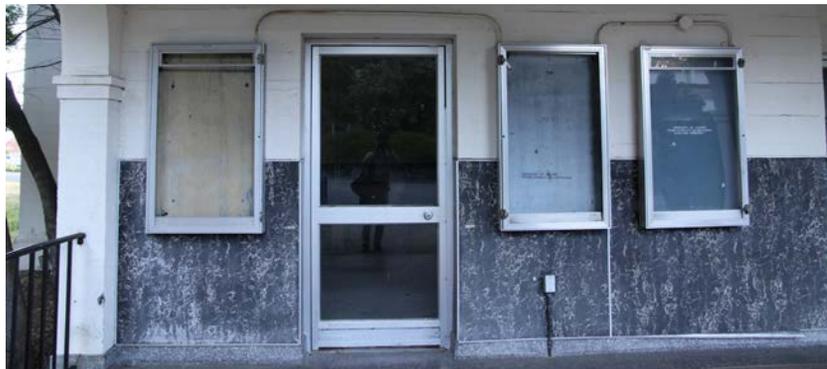
The replacement aluminum doors at the entrance of the building are in fair to good condition (3.30). Minor irregularities on the aluminum surface and framing show are caused by weathering but can be repaired. Hardware on some doors are missing. A makeshift ticket counter added to the east office door is intact but is of poor craftsmanship and should be removed.

3.30 The west office replacement door at the loggia. (2014, PT)

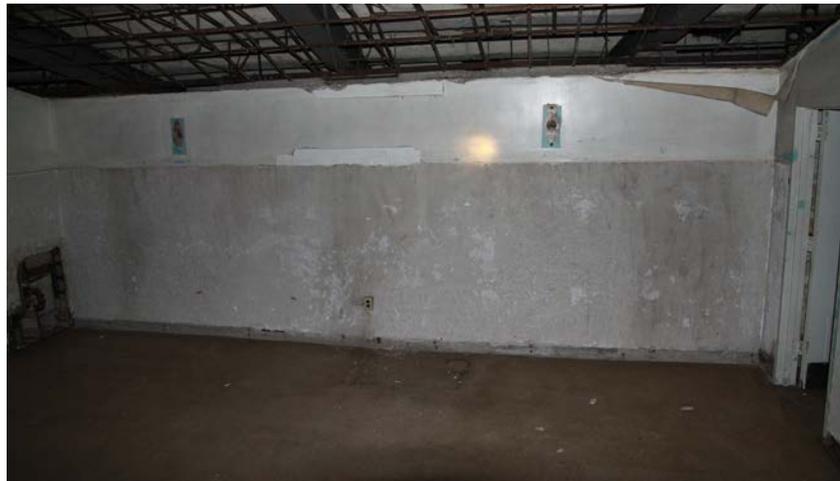
3.38 A composite tile flooring in poor condition remains in both lounges. It appears that all base boards were removed with much of the wall finish. (2014, PT)

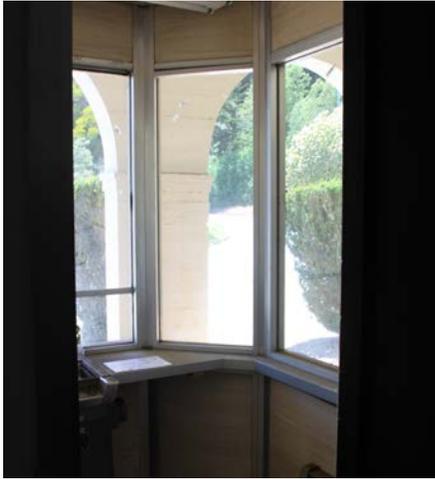
3.40 Aluminum frame Plexiglas windows replaced the original ticket booth windows in 1987. (2014, PT)

Windows in the front rooms are few in number and confined to the east and west offices, but are in fair to good condition. The ticket booth windows were replaced in 1987 and are in fair condition.

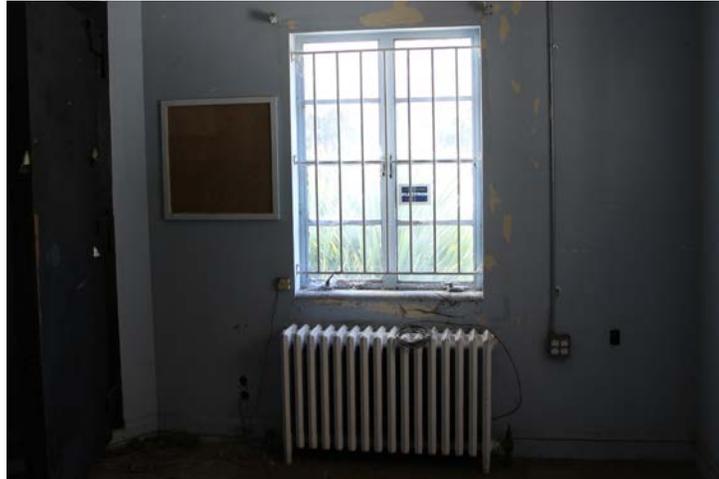
3.41 East office, double casement metal frame window with security bars attached to the inner sill. Deferred maintenance is evident around the frame and sill however all window panes are intact. (2014, PT)

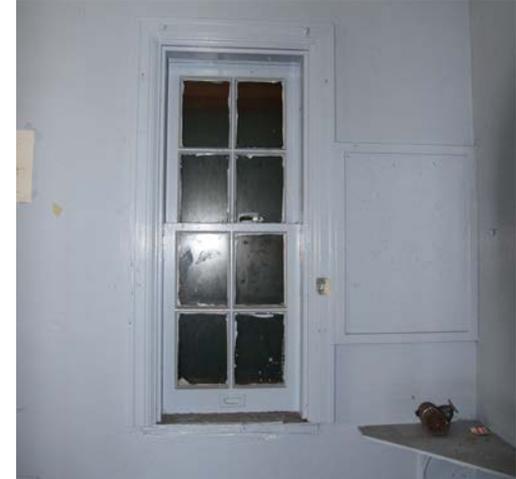
3.42 The east office wood frame window is in good condition but currently blocked by a poster case attached to the exterior wall of the loggia. (2014, PT)

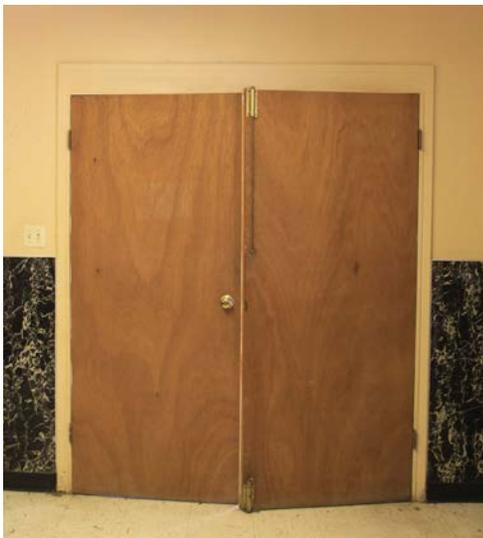
3.43 Non-historic wood, flat panel doors in the west office are in good condition. (2014, PT)

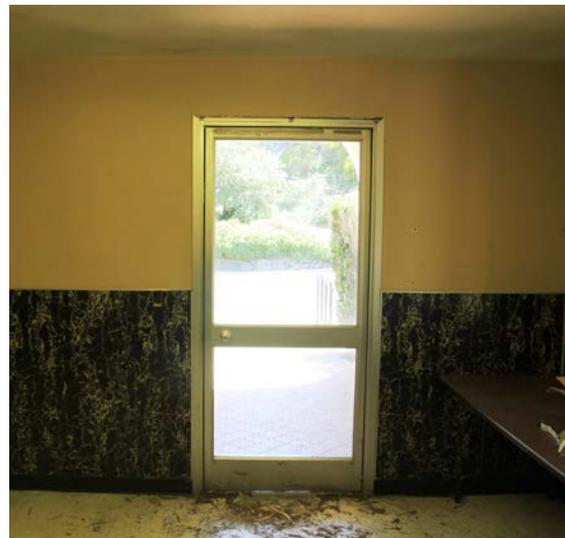
3.44 The non-historic, aluminum frame door in the west office, added in 1962, is in fair condition. (2014, PT)

Remove the aluminum entry doors and replace with compatible new doors based on available archival information.

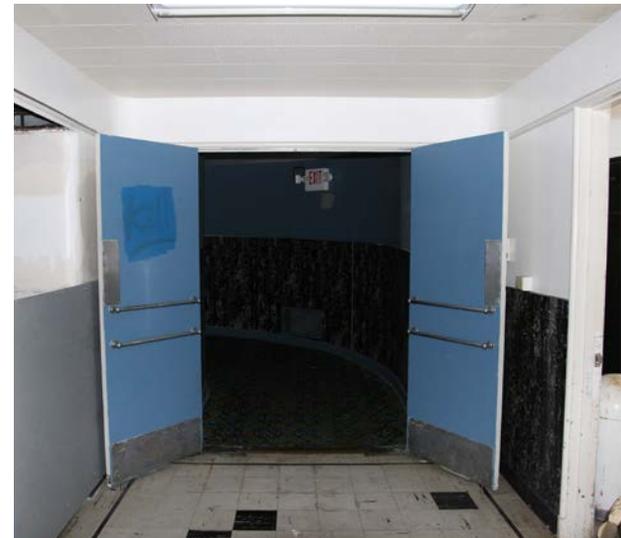
3.45 Original double foyer doors with original push bar handles are in good condition. (2014, PT)

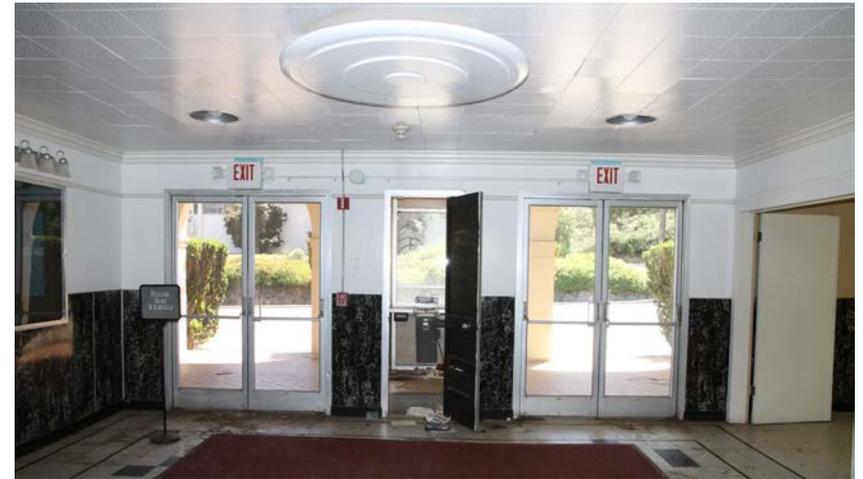
The lobby and foyers feature an acoustic tile ceiling, and though generally in good condition, some tiles are beginning to detach from the substrate. It is likely that the original ceiling is intact beneath the tiles and can be restored however further investigation is required.

3.46 The lobby originally featured a plaster ceiling but is now covered in acoustic tiles; it is likely that the original ceiling is intact and can be restored. (2014, PT)

Remove acoustic panel finish from the ceiling and replace with a new acoustic or other treatment that is compatible with the ceiling's original

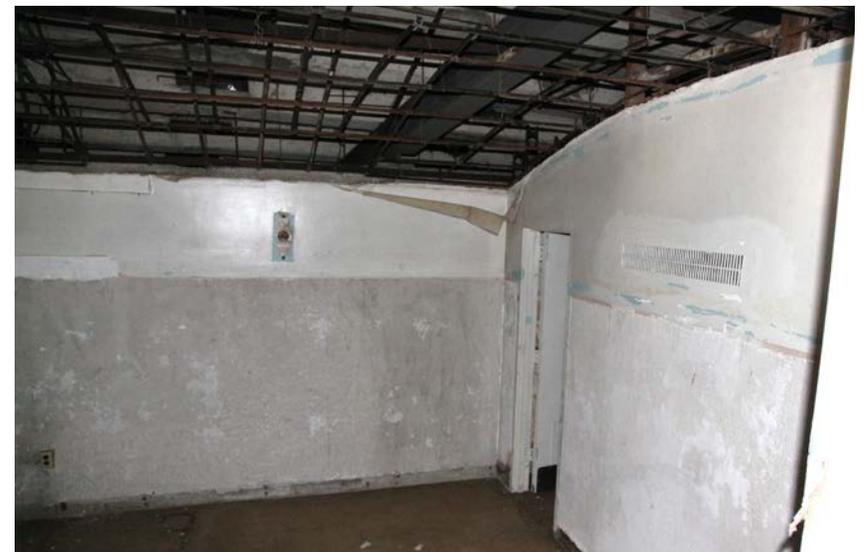
The lounges have undergone a complete ceiling removal thereby exposing the metal framing of the auditorium upper seating area.

3.47 No remnants of the ceiling remain in either lounge. (2014, PT)

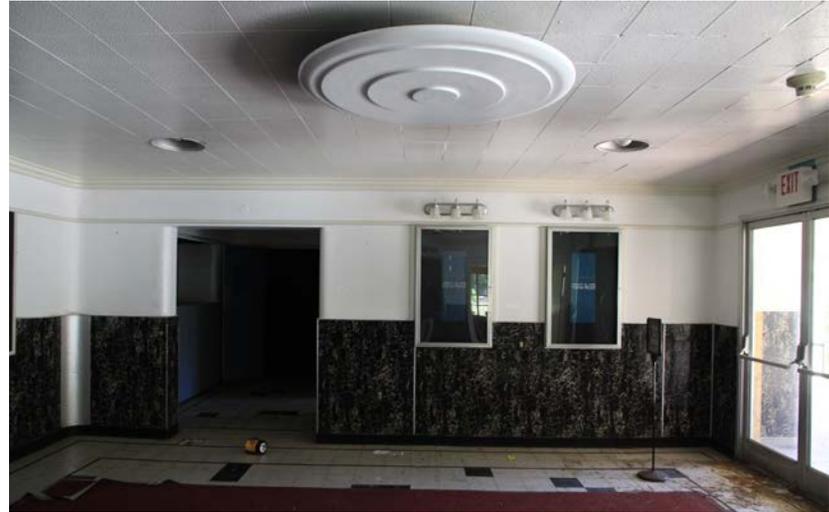
3.48 Flush single bulb lights in the lobby ceiling are likely original and should be kept. The Lobby also features several non-historic sconces over display cases that appear to be in good condition. (2014, PT)

Remove non-historic lighting fixtures in the lobby and adjacent offices, and replace with compatible new fixtures.

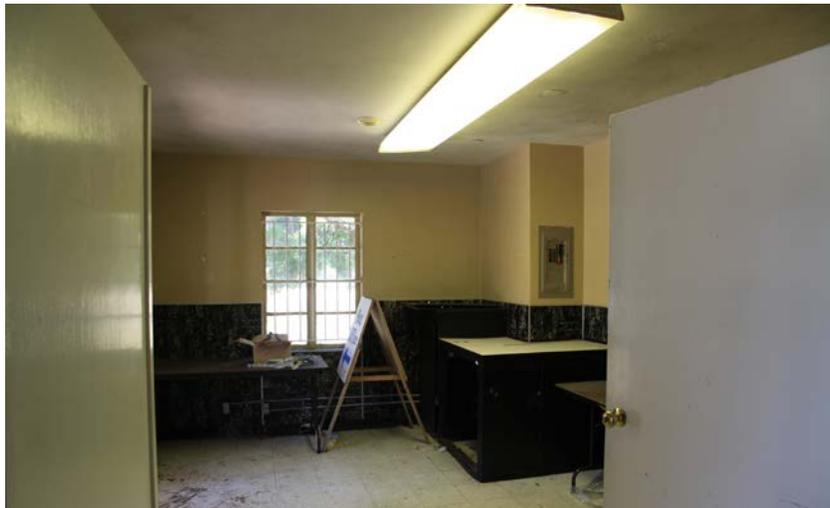
3.49 Florescent lights in offices not original but are functioning and in good condition. (2014, PT)

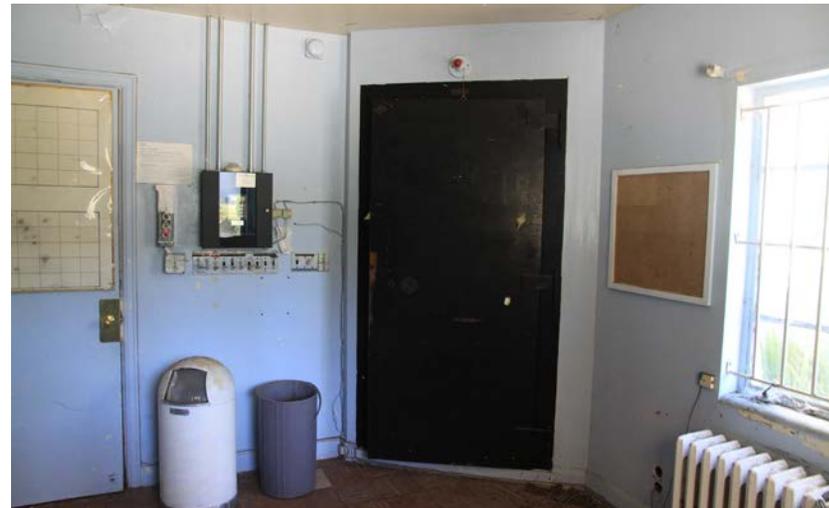
3.50 The red light bulb above the film vault is likely from the period of significance and should be kept. (2014, PT)

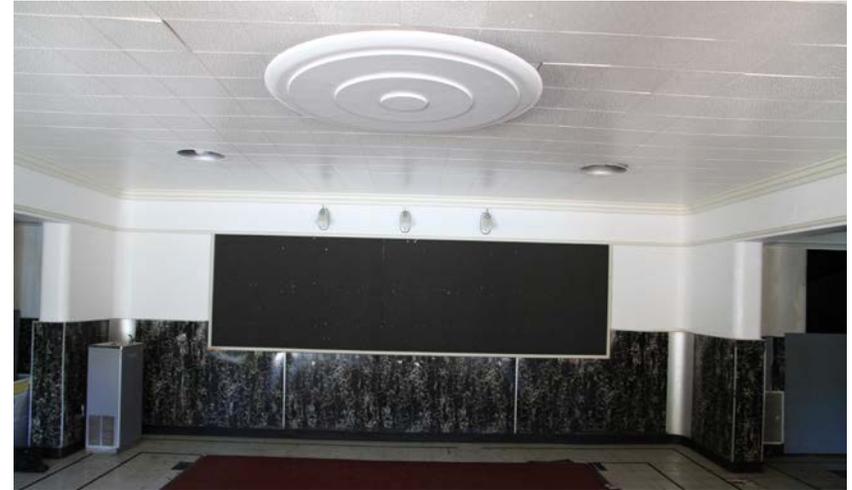
3.51 The lobby features a circular air handling unit. This decorative and functional fixture is in good visual condition however the operability of the fixture is unknown. (2014, PT)

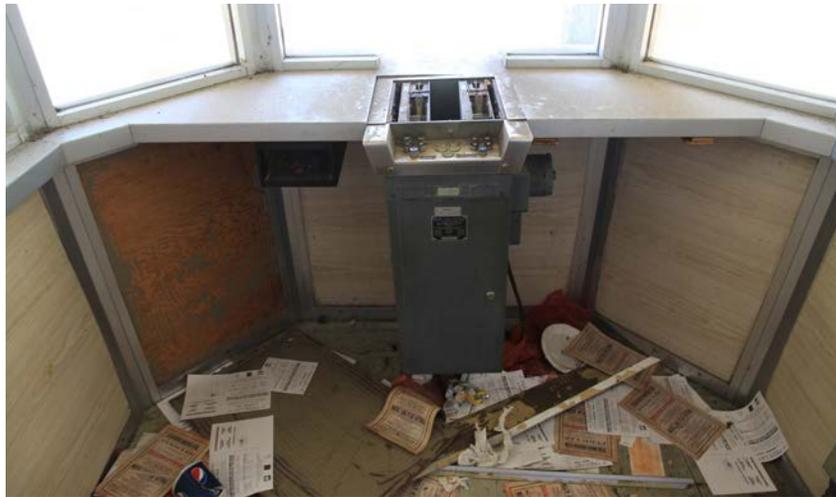
3.52 The ticket booth ticket machine is partially dismantled. (2014, PT)

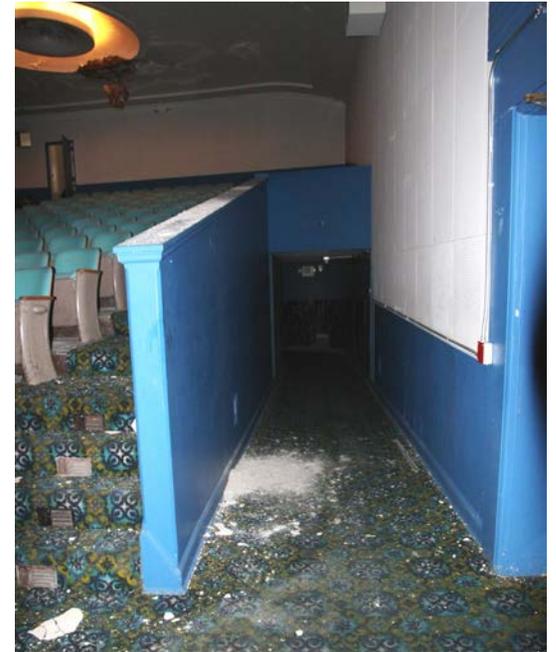
3.58 The stairs up to the upper seating area, looking south towards the west entrance hall. The plaster-concrete partial wall (left) and concrete wainscot (right) are in good condition. Fallen plaster from the ceiling has left small piles of white debris on the carpet. (2014, PT)

An acoustic tile treatment on the ceilings of the entrance halls has replaced the original acoustic plaster finish; the current treatment is in fair condition. However, condition of the auditorium ceiling is in poor and requires attention. Water infiltration from leaks in the roof have caused significant deterioration of the auditorium's original plaster ceiling. Many areas in the auditorium show staining while loss of plaster and metal lath framing is evident in others.

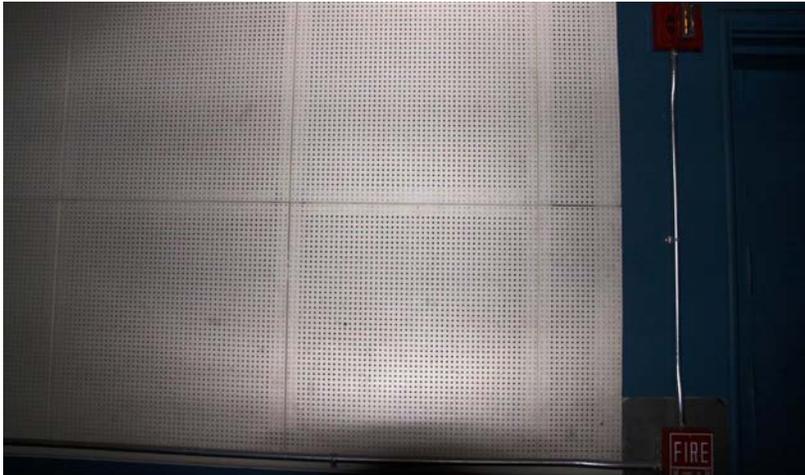
3.61 Square acoustic wall tiles found in the auditorium are a non-historic finish treatment that may conceal the original acoustic finish beneath. (2014, PT)

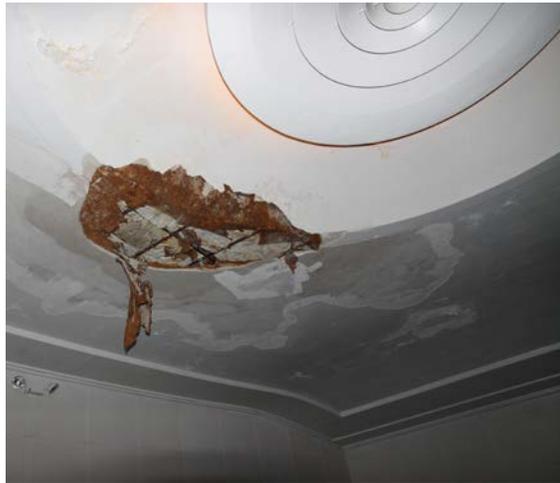
3.63 Missing plaster and lath at the southwest corner of the auditorium. (2014, PT)

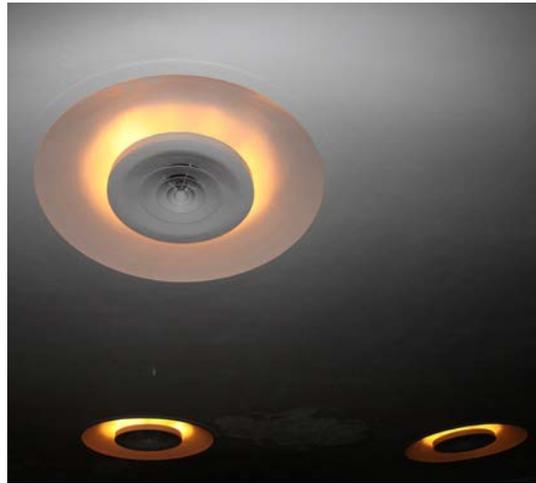
3.64 Despite years of inactivity, all lights fixtures are operable. (2014, PT)
