# PRESIDIO THEATRE BUILDING 99

Historic Structure Report

August 2015

Presidio  
Trust

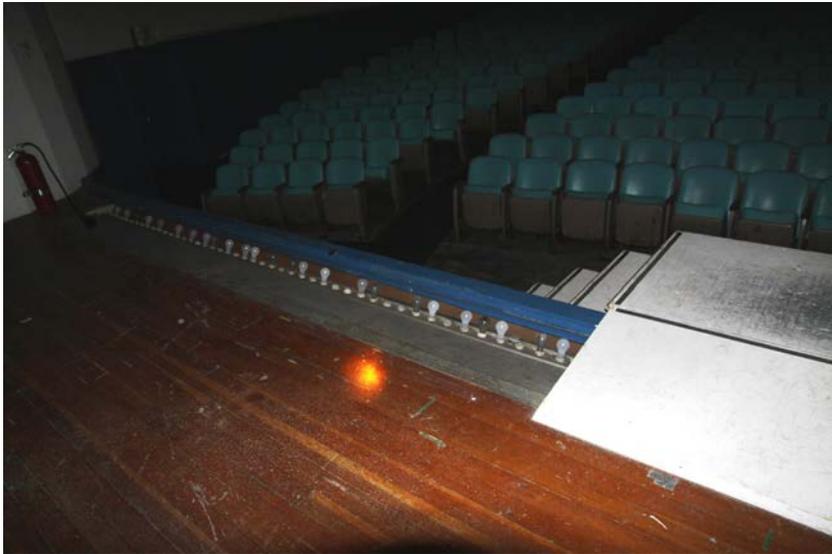
3.66 The stage retains fittings, and lightbulbs, for single bulb footlights. It is unknown if these fixtures are operable. (2014, PT)

Lighting around the stage is limited to original single bulb fixtures above the stage and a row of single bulb footlights. These fixtures were inoperable during site visits but appear to be in fair condition and can likely be restored.

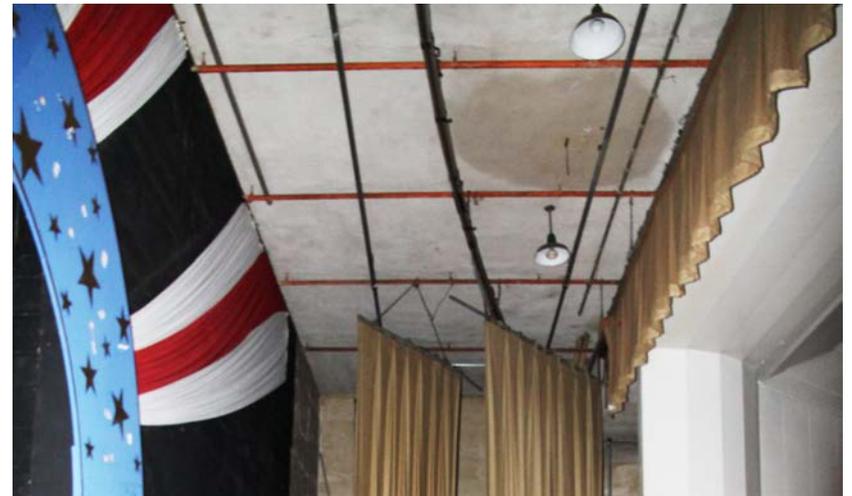
Water infiltration has caused some staining on the plaster ceiling but it is otherwise intact and in fair condition.

3.68 Water stains are visible on the stage ceiling. (2014, PT)

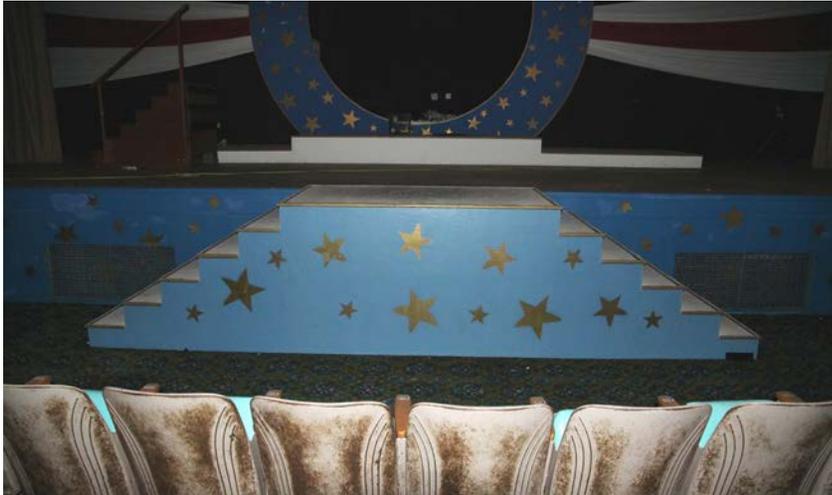
3.70 Two sets of stairs provide access to a platform at the foot of the stage. This added feature is in good condition. (2014, PT)

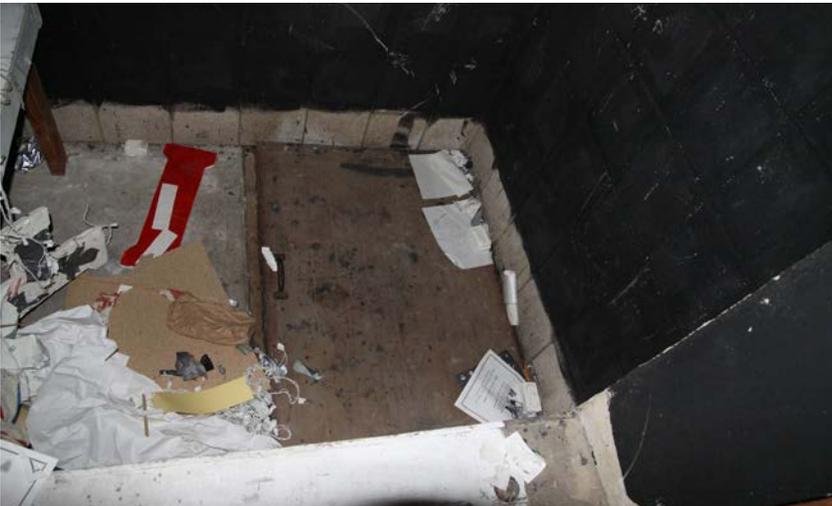
The stage baffle is intact and retains the original hatch door to the basement. Operability of the hatch door is unknown.

3.71 Hatch door in baffle room provides access to basement. (2014, PT)

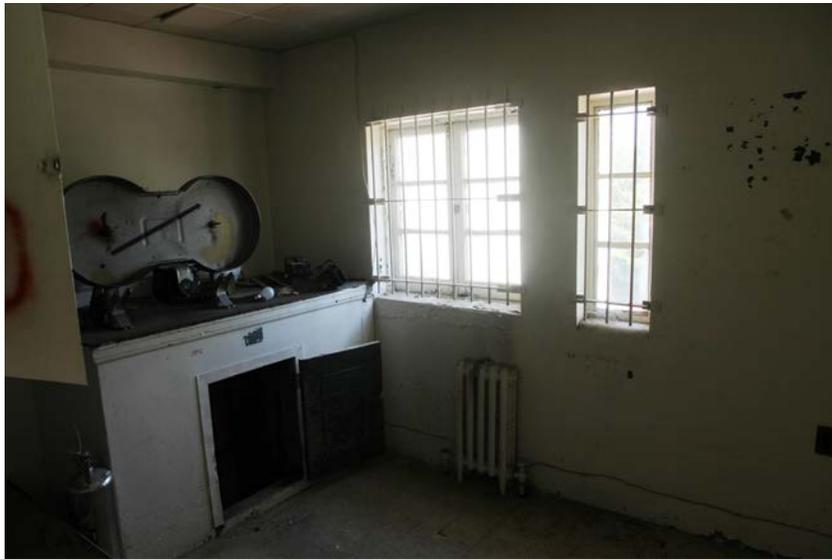
The original bulb nosing was lost when a double wood-frame casement window replaced two single casement windows on the west wall. A lack of maintenance has led to water infiltration, deterioration to the replacement concrete sill. The extant on the original single casement window is to the right of the replacement window. Security bars attached to the interior wall are a typical treatment to the theatre windows but are not an original feature.

3.77 The east projection room contains one original window and one replacement window. (2014, PT)

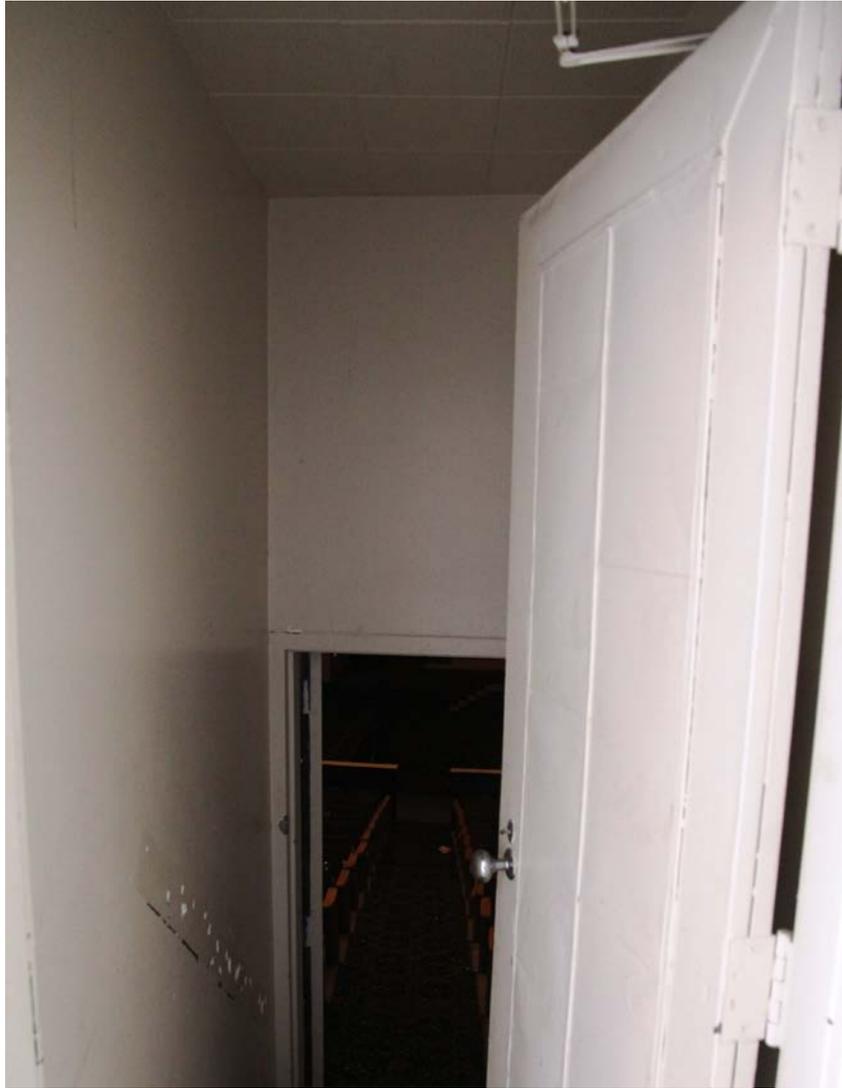
3.79 Metal door at top of the stairs leading into the projection room. (2014, PT)

Metal doors were a fire-safety feature due to the film's highly flammable quality. Both the entrance to the projection room and at the rewinding (east) room feature a metal door. The metal doors are in good condition.
