# PRESIDIO CHAPEL BUILDING 130

Historic Structure Report

March 2012

PAGE & TURNBULL

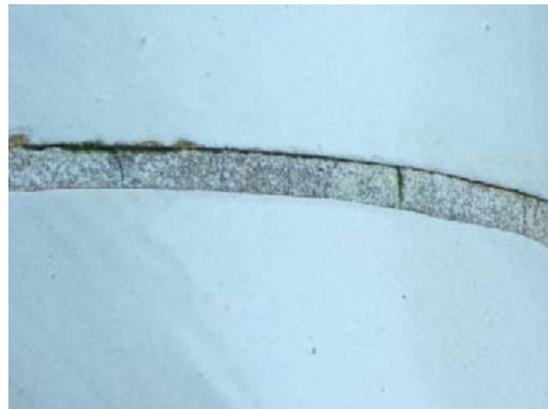
Example of terra cotta mortar joint

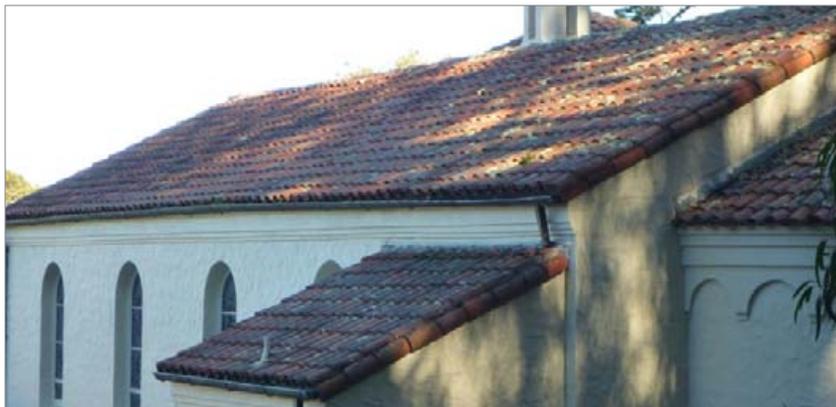
Roof condition, showing main chapel and shed roof extension.

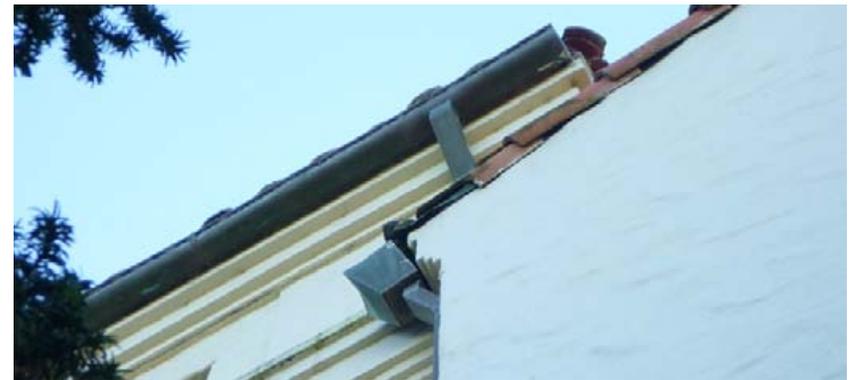
A patterning to the copper patina of the gutters suggests that the paint barrier between the steel hangar and the copper gutters has deteriorated and is leading to galvanic corrosion. Corrosion of the copper gutter seams is also evident, suggesting that the gutters have reached the end of their useful life. This problem is currently not affecting the functioning of the gutters, but it will accelerate the deterioration of the system unless the dissimilar metals are separated.

Typical gutter and downspout assembly.

Roof flashing in the bell tower and chimney has failed, allowing significant amounts of moisture to enter the building. The flashing needs to be repaired/ replaced as soon as possible to prevent water infiltration, stucco delamination, and efflorescence within the bell tower rooms.

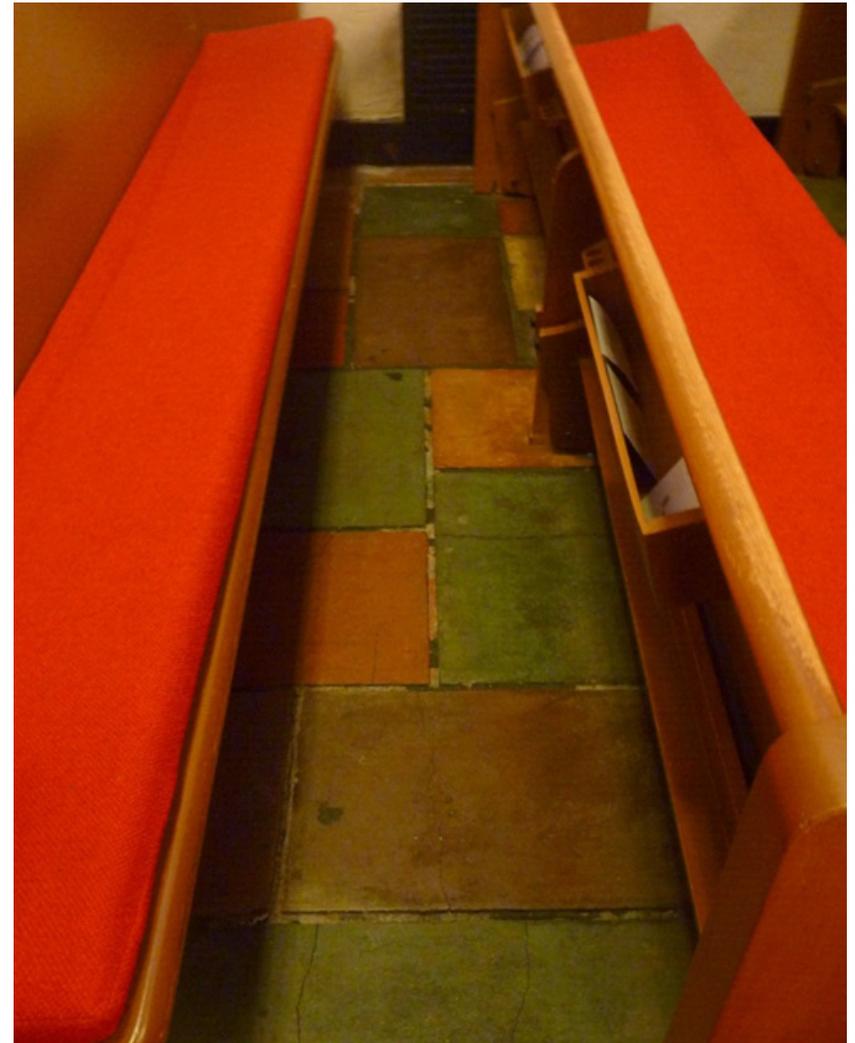
The stained cement floor tiles in the sanctuary, chancel, and organ space exhibit cracking, loss of setting grout, deterioration of the finish surface, and general spalling and loss of material. Tiles should be repointed, waxed, and possibly rebedded. Additional analysis is required to determine tile make, construction technique, and sealant requirements. All tiles should be salvaged and reused when possible. If new tile is necessary, tiles should match existing construction technique, material properties, polychromatic color scheme, and grout joint size. Focused attention should be paid to the tile in the next phase of the project in order to determine its materials composition, installation methods, etc., in order to specify the most appropriate repair treatment.

Example of concrete tiles stained in earth tones to give the appearance of clay tile.

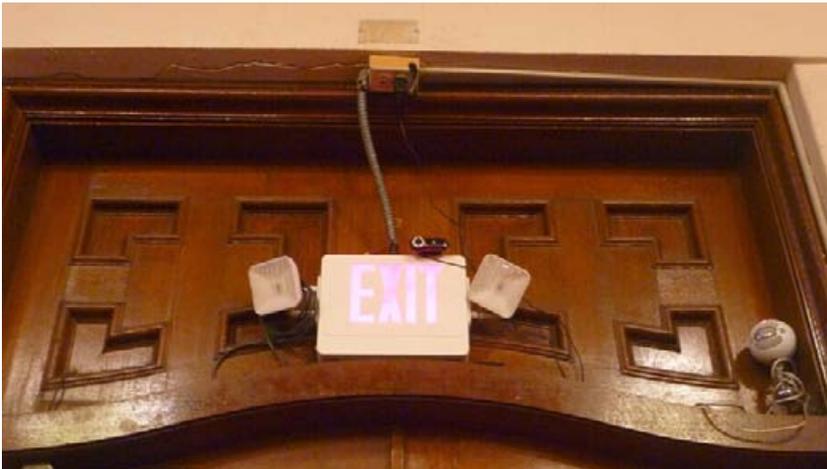
- Exit signs are required to be illuminated. The exit signs in the chancel do not meet this code requirement and must be replaced with approved illuminated exit signs, particularly if one or both are going to be designated as the alternate means of egress.

Main chapel entry transom with exit sign and webcasting equipment.

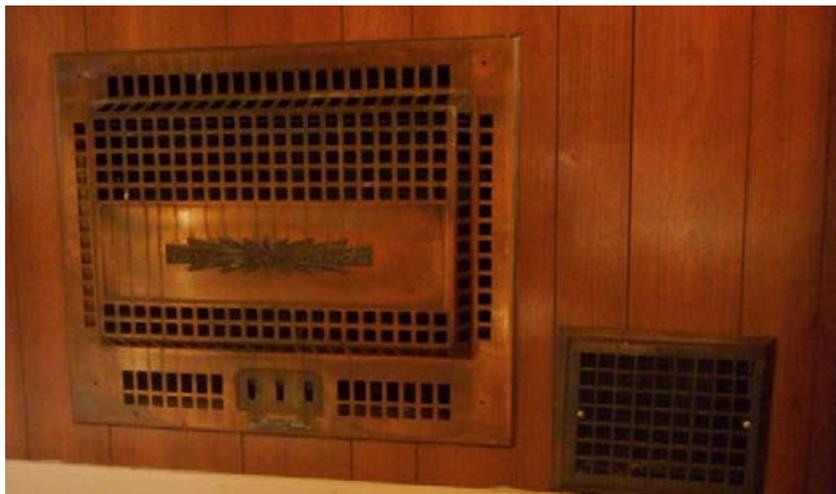
Historic Edison Electric Hotpoint wall heater.

- When a new HVAC system is installed, it is recommended that the historic Edison Electric Hotpoint wall heater be either reconditioned and restored to operability, or at the very least retained as a remnant of the building's historic fabric.
- It is recommended that programmatic changes be made to mitigate the need for a ramp from the cloister into the bride's room hall. If accessible restrooms are constructed elsewhere in the building, as proposed, then the ramp may no longer be needed if alternate accommodations can also be made for use of the bride's room.

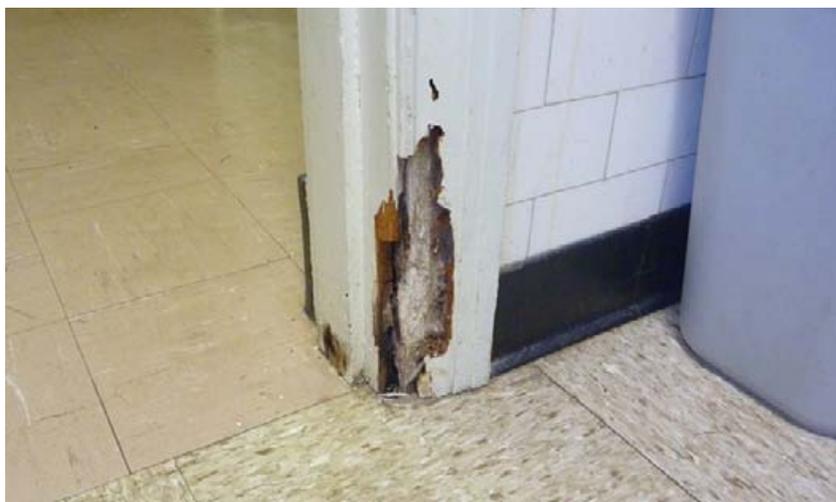
Rotted restroom door frame; also note asbestos floor tile.
